**AIRCRAFT ACCIDENT
INVESTIGATION REPORT**

ALL NIPPON AIRWAYS CO., LTD.

BOEING 737-800

JA56AN

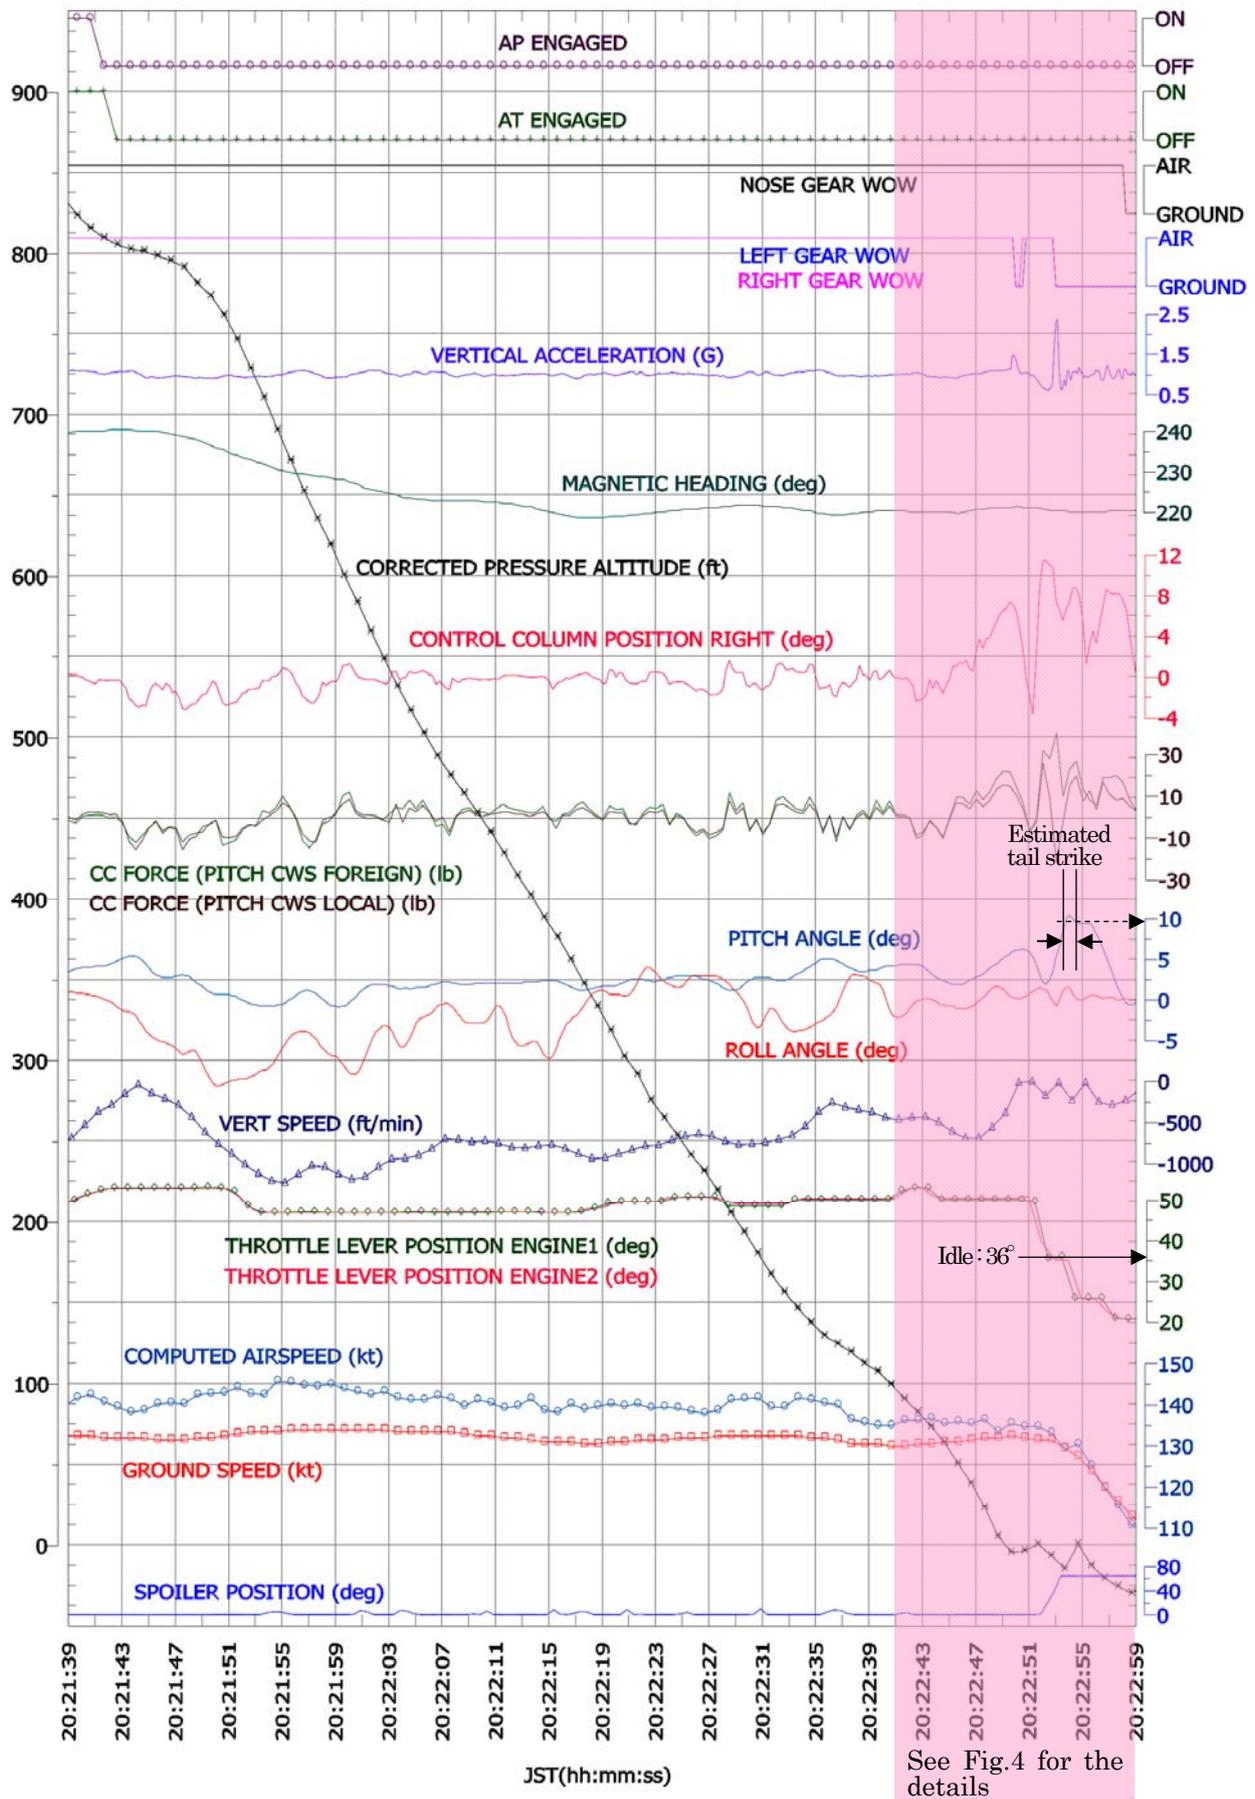
Figure 3 DFDR Records (1)

As depicted in Figure 3 and 4, DFDR records indicate that the CCP movement is followed by delayed pitch movement and there are points where a delay of approx. 1 sec is observed.

As depicted in Figure 3, the FO corrected the glide path near 150 ft, which the PIC mentioned that it was lower near 200 ft, by adding thrust and increasing pitch angle. Then he pushed the CCP after passing through 90 ft and it is considered highly probable that this input is linked to the decreasing pitch angle after flying over the runway 22 threshold with the altitude of approx. 60 ft RA and delayed increase in descent rate. He stated that he felt duration between automatic call-outs of "Fifty" and "Forty" shorter than usual, it is considered probable that his statement corresponds to then increasing descent rate of 600 to 700 fpm. Then the CCP value increases in the direction of pull when the Aircraft went through 30 ft. It is considered probable that this value increase corresponds to the action to reduce descent rate. He stated that when he heard "Thirty", he started to flare the Aircraft with added intention of maintaining then glide path, it is considered probable that this statement corresponds to the descent rate which started to decrease at around the time in the DFDR records. It is considered probable that the flare maneuver was started approx. 3 seconds before first touchdown, with the control column being pulled until the touchdown to reduce descent rate from 700 fpm, lead to a touchdown with approx. 100 fpm descent rate, while causing the pitch angle to

It is considered provable that the Aircraft bounced due to: approx. +6 ° pitch attitude at touchdown with airspeed of approx. 135 kt and the remained power setting –thrust levers not being retarded to idle position; and remained short-time nose-up attitude tendency of the Aircraft after the touchdown.

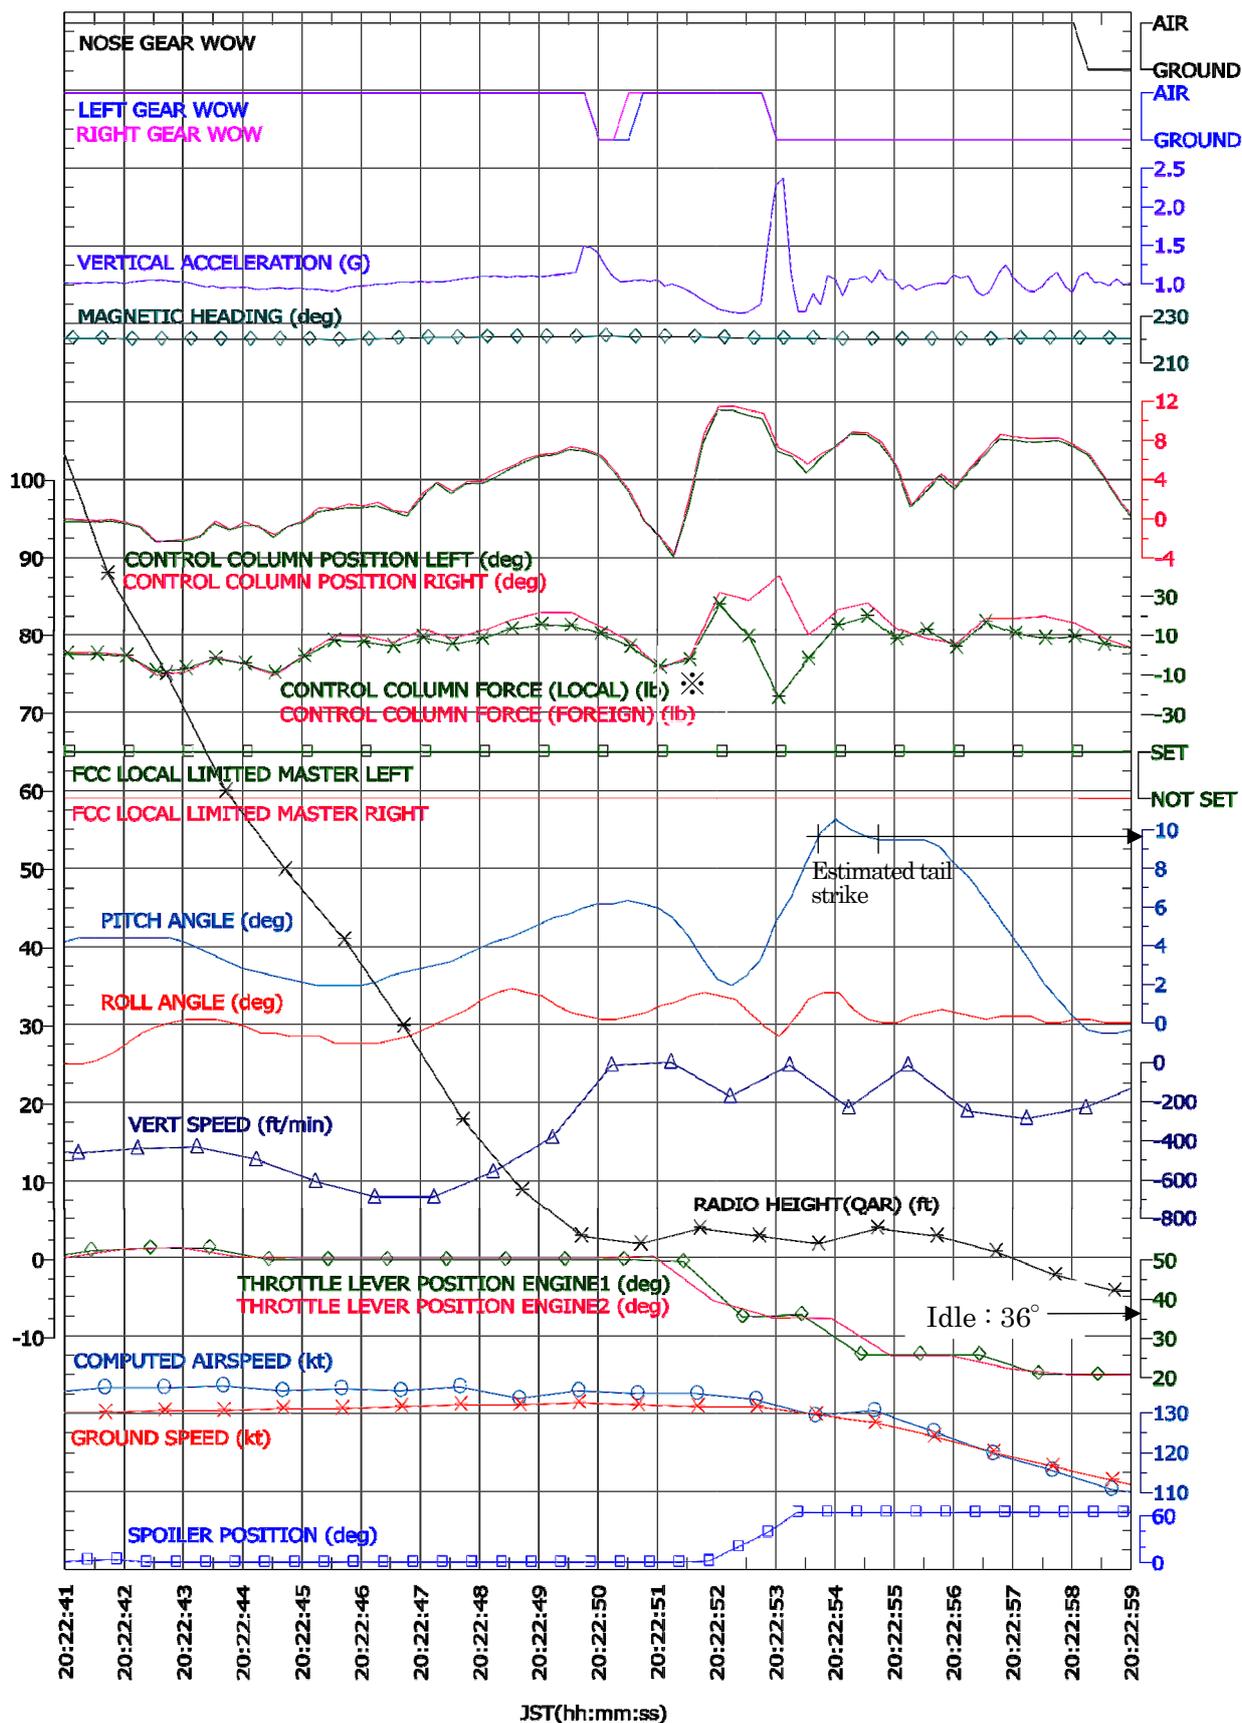
Figure 4 DFDR Records (2)

On the other hand, Figure 4 illustrates the PIC’s control column force as a push around 20:22:52, it is considered probable that this push corresponds to the PIC’s statement that when the Aircraft bounced he grabbed the control column and held it in place not to be pulled further, and he tried to restrain FO’s big control

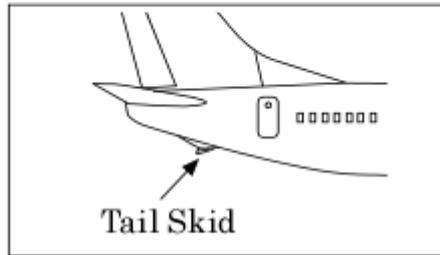
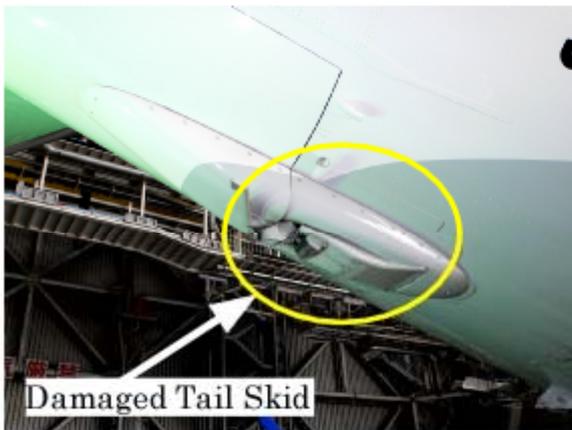
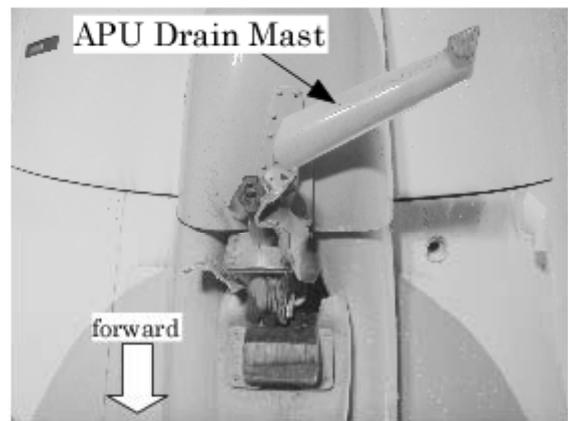
Photo 1 Damage on Tail Skid

- (1) Lower skin panel, aft fuselage: damaged
- (2) Lower frames and stringers, aft fuselage: damaged
- (3) Tail skid assembly: damaged

Wear shoe at the end of the tail skid was worn and its fairing was damaged. Aft drain mast, APU drain mast and APU cowl door were scratched and deformed.

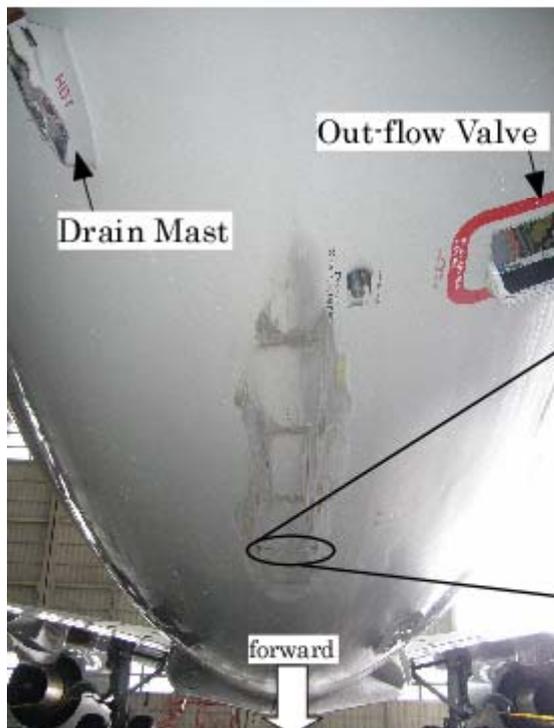
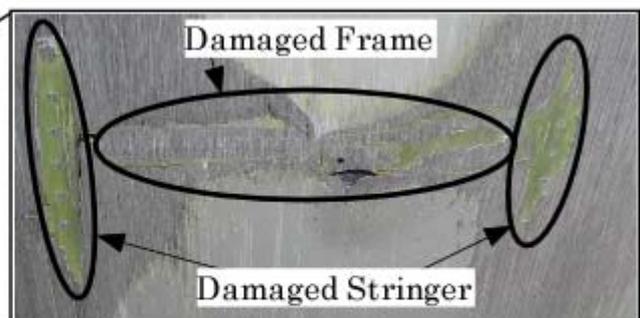
Photo 2 Damage on Fuselage

On the lower skin on and aft of Body Station⁵ (BS) 867, the area approx. 2.5 m (length) by approx. 25 cm (width) had dents and scratch marks with damaged inner structures of stringers and frames in the area.

Given the above mentioned facts it is considered highly probable that the effects of FO's large push-pull movement of the control column during the bounce lead to the delayed once-reduced pitch angle to regain its increase surpassing approx. 9.7 °, with added nose-up moment generated by the deployment of spoilers, consequently lead to a tail strike and fuselage damage.
