**AIRCRAFT ACCIDENT
INVESTIGATION REPORT**

DAMAGE FROM BELLY LANDING
SENDAI AIRPORT, JAPAN
AT AROUND 13:40, AUGUST 25, 2016

INDEPENDENT ADMINISTRATIVE INSTITUTION
CIVIL AVIATION COLLEGE
HAWKER BEECHCRAFT G58, JA5807

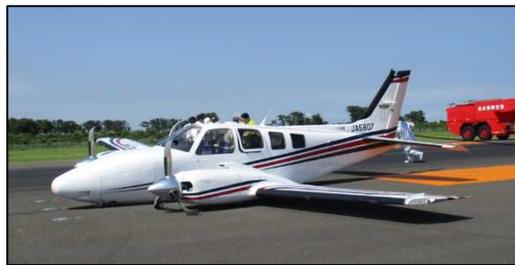
Photo 1 The aircraft

| <p>2.3 Damage to the Aircraft</p> | <p>(1) Extent of Damage: Substantial (2) Damage to the Aircraft Fuselage: Scratch marks on underside surface and Deformation of keels Propellers: Bending of blades Flaps in right and left: Deformed damage of internal parts</p> |

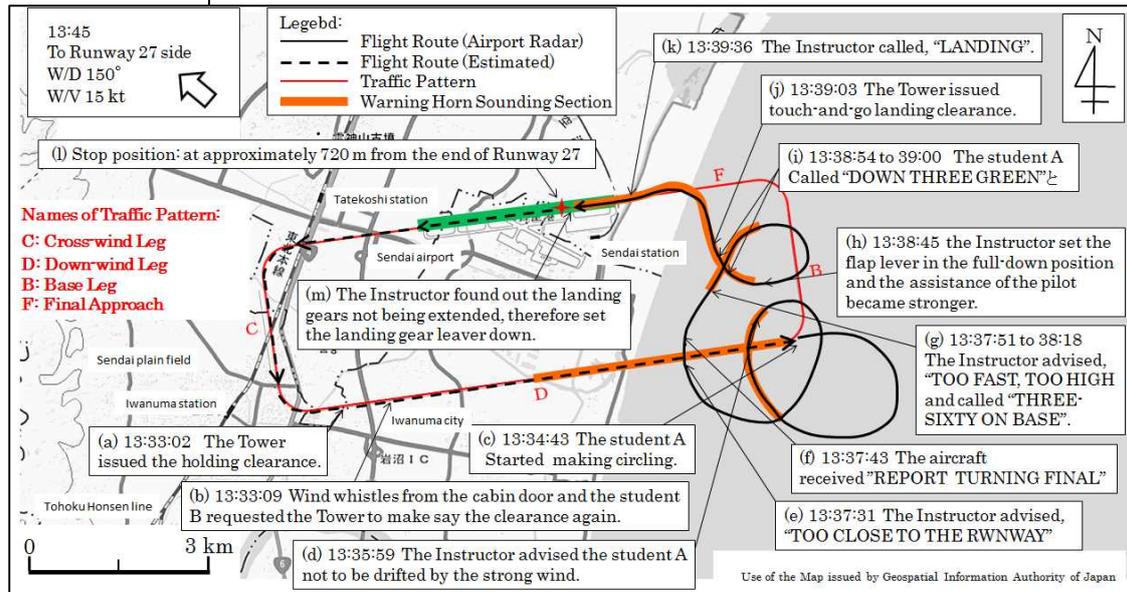
Figure 1 Estimated Flight Route Map

At 13:33:02, when the aircraft entered the Down-wind Leg at the south-side traffic pattern toward the Runway 27, a local controller of Sendai Airport traffic control tower (hereinafter referred to as “the Tower”) issued the holding clearance before the Base Leg to the aircraft (a). (corresponding to (a) in the Figure 1; hereinafter the same for (b) to (k)) The student A said to the student B that he accepted the clearance; but because student B could not hear it which was shielded by the wind whistle from the Door, at 33:09, student B requested the Tower to make say the clearance again (b), and read it back. The student B thought that it was difficult to continue the training as it was and reported the wind whistle to the Instructor. The Instructor found out that the lever of the Door were slightly off from the lock position and was about to open, therefore he operated the lever but it did not improve. The Instructor told students that he would retighten the Door during the next landing roll and continue the touch-and-go training, students agreed to the intention of the Instructor. The student A decided to postpone to perform the pattern checklist - to confirm that the landing gears were retracted and the flaps were set at up or at approach position based on the training manual of the college until the Instructor would have completed to check the conditions of the Door.

warning horn from the middle of the Down-wind Leg until the time of the main power of the aircraft was shut off. (See Figure 1 “Estimated Flight Route Map.”)

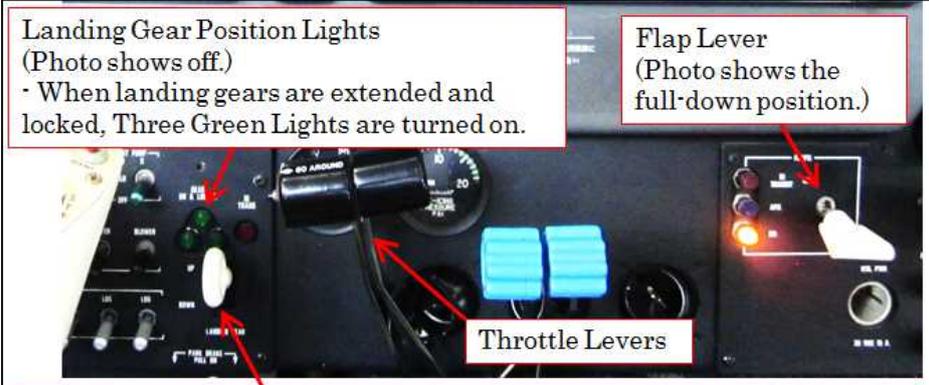
At 13:38:45, because the student A as PF did not issue an order, the Instructor called that “FLAPS DOWN” as setting flap lever in the full-down position (See Photo 2.). After that, the student A only placed his hand on the control wheel and the assistance to the pilot by the Instructor became stronger (h).

| <p>2.7 Additional information</p> | <p>(1) Situation at the Accident Site Marks hit by propellers blades and marks scratched by the undersurface of the fuselage were left on the Runway 27 from approximately 370 m inside of the Runway 27 threshold where the aircraft made a first touchdown until approximately 720 m where the aircraft stopped.</p> <p>(2) Confirmation of Landing Gears and others At the investigation after the accident, the landing gears, the flaps, the Door, the warning horn, the annunciator and the headset was confirmed that they did not have any functional malfunction.</p> <p>(3) Activate Condition of Warning Horn and Annunciator When any of the following conditions are satisfied, a warning horn and annunciator of notifying the gear-up status would be activated:</p> <ul style="list-style-type: none"> - Reduce one of the throttles to 13 inHg in the manifold air pressure or less without extending the landing gears. - Flaps are in the full-down position without extending the landing gears. (See Photo 2.) <div data-bbox="432 1429 1361 1928" style="border: 1px solid black; padding: 5px;"> <div data-bbox="432 1435 997 1579" style="border: 1px solid black; padding: 2px;"> <p>Landing Gear Position Lights (Photo shows off.) - When landing gears are extended and locked, Three Green Lights are turned on.</p> </div> <div data-bbox="1050 1435 1337 1556" style="border: 1px solid black; padding: 2px;"> <p>Flap Lever (Photo shows the full-down position.)</p> </div> <div data-bbox="901 1749 1125 1787" style="border: 1px solid black; padding: 2px;"> <p>Throttle Levers</p> </div> <div data-bbox="432 1821 1361 1928" style="border: 1px solid black; padding: 2px;"> <p>Landing Gear Lever (Photo shows the up position.) - When it is Pulled up, the landing gears are retracted; and when it is pulled down, they are extended.</p> </div> </div> <p style="text-align: center;">Photo 2 Landing Gear Lever and Flap Lever</p> |

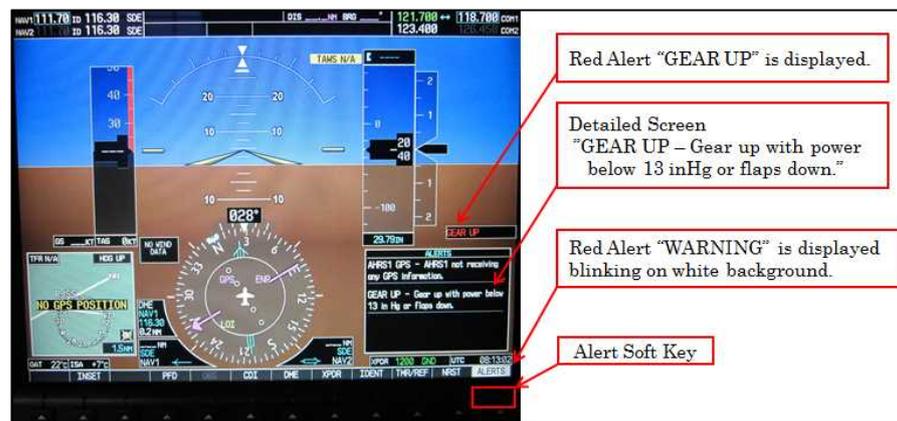
Photo 3 Display of the Annunciator on PFD when reset

When pressing the soft alert key meaning reset operation, the red blinking alert “WARNING” would be changed into the white display. When re-pressing the soft alert key, the details of the alert “GEAR UP–Gear up with power below 13 inHg or flaps down” would be displayed. (See Photo 3.)

However, as long as they are consistent with the operating conditions, the warning horn will not stop even if reset.

When the third times and the forth times Gear-up Warning were activated, it is somewhat likely that the student A reset the annunciator of notifying the gear-up status in a reflex manner

(7) Message which is in red or yellow of indicating abnormality should be shared with flight crew without leaving that as it is. As a characteristic of the aircraft, during the flight at traffic pattern, warning horn would be often activated. However, it should be understood that there should be no warning horn or no warning display of the annunciator when landing.
