**AIRCRAFT ACCIDENT
INVESTIGATION REPORT**

JAPAN AIRLINES CO., LTD.

J A 6 1 0 J

PASSENGER INJURY BY THE SHAKING OF THE AIRCRAFT JAPAN AIRLINES CO., LTD. BOEING 767-300, JA610J (JAPAN) AT AN ALTITUDE OF APPROX. 36,000 FT ABOVE FUJINOMIYA CITY, SHIZUOKA PREFECTURE NOVEMBER 26, 2012 AT 14:54 JAPAN STANDARD TIME

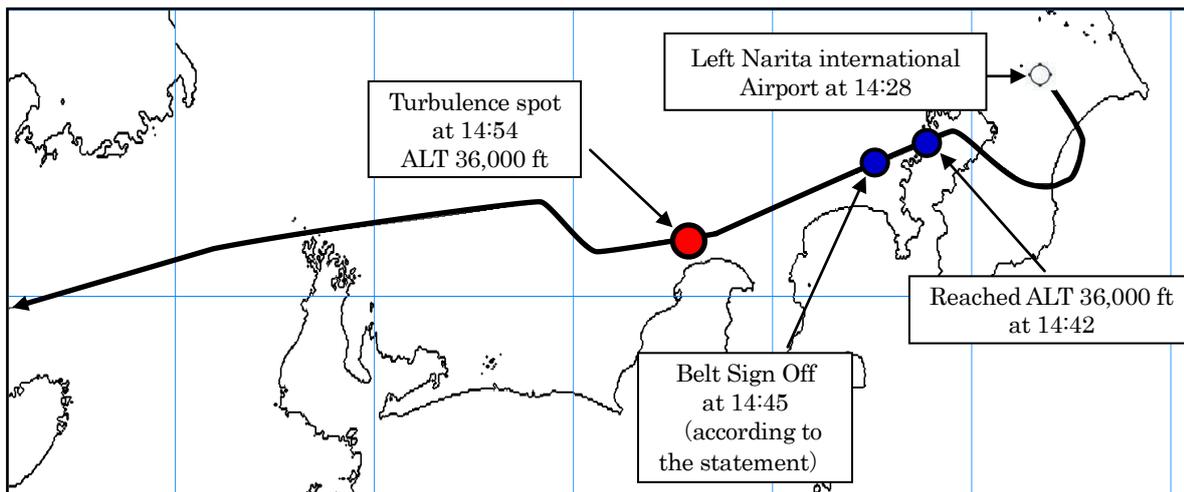
Figure 1 Estimated flight route

The accident occurred around 14:54 at an altitude of about 36,000 ft over Fujinomiya City, Shizuoka Prefecture (Latitude 35°12'24" N and Longitude 138°34'25" E). No PIREPs*3 were reported about turbulence at nearby airspace where the accident occurred around that time.

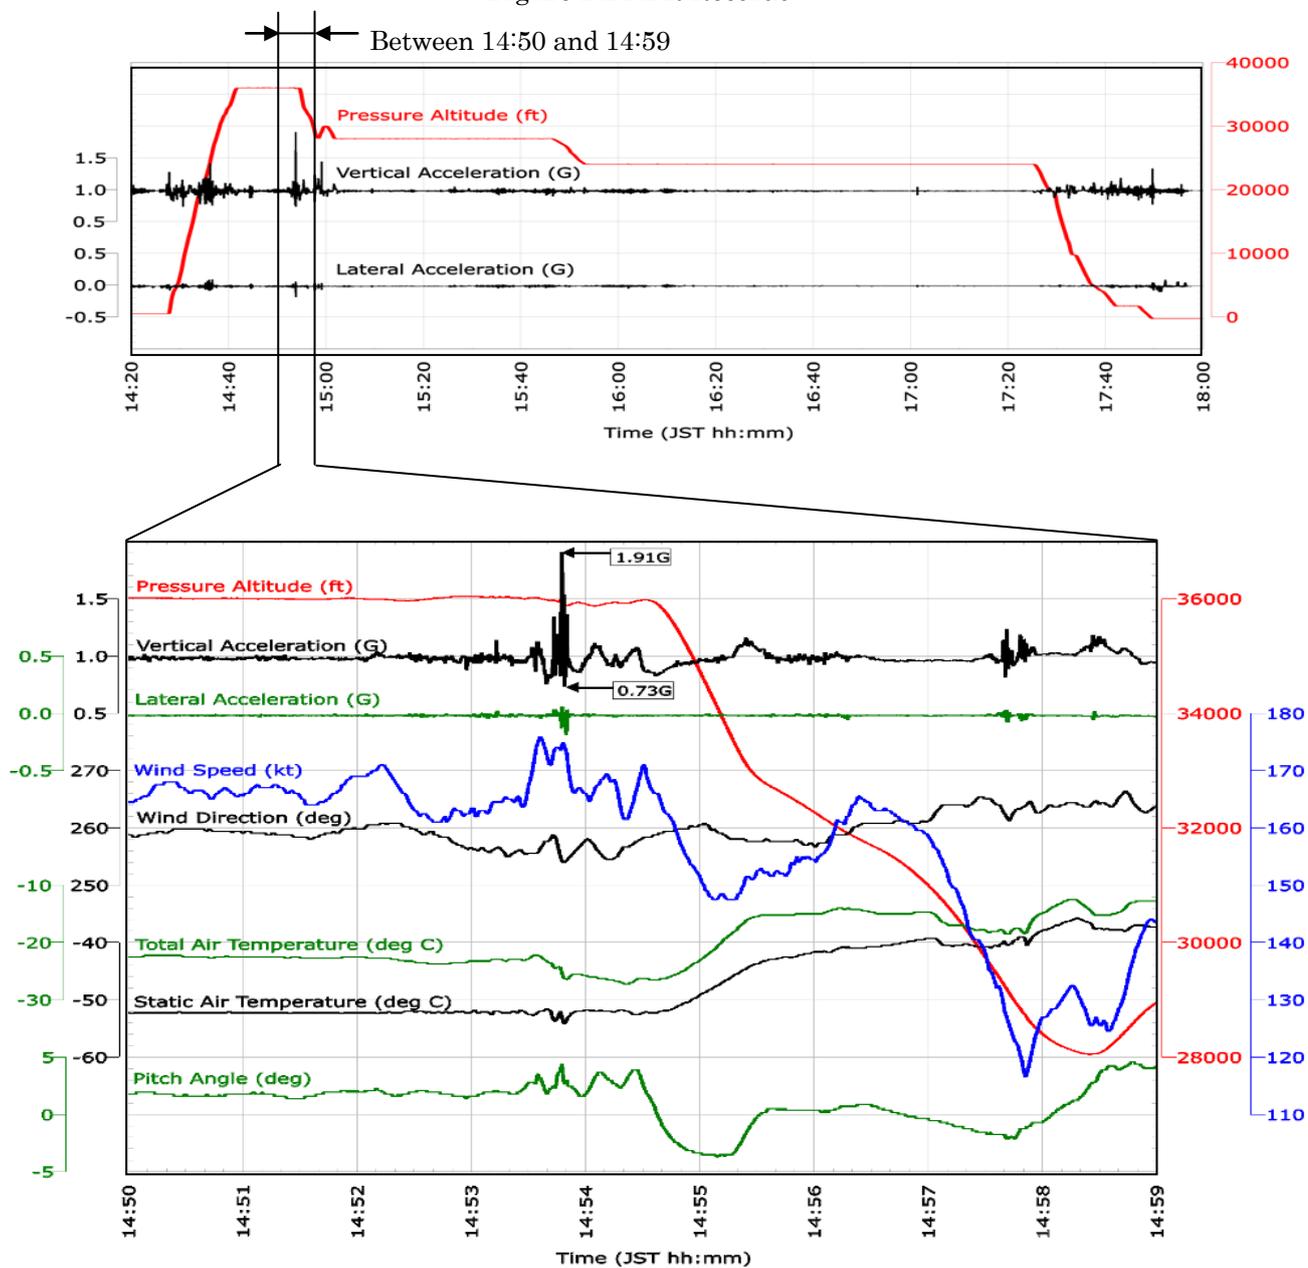
Figure 2 DFDR Records

The aircraft encountered the severe turbulence at an altitude of 36,000 ft over Fujinomiya City, Shizuoka Prefecture around 14:54, following some fluctuations in VSI (Vertical Speed Indicator). Until then, the aircraft had flown in a smooth and steady condition at that altitude and the on-board weather radar had not identified any active radar images. At the moment of shaking, the DFDR recorded the significant changes of vertical acceleration (deceleration to +0.7 G one second after acceleration to +1.9 G). The FO immediately turned on the seatbelt sign and started to descend to evade further turbulences.

3.1 Involvement of Weather	Yes
3.2 Involvement of Pilots	None
3.3 Involvement of Airplane	None
3.4 Analysis of Findings	<p>(1) In view of the history of the flight, it is highly probable that the severe turbulence corresponded to the significant change of the vertical acceleration recorded on the DFDR data. Due to this significant change of the vertical acceleration, it is highly probable that one of the passengers who had been away from his seat lost his body’s balance in front of the AFT lavatory, and injured the right foot seriously.</p> <p>(2) Around the time when the aircraft encountered severe turbulence, the</p>

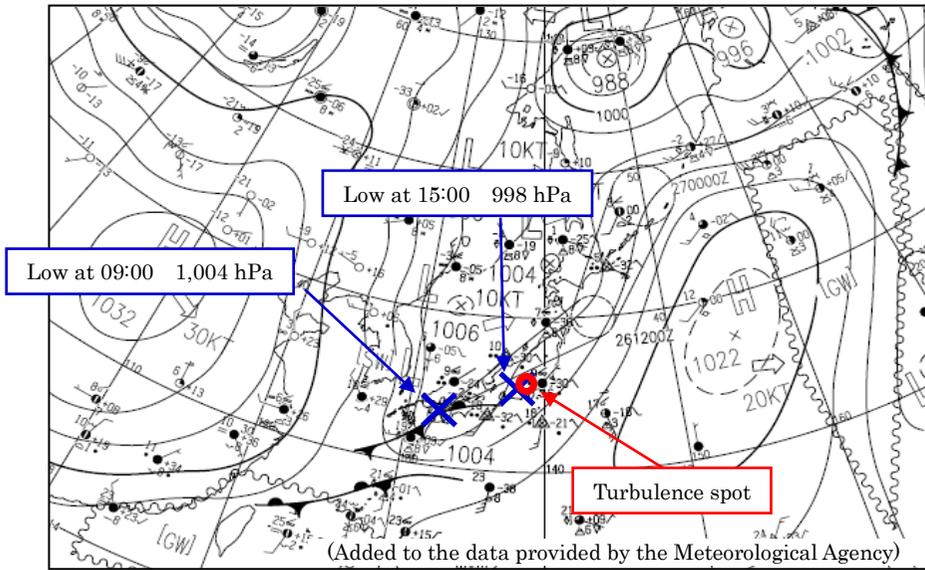
Figure 3 Asia-Pacific Surface Weather Chart (As of Nov. 26, 2012 at 09:00)

<p>developing Low with front stayed in the Tokai region. In the upper-level, Transverse Band which was generated along with the Jet stream was moving eastward. Bulge was formed in the north edge of Transverse Band and covered the turbulence spot. It is highly probable that, associated with the development of the ground-level Low, the strong southerly warm wind flowed into front of the Low in its direction of movement and this warm air flow caused to enhance the horizontal temperature gradient in the upper-level frontal zone. As a result, it is probable that the wind velocity in the vicinity of the Jet stream axis grew bigger in specific areas and the turbulence spot contained the possible large VWS in temporally and spatially limited narrow range.</p> <p>(3) It is probable that the aircraft encountered the severe turbulence caused by large VWS formed in a temporally and spatially limited narrow range, which made the aircraft shake severely, though VWS was not identified in the hourly analysis chart in spite of the fact that the turbulence spot was located in the vicinity of the jet stream axis.</p> <p>(4) The large VWS in the vicinity of the Jet stream axis that was seemed to occur at the turbulence spot (where the aircraft had flown) was not corresponded to the upper-level frontal zone or Transverse Band. Therefore, it was probable that the prediction of the occurrence of the turbulence was difficult. It is hoped that the prediction accuracy regarding detection of the turbulence areas will advance in the future through the progress in research and development of analysis technology in the field of aviation meteorology.</p>

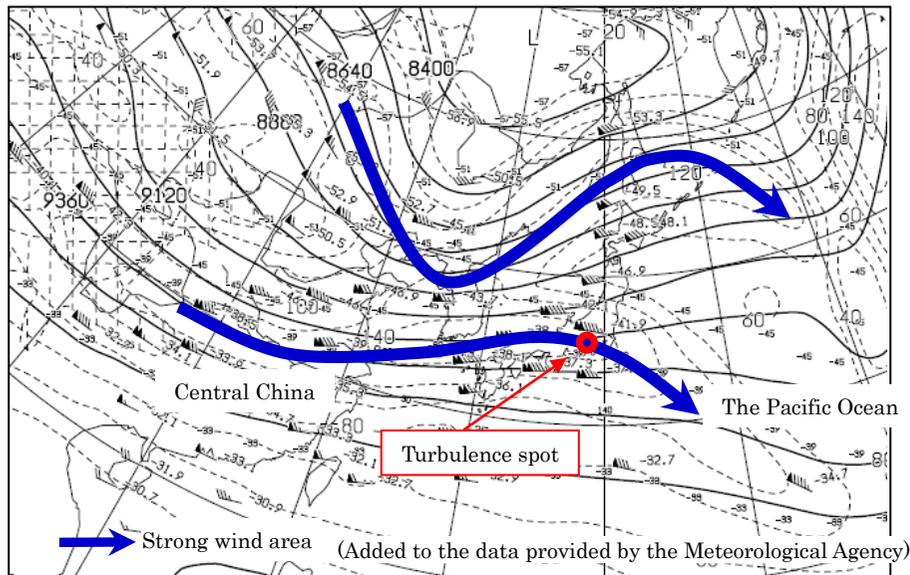
Figure 4 Asia-Pacific Isobaric Chart at 300hPa (As of Nov. 26, 2012 at 09:00)

<p>(3) Hourly Analysis Chart (cross-section drawing along 140°E longitude)</p> <p>On the hourly analysis chart (cross-section drawing along 140°E longitude) as of November 26, 2012 at 15:00, there were southern strong wind areas over eastern Japan which appeared in the Asia-Pacific Isobaric Chart at 300 hPa. Strong wind areas were shown at 35,000 ft and 40,000 ft in the vicinity of the Jet stream axis (the central axis of the Jet stream). There were two significant Vertical Wind Shear (VWS^{*5}) areas, which implicated the atmospheric disturbance. One appeared around 38,000 ft where Transverse Band was formed, and the other appeared in the upper-level frontal zone just below Jet stream axis of 35,000ft. However, there were not any VWS areas close to the turbulence spot.</p> <p>Observing the hourly analysis charts from 13:00 to 15:00 along with time went by, there was no definite change in the strong wind bands. However, the air-mass below the Jet stream axis was gradually turning bigger in the temperature gradient and at 15:00, the analyzed VWS areas were becoming narrow and the upper-level frontal zone was getting clear and distinct.</p> <p>(See Figures 3, 4, 5 and 6)</p>
