**AIRCRAFT ACCIDENT
INVESTIGATION REPORT**

**TOHO AIR SERVICE CO., LTD
J A 6 1 1 7**

October 30, 2009

**TOHO AIR SERVICE CO., LTD.
AEROSPATIALE SA315B ALOUETTE III (ROTORCRAFT)
JA6117
TAZAWAKO OBONAI TEMPORARY HELIBASE
SEMBOKU CITY, AKITA PREFECUTURE
AT ABOUT 12:15, OCTOBER 23, 2008**

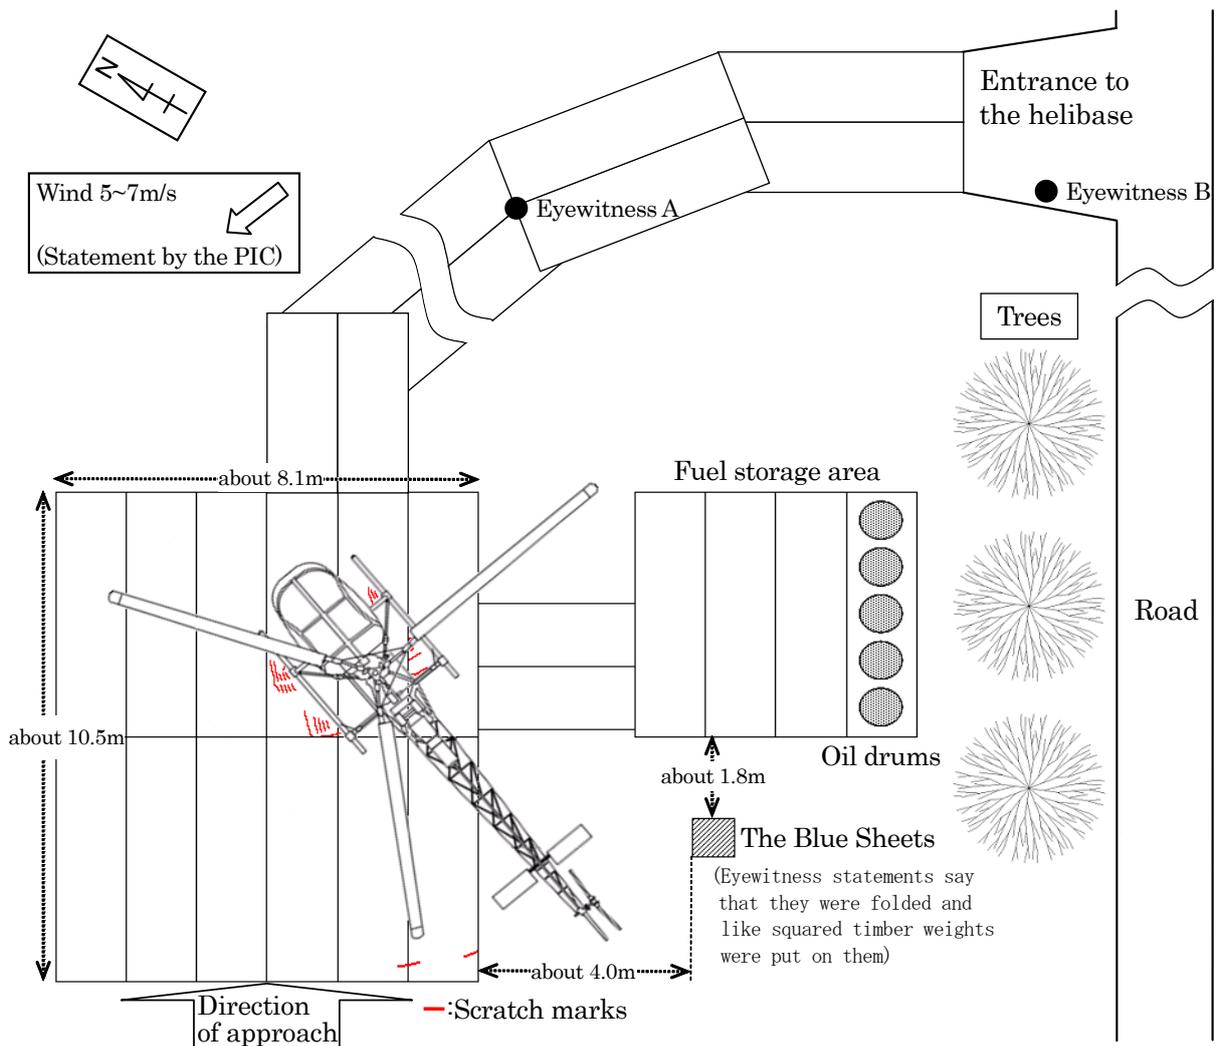
Figure 2 Accident Site Layout

The Aircraft sat on the steel plates orienting to the north, shifted away from the direction of the north-east approach. On the surface of the steel plates remained a series of scratch marks made by the skids and the tail rotor guard.

A scatter of Blue Sheet fragments as a result of being sucked into the main rotor disc was found within 10 m radius of the landing pad.

The Blue Sheets, as shown in Figure 2, were placed between the helipad and the 10 m away trees lining along the road. It is considered probable that the Blue Sheets were blown up in the air by downwash, with the added factors that the lateral dispersion of the air was blocked by the trees and the direction of the flow was channeled upwards, and it is considered highly probable that, consequently, one of the Blue Sheets was sucked into the rotating main rotor disc.

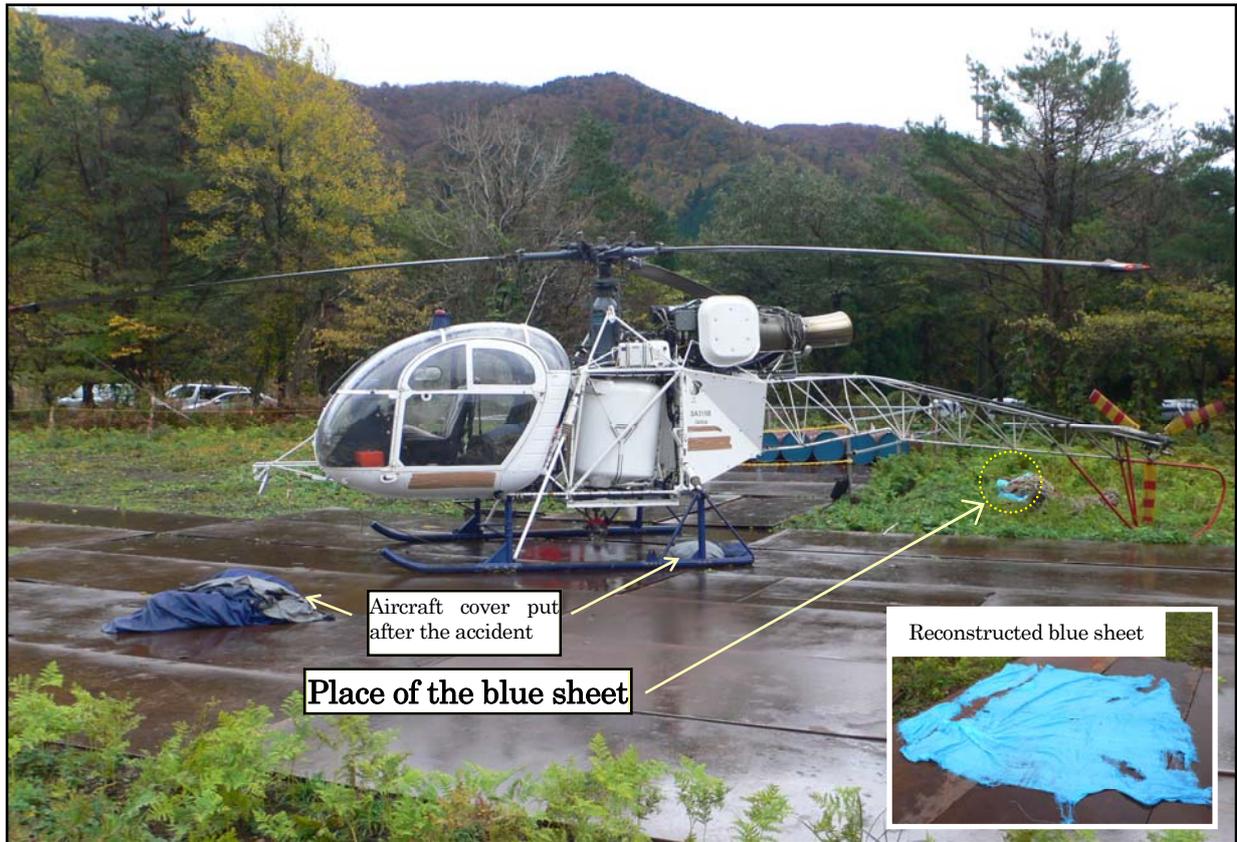
Photo 1 The Aircraft and Reconstructed Blue Sheet

Each of the Blue Sheets measures 3 m by 3 m. According to the statements by the PIC and the mechanic, they were folded and placed about 4 m away from the landing pad (1.8 m away from the fuel storage area), with some square cut timbers as weights. Although many square cut timbers (10 cm by 10 cm, 1 m long) were found in the accident site, timbers used as weights were not identified.

With regard to the Blue Sheets being blown up in the air, it is considered highly probable that they were placed under the effective downwash, while the square timbers, as the occupants of the Aircraft confirmed, were used as weights to secure the Blue Sheets, were not heavy enough to serve their purpose.

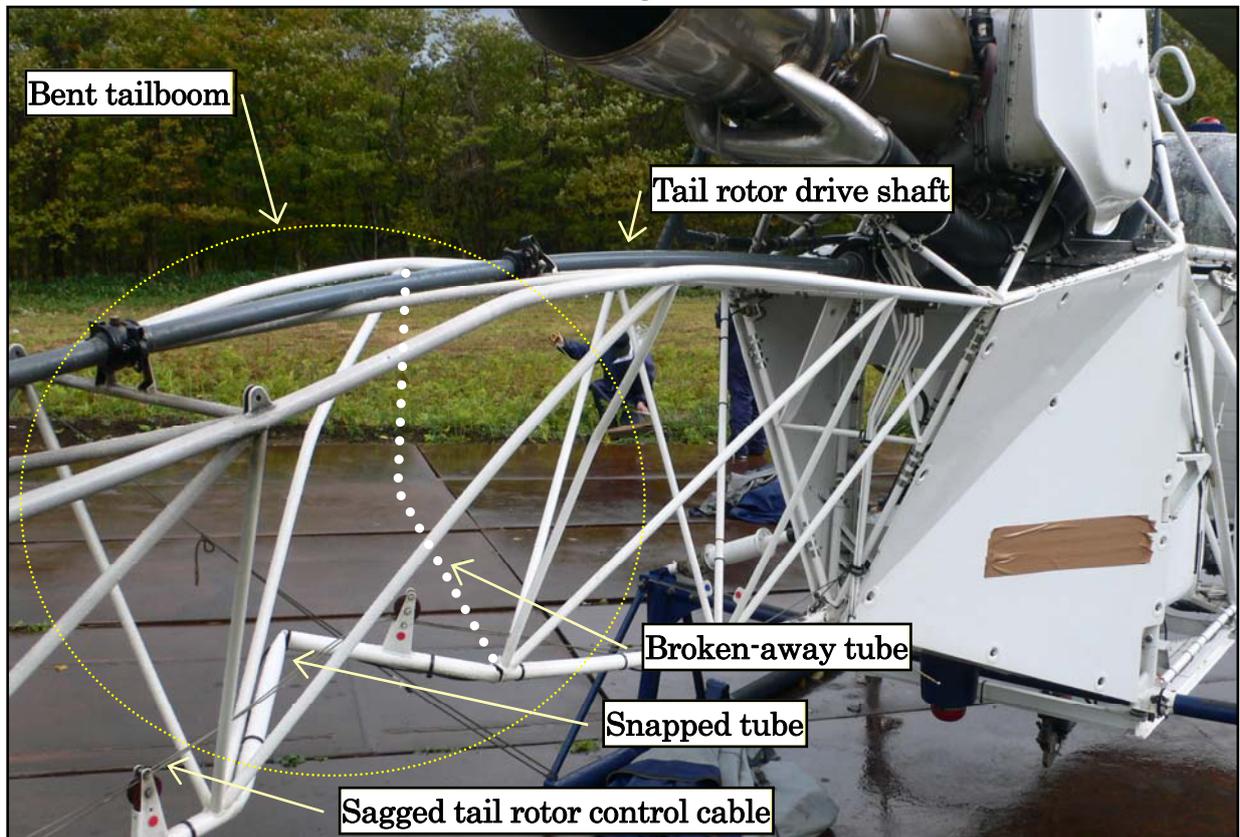
Photo 2 Damaged Tailboom

Tailboom and tail rotor drive shaft: bent and some support tubes were destroyed

(1) Some of the tubes forming the truss structured tailboom were damaged and snapped. The tail rotor drive shaft and the tailboom itself were bent downwards. Due to the bent tailboom, tail rotor control cable sagged. (See Photo 2 Damaged Tailboom)

The Aircraft landed on the ground with the right skid first and the vibration increased after the touch-down. It is therefore considered possible that touch-down force of the left skid was augmented by the downward phase of vibration, causing the shock struts to damage themselves. Also it is considered possible that at the same time, weight of tail rotor gearbox and other parts placed near the end of the tailboom acted upon it with excessive downward force --the tailboom was unable to withstand and it collapsed bending itself downward.

With regard to the counterclockwise directional change of the Aircraft on the ground, it is considered highly probable that the tail rotor control cable sagged as the result of the failed tailboom and tail rotor pitch was reduced to almost zero generating reduced amount of thrust.

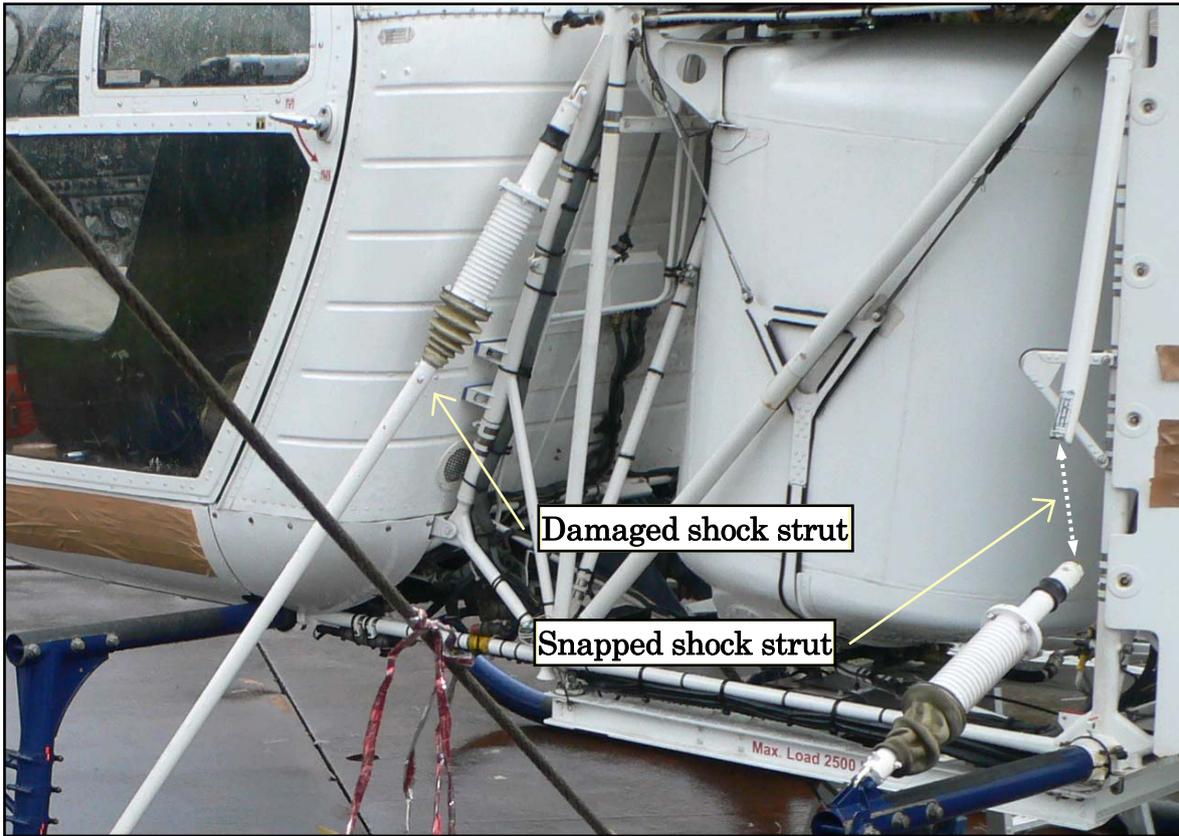
Photo 3 Damaged Left Shock Struts

Left shock strut: broken and snapped

(2) The forward shock strut on the left side of the fuselage was damaged and the aft shock strut was snapped. (See Photo 3 Damaged Left Shock Struts)

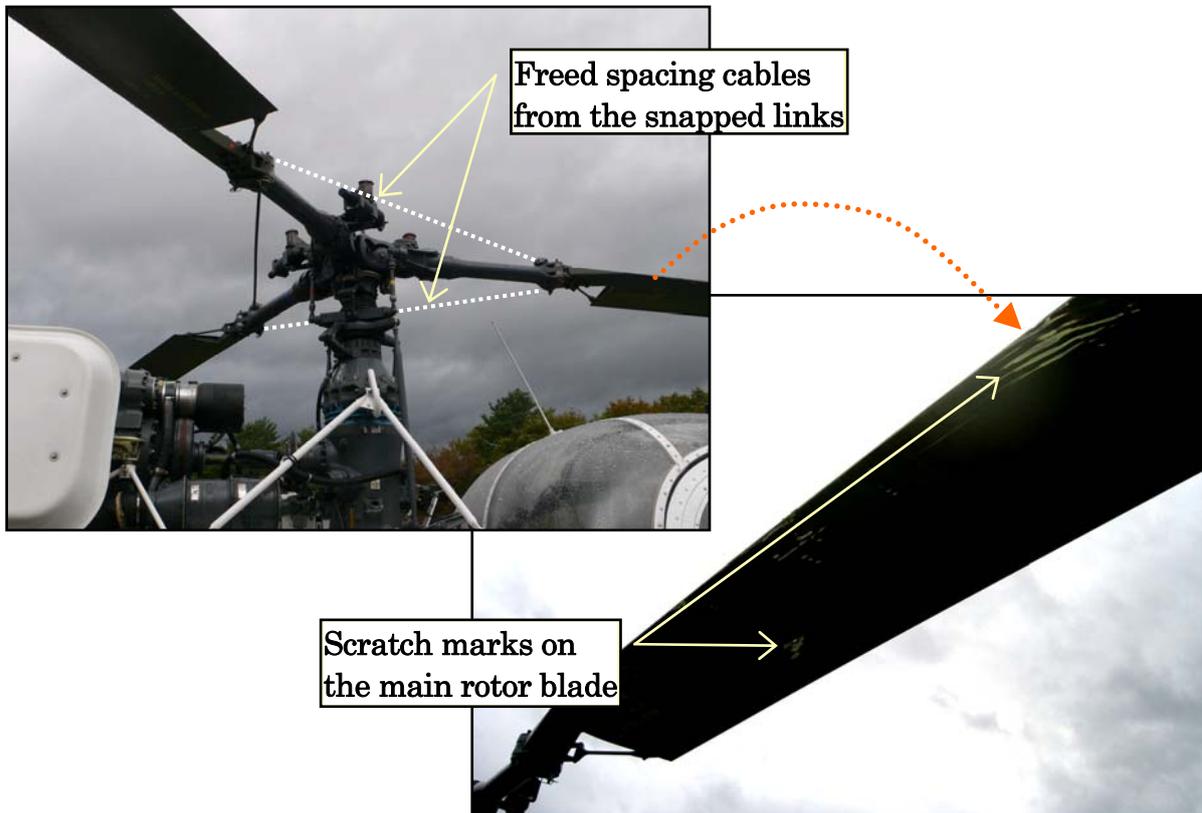
Photo 4 Damaged Main Rotor Blade

Main rotor blades: one of three blades was damaged

Spacing cables: Two of three cables were detached

(3) Among three main rotor blades, one blade had scratch marks solely on its leading edge. Among three spacing cables which maintain inter-blade distance, two spacing cables attached to the damaged main rotor blade were freed as a result of the damaged links to the blade. (See Photo 4 Damaged Main Rotor Blade)

It is considered highly probable that the main rotor blade which caught the Blue Sheet experienced increased drag and the lateral relationship with other blades became deteriorated causing the spacing cable connection links to snap. Freed spacing cables hit one of the main rotor blades and damaged it.
