**AIRCRAFT ACCIDENT
INVESTIGATION REPORT**

**ANA WINGS CO., LTD.
J A 6 4 A N**

October 28, 2021

CABIN CREW MEMBER INJURY BY SHAKING OF THE AIRCRAFT ANA WINGS CO., LTD. BOEING 737-800, JA64AN AT AN ALTITUDE OF APPROX. 8,200 M (FL270) OVER OZU CITY, EHIME PREFECTURE AT ABOUT 19:30 JST, APRIL 12, 2020

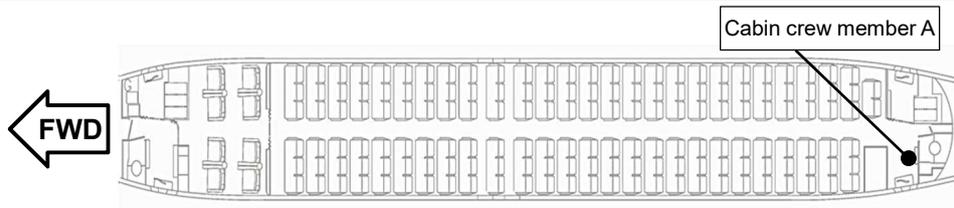
Figure 4 Location of the injured person at the time of Aircraft shaking

Besides, three cabin crew members were in the forward galley and L2 cabin crew member (hereinafter referred to as “the Cabin crew member A”) was in the aft of the airframe. The three cabin crew members in the forward galley escaped injuries by seating themselves or keeping their balance grasping the galley handle in response to the sudden shaking. On the other hand, the Cabin crew member A in the aft of the airframe was standing in front of L2 cabin crew member seat (Figures 3 and 4) facing the seat side at the time of encountering the shaking. At this time, the Cabin crew member A squatted and lowered his or her position to protect from the first shaking. However, he or she encountered the second shaking before being seated and fell on the floor from the left side of the body after his or her body floated in the air with his or her head hitting the ceiling. The Cabin crew member A severely hit the left lower back, left leg and forehead on the floor feeling terrible pains, nevertheless immediately took the seat and fastened seat belt. Then, the Cabin crew member A was asked about the situations by Senior cabin crew member and told that he or she fell by the shaking and was suffering severe pains.

It is probable that this accident occurred when the Aircraft shook during the flight in the clouds accompanied by the disturbance, and thereby one of the cabin crew members, who was not seated and floated in the air, was struck on the floor losing his or her balance, and sustained the injury.

(i) Flight safety information, etc. has been issued to secure that the outline of the event has fully been understood, and internal documents describing response for the case of encountering turbulence have been updated for thorough understanding.

(ii) Documents have been issued to ensure that in-flight monitoring, while seated depending on the situations, is conducted even if seat belt sign is turned off unless providing in-flight services or taking care of passengers.

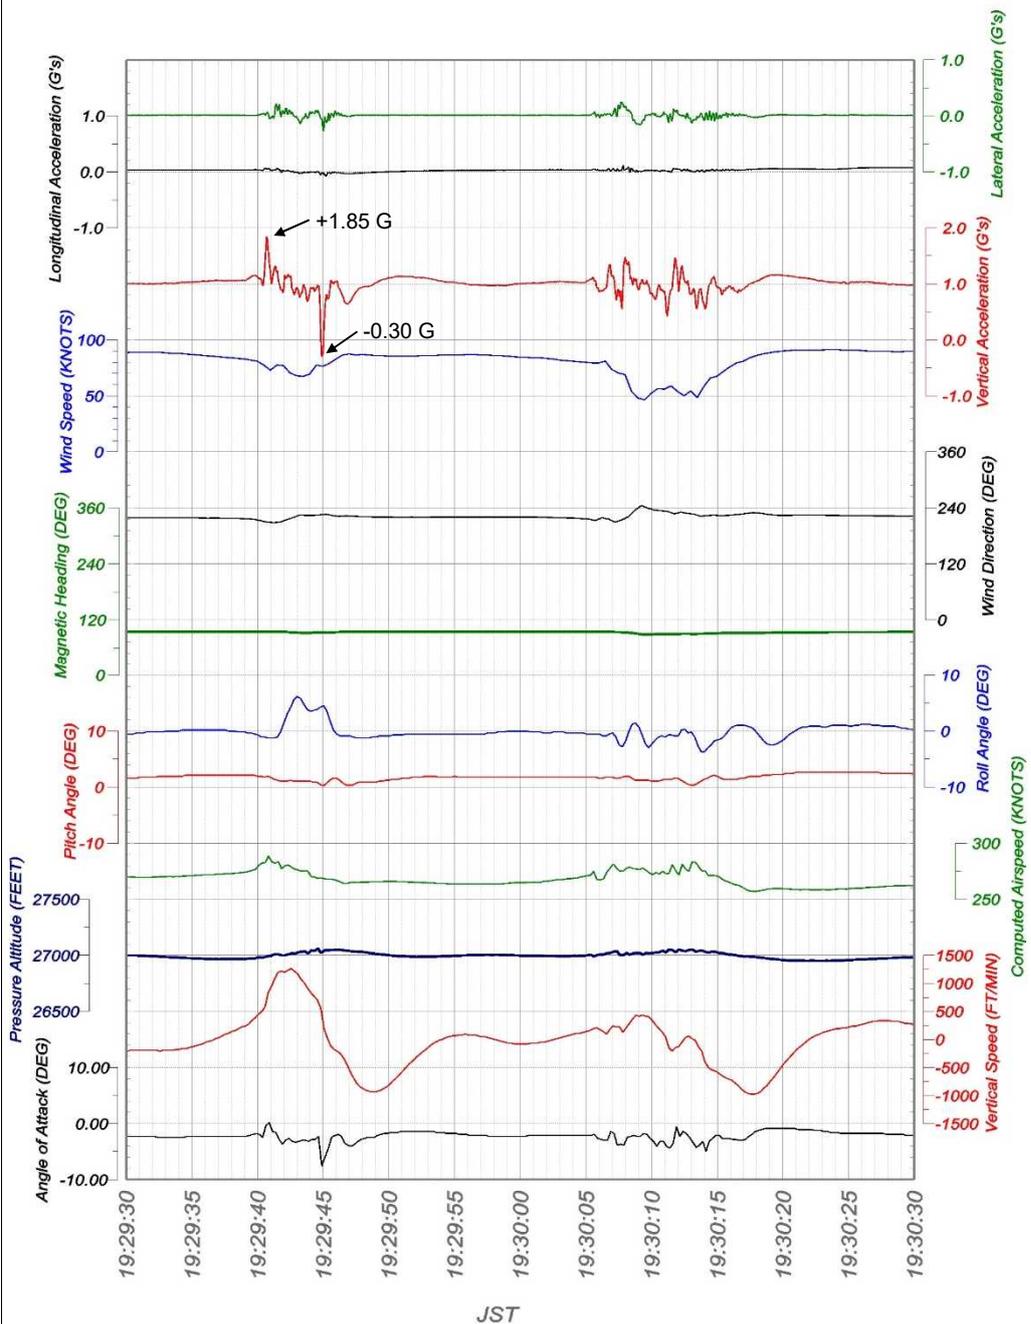
Figure 5 FDR record

<p>observe strongly developed echoes in the vicinity of the accident location.</p> <p>(2) Shaking of the Aircraft</p> <p>The FDR recorded that the vertical acceleration fluctuated between +1.85 G and -0.30 G for approximately eight seconds from 19:29:40. The Aircraft is more likely to have temporarily been flying in the clouds during this period and have fiercely shaken by the disturbance generated by convective activity in the clouds.</p> <p>(3) Meteorological judgements by flight crew members</p> <p>As the Aircraft was in the night flight at dark night when the accident occurred, which requires that judgments on the meteorological conditions be made by the visibility of the stars and lights can be seen in the external monitoring by visual recognition, it is probable that the situations were that detection of the clouds ahead and recognition of the shape of the clouds, etc. were difficult.</p> <p>(4) Response by a cabin crew member</p> <p>It is most likely that the Cabin crew member A, who received the negative gravity acceleration, was unable to avoid floating in the air due to the sudden shaking of the Aircraft, was struck on the floor losing his or her balance when dropped and sustained the injury.</p> <p>(5) Securing safety of passengers</p> <p>When the Aircraft shook fiercely, all 20 passengers were seated and fastened seat belts although seat belt sign was turned off, That is most likely to have contributed to the fact that none of the passengers sustained injuries. This is more likely to have successfully been achieved by the safety measures regularly taken to urge passengers to fasten seat belts anytime while seated.</p>

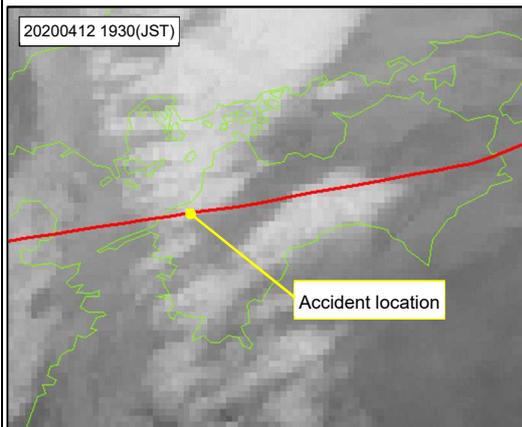
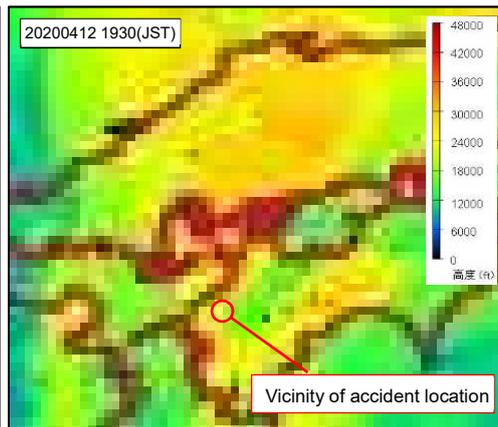
2.6 Meteorological Information	<p>(1) Meteorological conditions in the airspace of the accident occurrence</p> <p>According to the Meteorological Satellite Image announced at 19:30 on April 12, 2020 (Figure 6), there existed white and deep cloudy areas in the vicinity of the location where the Aircraft shook, and according to the cloud top height analysis of the High-Frequency Satellite Image announced at the same time (Figure 7), the existence of clouds with the cloud top height of 24,000 ft to 30,000 ft was analyzed. Besides, according to the Radar composite maps issued at the same time, generally weak echoes were observed in wide areas in the echo strength (Figure 8), and the echo top height (Figure 9) showed that the echoes at the heights of 7 km (approximately 23,000 ft) to 8 km (approximately 26,000 ft) were scattered in the vicinity of the location where the Aircraft shook and the echoes at the heights of 5 km (approximately 16,000 ft) to 6 km (approximately 20,000 ft) were</p>

<p>3.1 Involvement of Weather</p>	<p>Yes</p>
<p>3.2 Involvement of Pilots</p>	<p>None</p>
<p>3.3 Involvement of Aircraft</p>	<p>None</p>
<p>3.4 Analysis of Findings</p>	<p>(1) Weather From the CVR records and Meteorological Satellite Images (Figures 6 and 7), the clouds accompanied by the disturbance and developed to the altitude close to the cruising altitude are most likely to have existed in the flight route in the vicinity of the location where the Aircraft was shaken. However, it is probable that such strong echoes as ones from which flight crew members could predict the disturbance with the airborne weather radar were not observed because the Radar composite maps (Figures 8 and 9) did not</p>
