**AIRCRAFT SERIOUS INCIDENT  
INVESTIGATION REPORT**

**TOHO AIR SERVICE CO., LTD.  
J A 6 6 9 7**

## DAMAGE OF ENGINE (LIMITED TO SUCH A CASE WHERE FRAGMENTS PENETRATED THE CASING OF SUBJECT ENGINE) TOHO AIR SERVICE CO., LTD. AEROSPATIAL AS355F2, JA6697 OVER AN AREA NEAR AIKAWA-CHO, AIKO-GUN, KANAGAWA PREFECTURE, JAPAN AROUND 17:55 JST, JUNE 19, 2019

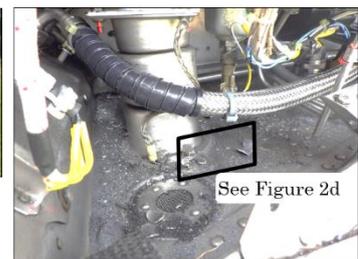
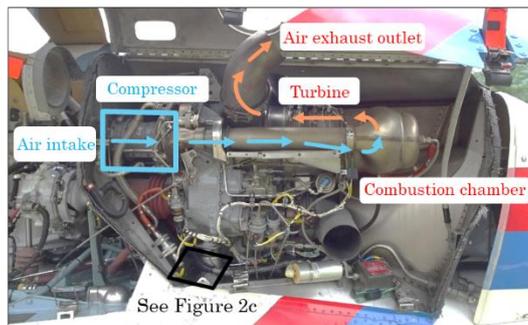
Figure 2: Fragments of the blades scattered inside the engine compartment

Fragments of the stator vanes and blades of compressor were scattered inside the engine compartment. (See Figure 2)

The engine cowl partially turned black in the interior areas.

Figure 2c Undersurface of engine compartment (fragments of blades etc. were scattered)

Figure 2b Engine compartment interior (Engine cowl is opened)

Figure 2d Fragments of (typical) blades penetrated the compressor case

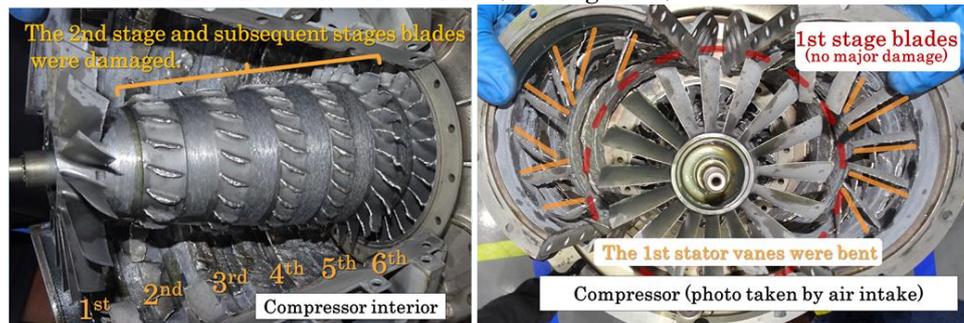
Figure 4: Compressor interior      Figure 5: Leading edge of compressor

The 1st stage blades of compressor had no major damage, but the 2nd stage and subsequent stages blades, and stator vanes were remarkably damaged. (See Figure 4)

The 1st stage stator vanes in front of the 2nd stage blades were bent in the direction of rotation. (See Figure 5)

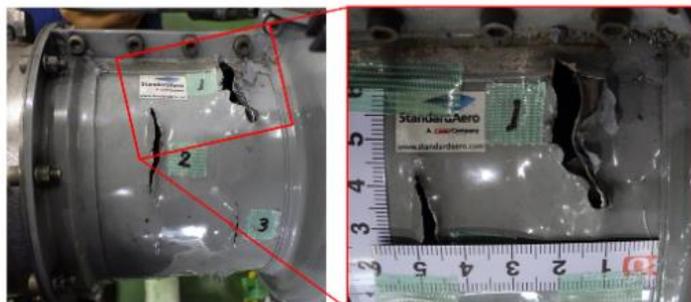
Figure 6: Compressor case

On the compressor case, there were 11 openings cracking toward the outside, and deformation and dents were observed all around. (See Figure 6)

On the compressor case there were 11 openings cracking toward the outside in the 2nd stage and subsequent stages of compressor, and deformation and dents were observed all around (See Figure 6). It is highly probable, therefore, that fracture of the 2nd stage blades was the starting point of the continuous damage to the subsequent stages blades and stator vanes etc., and those fragments penetrated the compressor case.

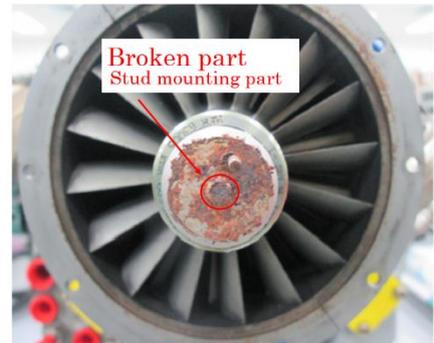
Figure 7: Corrosion on the front bearing housing

Note 1: A mechanic conducted an inspection on the front bearing housing of compressor and found that the stud of the housing was broken.

Note 2: During the teardown inspections of the compressor at the engine repair facility, it was found that the front bearing housing of the compressor was remarkably corroded centering on its stud, thus, it was replaced.

Besides, the compressor blades were slightly damaged by the corrosion removable by cleaning, and the compressor case was damaged by the corrosion required to replace. According to each section in the Maintenance Manual of Design and Manufacture of the engine (hereinafter referred to as “the Engine Manual”), they were cleaned and replaced. In addition, inspections of every 300 flight hours or every 12 months, whichever occurs first, for the compressor case, blades and vanes was performed and it was confirmed that there were no other anomalies in the compressor.

According to the history of the Engine, during the period between April 2015 and August 2017, the Engine was installed to be operated as the No. 1 Engine for JA9647 which was operated by the Operator and based in Miyagi Prefecture. And in August 2017, as the stud for the front bearing housing of compressor was broken, the Engine was removed from the airframe. On this occasion, at the engine repair facility, in addition to the remarkable corrosion developed centering around the stud for the front bearing housing, the corrosion on the compressor case were observed, therefore, they were replaced with new ones. (See Figure 7)

In case of observing corrosion so remarkable that the stud for the front bearing housing of compressor could be broken, it is important for the Operator to properly perform maintenance by fully considering that engines might have been exposed to a severely corrosive environment and carefully inspecting components subjected to corrosion during visual examination at the time of the engine storage management and installation, even if engines have been repaired at an engine repair facility.
