**AIRCRAFT SERIOUS INCIDENT
INVESTIGATION REPORT**

**NAKANIHON AIR SERVICE CO., LTD.
JA6717**

DROPPING OF OBJECT
DURING EXTERNAL CARGO SLING OPERATION
KITAGAWA-VILLAGE, AKI-GUN, KOCHI PREFECTURE, JAPAN
AT AROUND 15:32 JST, SEPTMBER 23, 2017

NAKANIHON AIR SERVICE CO., LTD.
AÉROSPATIALE AS332L1 (ROTORCRAFT), JA6717

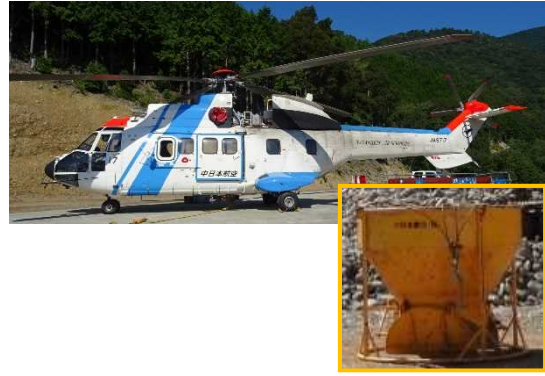
1.1 Summary of the Serious Incident	On Saturday, September 23, 2017, an Aérospatiale AS332L1, registered JA6717 and operated by Nakanihon Air Service Co., Ltd., dropped stones being carried in a bucket that was slung external to the aircraft immediately after taking off from a cargo sling point of the Kojima temporary helipad in Kitagawa-village, Aki-gun, Kochi Prefecture.

Photo 1 The Aircraft and Bucket of the Serious Incident

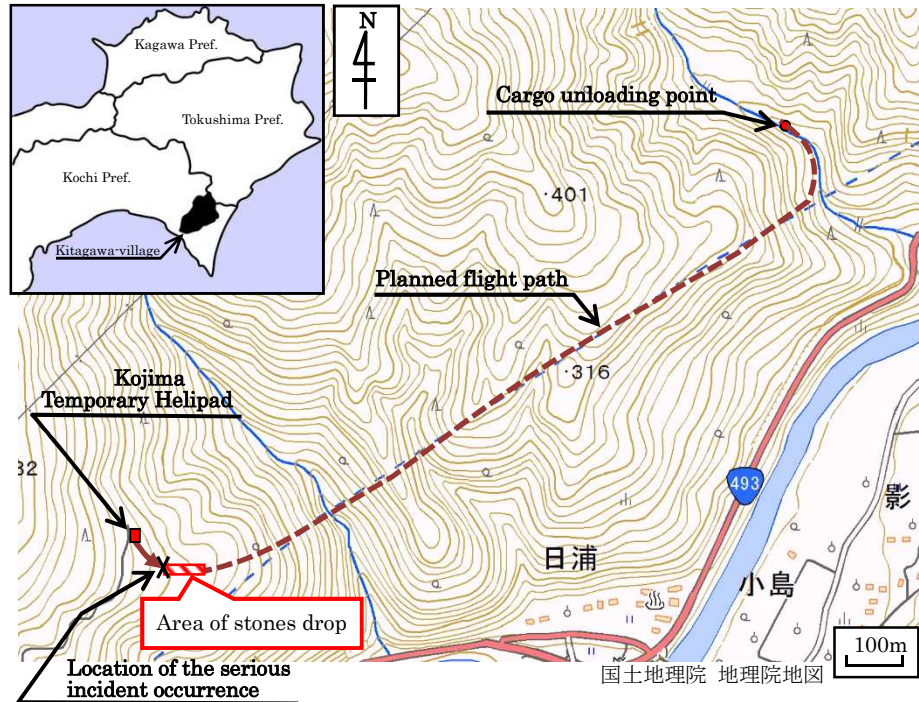
This serious incident occurred at approximately 80 m southeast from the Temporary Helipad (N 33° 29' 55", E 134° 05' 27") and at around

Figure 1 Estimated Flight Route and Area of Stones Drop

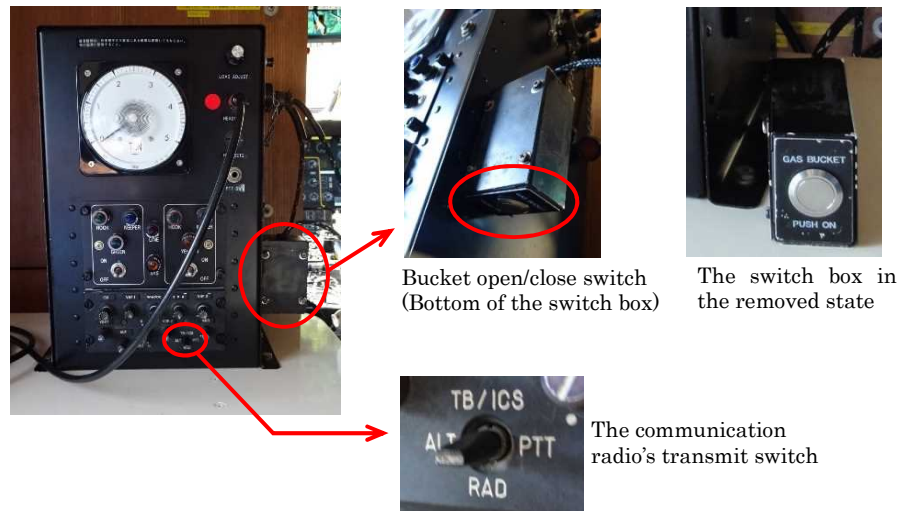
A switch box was installed on the right side of the control box, and the bucket open/close switch was installed on the bottom of the switch box. This switch box can be removed from the control box and can be operated by placing it on a desk or holding it with a hand; however, at the time of this serious incident, the switch box was being used while attached to the control box.

The bucket open/close switch is a push button. The bucket opens during the time the button is pushed.

The transmit switch of the communication radio is installed on the lower front side of the control box. Moving the switch down (to the “RAD” position shown in Photo 2) puts the radio in the transmit mode.

Photo 2 The Control Box

3.1 Involvement of Weather	None
3.2 Involvement of Pilots	None
3.3 Involvement of the Equipment	None
3.4 Analysis of Findings	<p>(1) Dropping of the stones</p> <p>It is certain that this serious incident occurred because the bucket opened and the stones dropped immediately after the Aircraft took off from the cargo sling point carrying stones in the bucket, in the reason why the onboard mechanic mistakenly operated the bucket's open/close switch instead of the transmit switch of the communication radio when he intended to communicate a warning to the trainee.</p> <p>(2) The onboard mechanic</p> <p>It is certain that the onboard mechanic had received the necessary education and training.</p> <p>Regarding the onboard mechanic operated the bucket's open/close switch by mistake instead of the communication radio's transmit switch, it is probable that this occurred when, while in a state in which his attention was focused on thinking about how to communicate a warning to the trainee and his attentiveness to the bucket's operation was faded, the onboard mechanic unintentionally operated the bucket's opening, which was an action that he had been conducting repeatedly until that time.</p> <p>Additionally, it is somewhat likely that the onboard mechanic did not notice the mistake in the switch he was about to operate because he was not looking at his hand when operating the switch.</p> <p>(3) Design of the control box</p> <p>The bucket's open/close switch had a design that opened the bucket simply by pressing the open/close switch and did not have a mechanism to prevent wrong operation. Because of this, the bucket opened when the onboard mechanic mistakenly pressed the bucket's open/close switch. It is probable that using a mechanism that requires the operation of multiple switches to open/close the bucket or a switch fitted with a guard, etc., would be effective measures for preventing wrong operation.</p>

It is certain that this serious incident occurred because the bucket opened and the stones dropped immediately after the Aircraft took off from the cargo sling point carrying stones in the bucket, in the reason why the onboard mechanic mistakenly operated the bucket's open/close switch instead of the transmit switch of the communication radio.

- (1) The Company carried out individual re-education on preventing human errors for the onboard mechanic.
- (2) The Company carried out education on preventing human errors for all employees involved in operations and executive-led safety education at cargo transport sites. Additionally, the Company issued a notification concerning the prevention of human errors by the safety supervisor and disseminated it within the company.
- (3) For the Aircraft and other aircrafts in the Company that use a bucket's open/close switch of the same type as that used on the Aircraft, by installing an additional toggle switch in order to prevent wrong operation, the Company improved the switch function so that open/close operation for the bucket cannot be performed without a simultaneous operation with the existing switch.
