**AIRCRAFT SERIOUS INCIDENT
INVESTIGATION REPORT**

**TOHOKU AIR SERVICE, INC.
JA 6777**

TOHOKU AIR SERVICE, INC.
AEROSPATIALE AS332L1 (ROTORCRAFT)
JA6777

DROPPING OF OBJECTS
DURING EXTERNAL CARGO SLING OPERATION
YURIHONJO CITY, AKITA PREFECTURE, JAPAN
AT AROUND 12: 30 JST, JULY 22, 2015

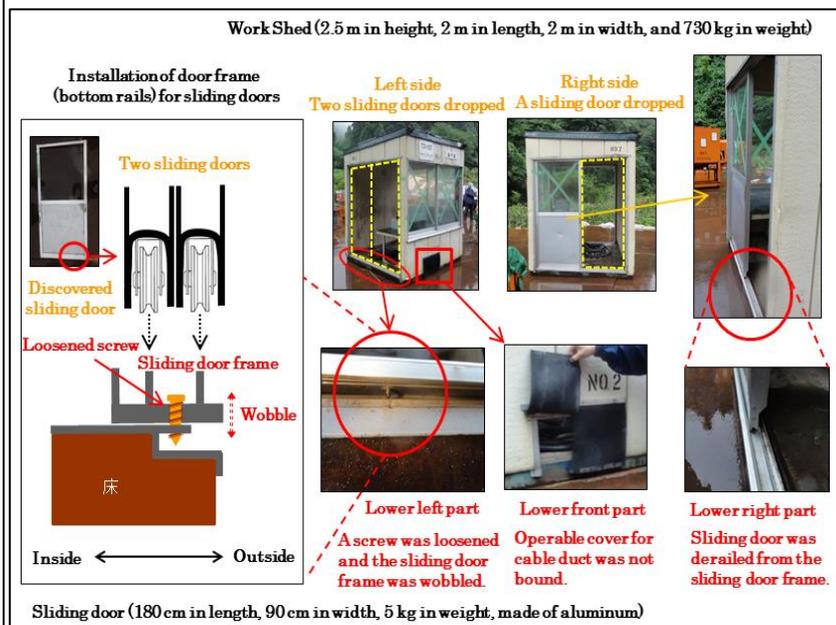
Figure 2 Work Hut

Two sliding doors from the left side and one sliding door from the right side was missing. The remaining sliding door at the right side derailed from the rail of the sliding door frame. The sliding door frame at the left side where lost two sliding doors was installed with to the hut by steel screws, but the screws were loosened and the frame was wobbled. A sliding door of the recovered three sliding doors was confirmed to be

<p>locked and the remaining two doors were not confirmed to be locked because the damages by the drop were too severe. The lower front part had a rubber cover for cable duct which can be opened and closed but it was not bound.</p> <p>(6) Flight route to transport cargo</p> <p>The operator to transport cargo by slinging usually selected the flight route to cause no effect to persons and objects on the ground as a safety measures. The rotorcraft was also flying with due consideration to the weather and the transport condition of the day based on the flight handbook that the subcontractor A set by considering the influences regarding the safety of the ground.</p> <p>(7) Discovery point of sliding doors</p> <p>One sliding door dropped from the work hut was found in a mountain forest and two doors were near forest road, but there were no damage to the ground.</p>
--	--

In this serious incident, it is probable that the sliding doors of the work hut derailed and dropped because of no effective measures taken to prevent the objects from dropping, when transporting the work hut by slinging.

- (1) The subcontractor A stipulates the handbook to specify the binding with a rope and packing method by using cargo net in details in order to prevent sliding doors of the work hut as a unique shaped cargo from dropping.

- (4) Regarding the contents of the detailed action to prevent the objects from dropping of each cargo to sling, the ground workers executes a check based on a newly stipulated check list and a captain and a person of the main contractor in charge confirm with the ground workers while looking the check list.
