**AIRCRAFT SERIOUS INCIDENT
INVESTIGATION REPORT**

**AERO ASAHI CORPORATION
J A 6 9 1 1**

ENGINE DAMAGE

MCDONNELL DOUGLAS MD900 (ROTORCRAFT), JA6911

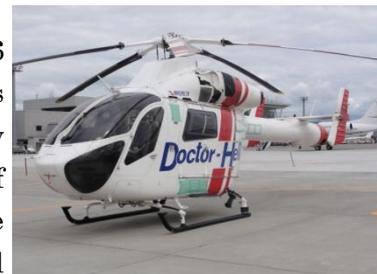
Serious incident aircraft

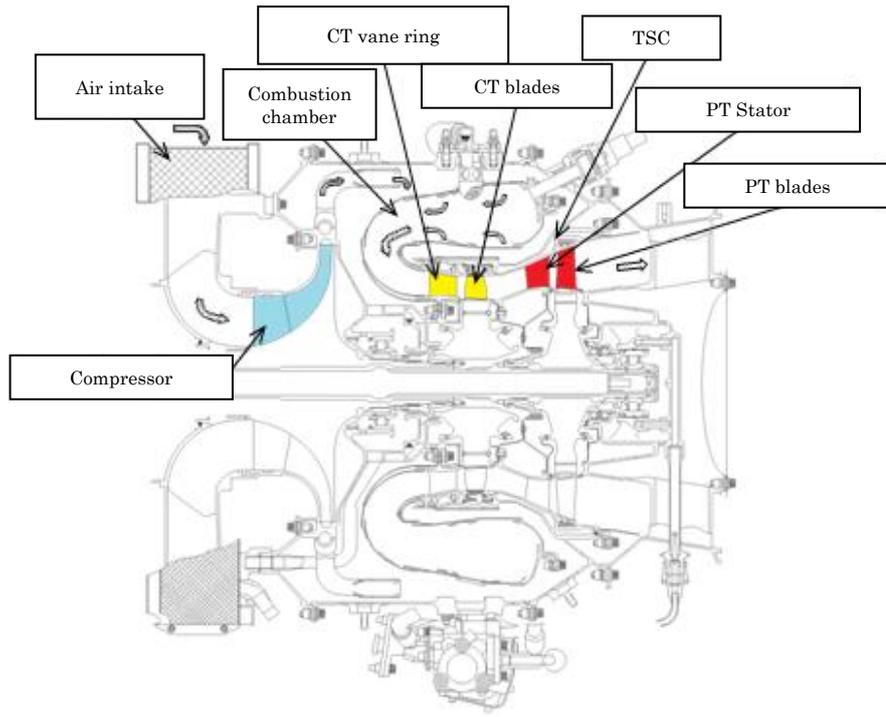
Cross-section Diagram from Engine Rotation Shaft Direction

(2) Extent of Damage to No. 1 Engine
 The compressor turbine (CT) vane ring*2, CT blade, power turbine (PT) stator, PT blade, and turbine support case (TSC) were damaged. The CT blades and the PT blades were fractured around the full circumference and others were damaged by heat.

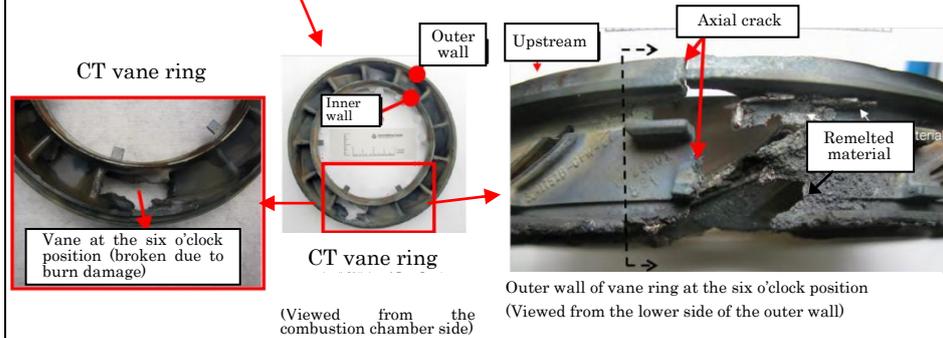
- CT vane ring

The CT vane ring for smoothing the flow of combustion gas had been severely damaged at the six o'clock position (viewed from the front (combustion chamber side) and the top aligned to 12 o'clock; same for all others) due to heat. One vane at the six o'clock position had

been burnt away. Also, at the six o'clock position of the CT vane ring, there was evidence of remains of cracks across the outer wall of the CT vane ring. The downstream side had suffered burn damage. There was presence of remelted material on the outer surface of the outer walls.

Corrosion was also observed on the inner surface of the outer walls of the CT vane ring. Scanning electron microscope (SEM) analysis showed that the corrosion did not reach the parent material of the vane. Sulphidation was observed on the corroded surface.

Numerous axial small fatigue cracks were observed on the inner surface of the outer walls of the CT vane ring near the six o'clock position, which are thermal fatigue cracks. In addition, minor cracks were observed at the one o'clock and 11 o'clock positions of the CT vane ring. SEM analysis showed that the cracks near the six o'clock position of the CT vane ring extended from the inner surface to the outer surface, and cracks extended throughout the outer surface in the thinnest section of the outer wall. The cracks originated from the corrosion, but there were no evidence of sulfuric corrosion along the cracks. There were traces indicating overheating near the six o'clock position of the CT vane ring, but no traces of overheating were found at either the one o'clock or 11 o'clock position.

| 3.4 Analysis of Findings | <p>(1) It is highly probable that the small axial cracks that had developed in the outer wall of the CT vane ring were thermal fatigue cracks that had developed due to being constantly exposed to high temperature on each flight. At the six o'clock position of the CT vane ring, there was evidence that axial cracks in the outer wall of the CT vane ring. It is probable that minor heat-fatigue axial cracks that were seen in other positions had also developed in the section of the</p> |

CT vane ring (six o'clock position) that had been burnt away. Moreover, it is probable that the cracks that had developed at the six o'clock position had also penetrated the outer wall from the inside surface to the outside surface as with the cracks that had developed near the six o'clock position.

(2) It is probable that as the cracks penetrated the outer wall of the CT vane ring, the pressurized air from the exterior of the outer wall of the CT vane ring had entered the passageway of the combustion gas from the opening. It is probable that with pressurized air flowing into the high-temperature combustion gas, the oxidization of the section that had been penetrated by the cracks had accelerated. Also, it is probable that as the smooth flow of combustion gas was disturbed, the temperature distribution of the passageway of combustion gas was changed, and a localized increase in temperature had occurred. Due to this, it is somewhat likely that the corrosion due to heat for the CT vane ring at the six o'clock position had progressed further, and this also affected the cooling of the vanes, which further accelerated the corrosion of the vanes. As a result, it is probable that the CT vane ring at the six o'clock position had been severely damaged by the time of the occurrence of the serious incident. For the reason why the CT vane ring was severely damaged at the six o'clock position in comparison with the other positions, it is possible that the cracks that extended into the fillet radii of the vane and/or cracks that converged at a point had formed, and that this expedited the progression of the cracks. However, it was not possible to identify the cause of this as the CT vane ring had been burnt away.

| <p>It is probable that this serious incident occurred due to the severely damaged CT vane ring (at the six o'clock position) causing the hot sections to become severe overtemperature condition, leading to the CT blades becoming fractured and the PT blades downstream also becoming fractured .</p> <p>For the reason as to why the CT vane ring was severely damaged at the six o'clock position in comparison with the other positions, it is somewhat likely that the cracks that extended into the fillet radii of the vane, and/or cracks that converged at a point had formed, and that said cracks expedited the progress of the cracks. However, it was not possible to identify the cause of this as the CT vane ring had been burnt away.</p> |
