**AIRCRAFT ACCIDENT
INVESTIGATION REPORT**

J A 7 0 1 M

COLLISION WITH MOUNTAIN SLOPE
A PRIVATELY OWNED PIPER PA-46-350P, JA701M
SOUTH-SOUTHEAST SLOPE OF MT. YAGO
APPROXIMATELY 14 KM NORHTEAST OF KUMAMOTO AIRPORT
AROUND 17:15 JST, JANUARY 3, 2011

September 7, 2012

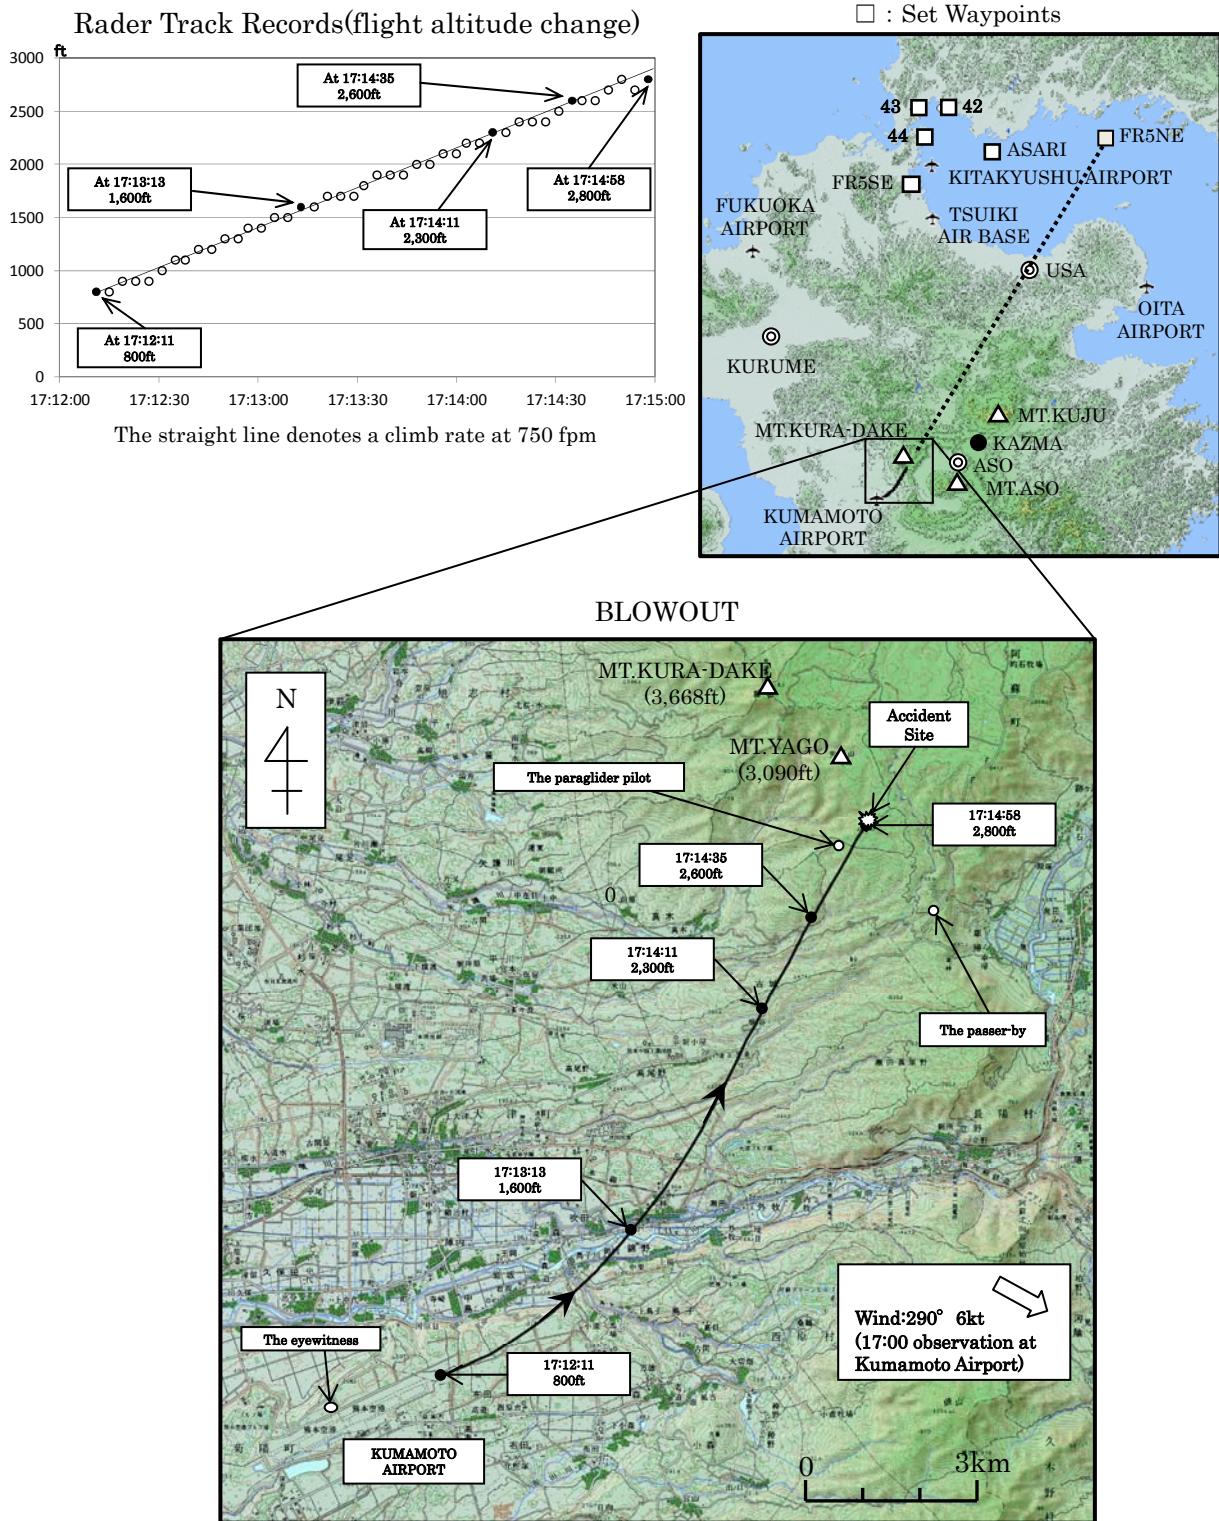
Figure1: Estimated Flight Route

The accident occurred on a south-southeast slope ($32^{\circ} 55' 49''$ N, $130^{\circ} 57' 12''$ E) of Mt. Yago, about 14 km northeast of Kumamoto Airport at 17:15, January 3, 2011.
(See Figure 1: Estimated Flight Route)

As described in 2.8.4, the Handbook maintains that the malfunction of any required deice equipment requires immediate action to exit (climb or descend from) icing conditions. However, as the figure 1 illustrates that the aircraft maintained speed and heading after the rollout from a left turn during its takeoff climb, it is possible that its icing protection was functioning.

The cloud conditions in the vicinity of the accident site as the statements described in 2.1.2.b and c, and 2.7.5.a and the reduced aircraft climb rate as the statement described in 2.1.2.c and the show in Figure 1, it is somewhat likely that the PIC expected icing conditions and kept the climb rate low in order to gain climb speed activating the ice protection as described in 3.5.2. However, as described in 3.6.1, he was not familiar with the terrain features north of Kumamoto Airport, he possibly judged the climb rate non-problematic. It is somewhat likely that the following suggest that he stabilized the aircraft after rolling out to the east-northeast, and made a data input during straight ascent into the clouds with a low climb rate:

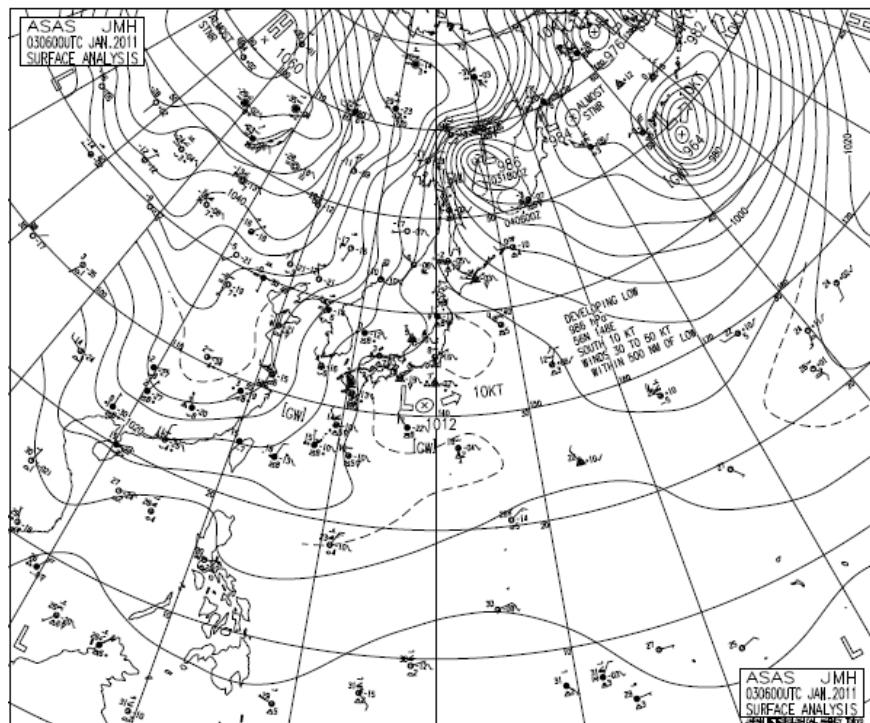
Figure 3: Asia Surface Weather Chart

Kumamoto prefecture in the night of January 3, due to the influence of pressure trough and cold weather, will be rain or snow; besides, there will be a place with a lightning.

Northern Kyushu district is clouded by the influence of the pressure trough and cold weather, there are raining places centered on the coasts of Tsushima Strait.

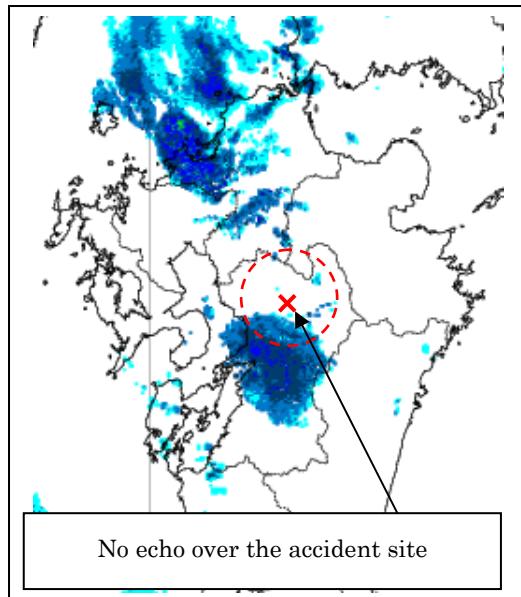
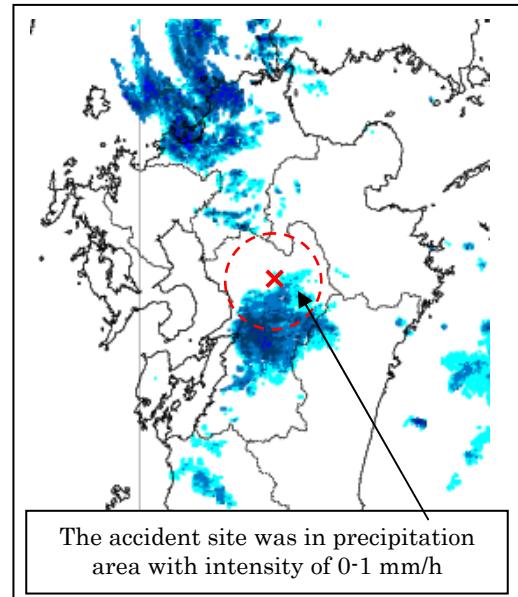
Figure 4: Radar Echo Charts

According to the radar echo chart observed at 17:00 and 18:00 January 3, the accident site was out of precipitation area at 17:00, while it was entering in precipitation area with intensity of 0-1 mm/h at 18:00.

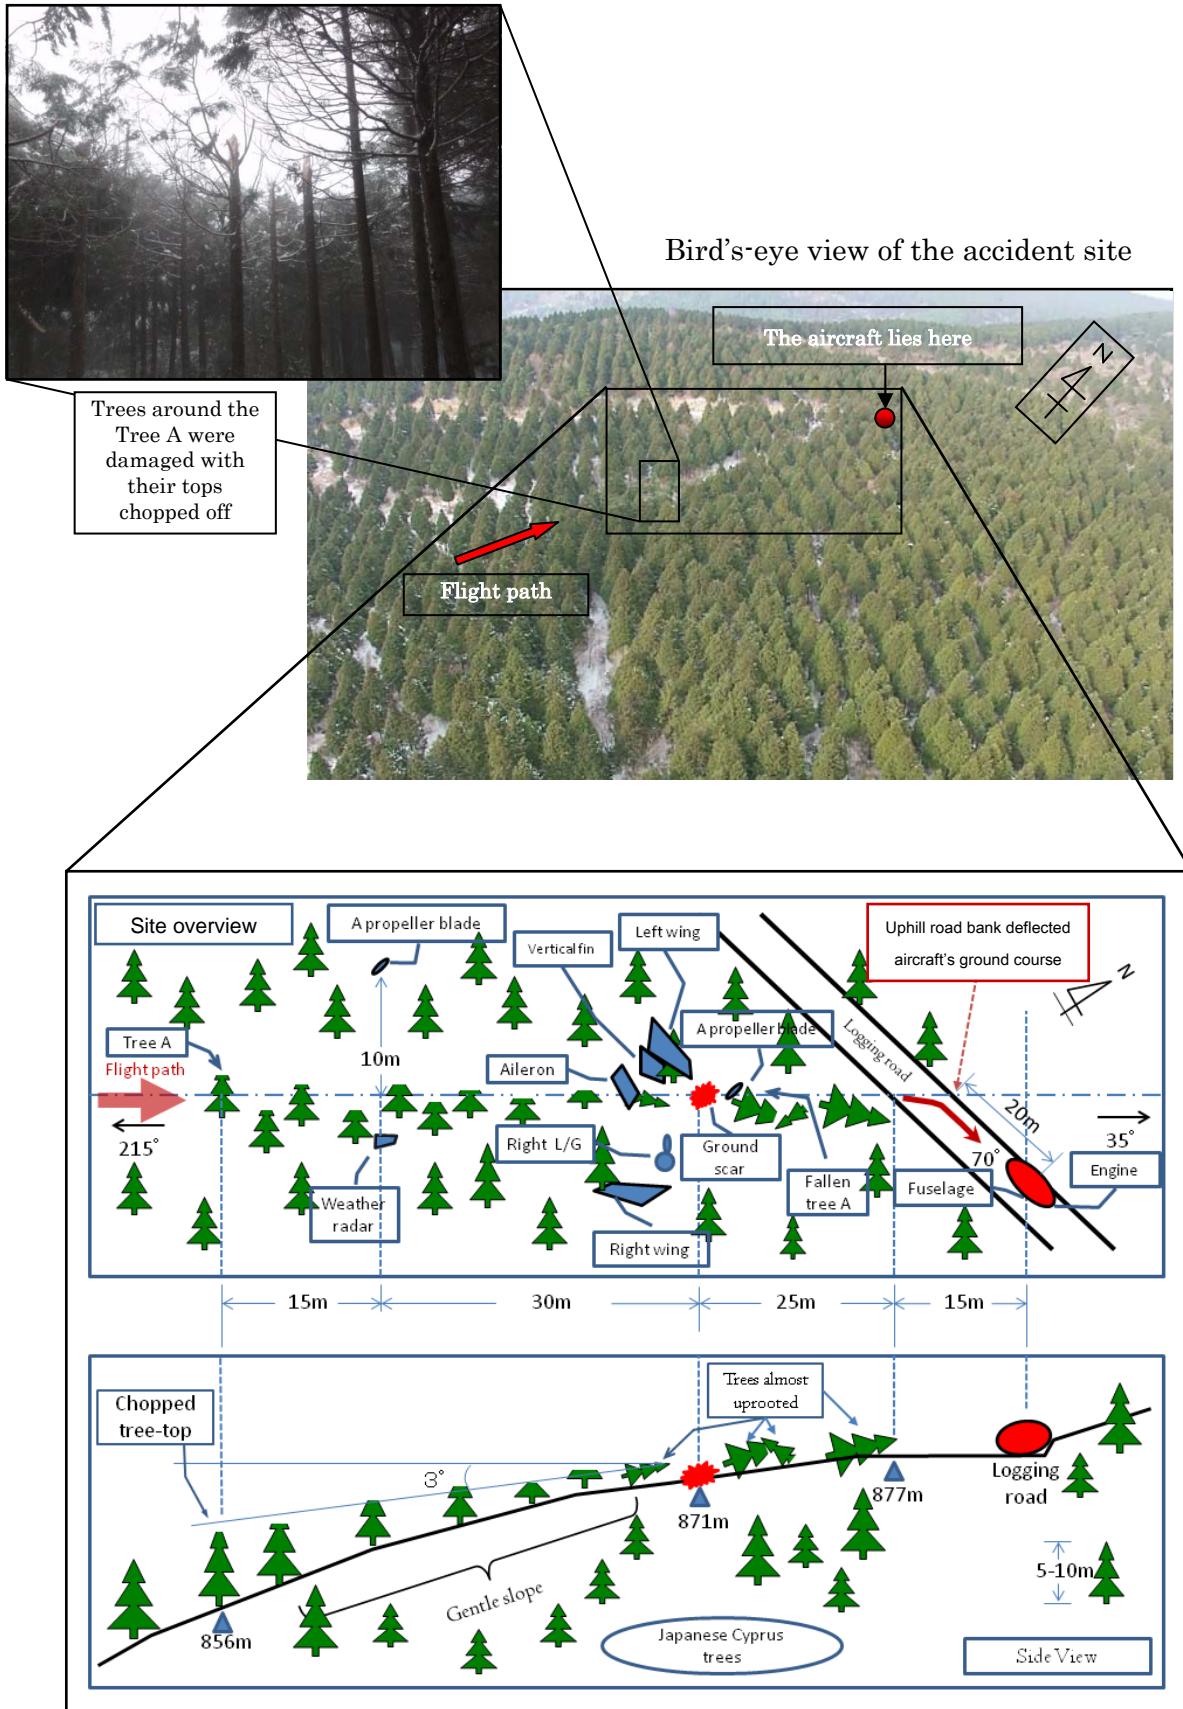
Figure 5: Accident Site Layout

The aircraft was lying on a logging road (elevation about 2,880 ft) heading to the east-northeast (about 070°). The road runs in an east-west direction on a southeast mountain slope of Mt. Yago (top elevation: about 3,090 ft). 85 m (on the side of Kumamoto Airport) from the aircraft to the southwest stands a tree whose top was chopped (hereinafter referred to as the “Tree A”). Trees standing between the first ground impact scar and the Tree A were all damaged: the nearer to the ground scar, the lower the damaged portion on the trees; and tree tops near the Tree A were chopped horizontally. The distance between the Tree A and the ground scar was about 45m and the dip angle from the ground scar to the top of Tree A was about 3°. A tree at the ground contact trace was pushed down uphill (hereinafter referred to as the “Fallen tree A”). There was a large contact trace on the uphill bank on the logging road 25 m from the Fallen tree A. The aircraft was about 20m away from the contact trace to the northeast. Contact traces were found on the road bank leading to the aircraft.

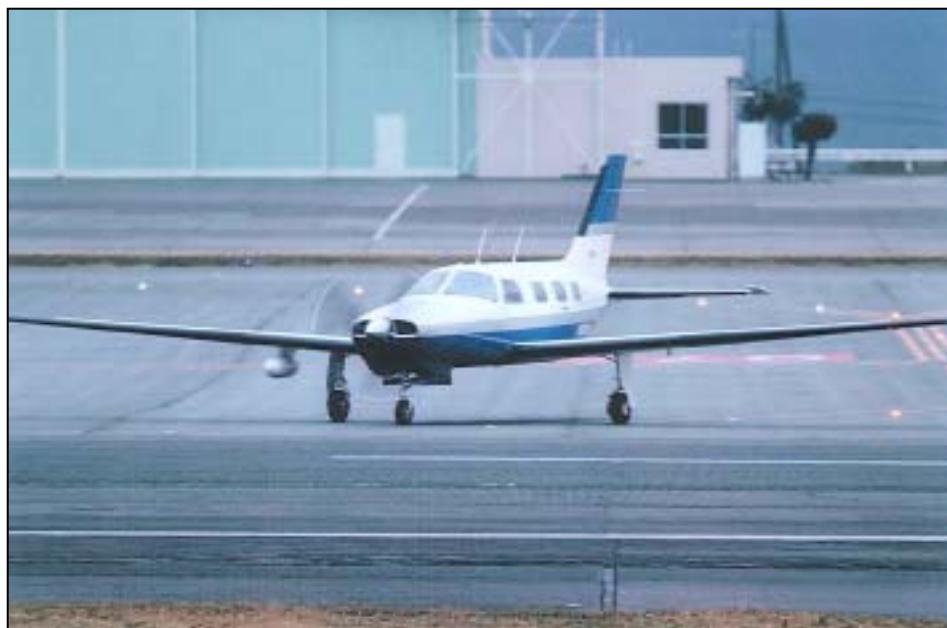
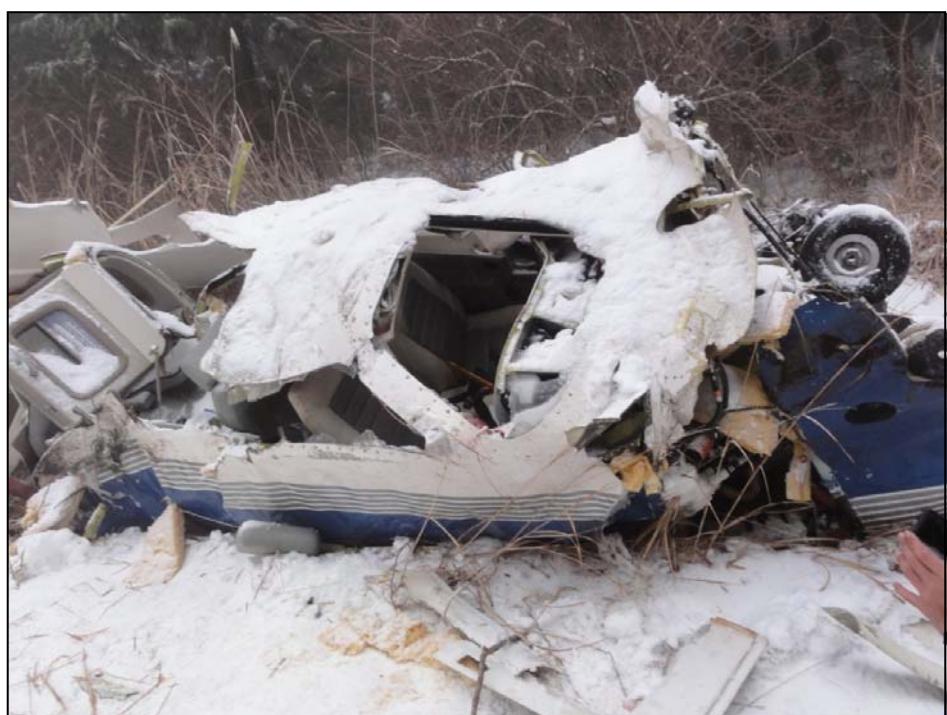
Photo1: Accident Aircraft

The fuselage was severely damaged with longitudinal compression buckles.

The left wing was broken into three major pieces; the right wing, four major pieces.

Both horizontal wings were fractured at its attaching point to the fuselage. Upper portion of the vertical fin was severed.

Engine support frame was bent downward causing the engine to face aft in an upside-down posture. The forward portion of the engine was damaged severely: out of six cylinders, the No. 2 cylinder head was broken.

Three propeller blades were all broken at their roots and part of them were found in small pieces.
