**AIRCRAFT ACCIDENT  
INVESTIGATION REPORT**

ROLL-OVER UPON TAKEOFF

EUROCOPTER EC120B (ROTORCRAFT), JA710H

KARIFURIDAKE TEMPORARY HELIPAD

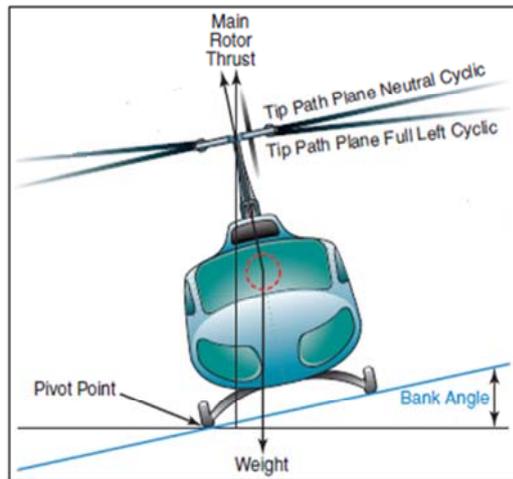
*For dynamic rollover to occur, some factor has to first cause the helicopter to roll or pivot around a skid, or landing gear wheel, until its critical rollover angle is reached. Then, beyond this point, main rotor thrust continues the roll and recovery is impossible.*

*If the critical rollover angle is exceeded, the helicopter rolls on its side regardless of the cyclic corrections made. (omitted) Quickly applying down collective is the most effective way to stop dynamic rollover from developing. Dynamic rollover can occur in both skid and wheel equipped helicopters, and all types of rotor systems.*

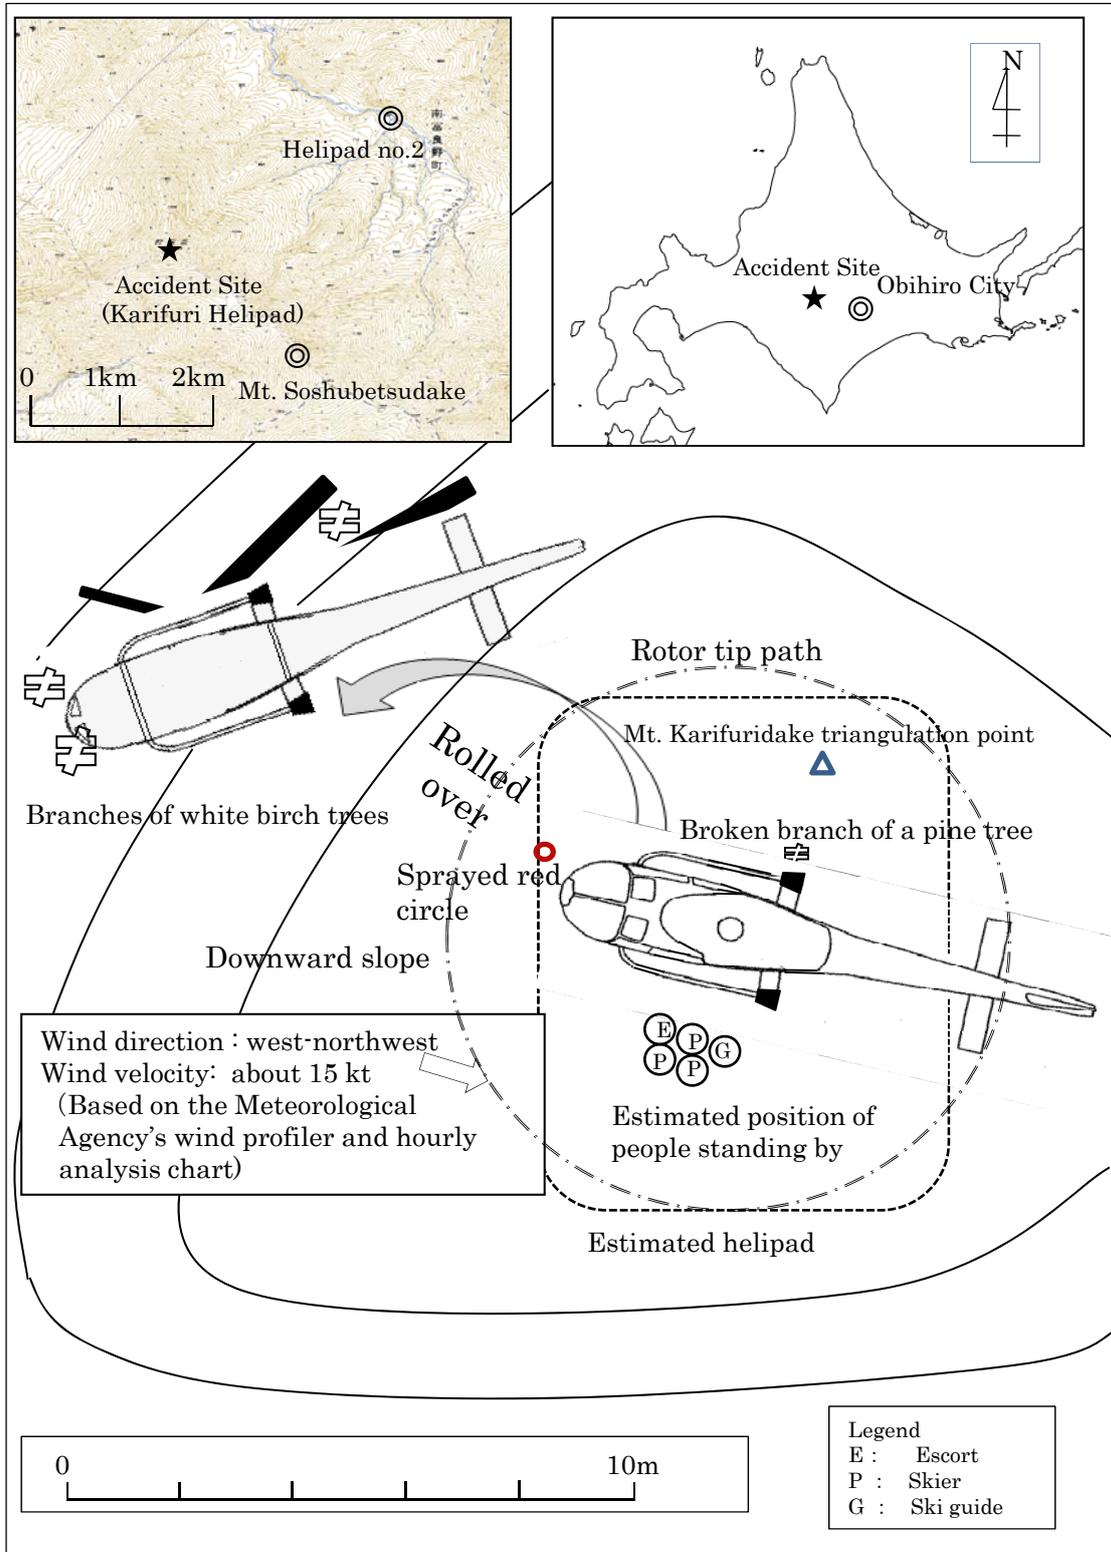
Figure 1 : Accident Site Layout

The helipad measured about 7 meters in the east-west direction, and about 9 meters in the north-south direction, assuming the pilot landed the helicopter placing himself in front of the painted red circle.

Karifuridake triangulation point sits at the northern corner of the helipad. No trees on surrounding downhill slopes protruded into the approach surface.

On the surface of the helipad the investigators identified: the painted red circle; and two broken pine branches about 1.5 meters southwest of the triangulation point: one as thick as about 5 centimeters, the other as thick as about 2 centimeters.

Although other thin branches were lying on the snow surface, none of them were broken.

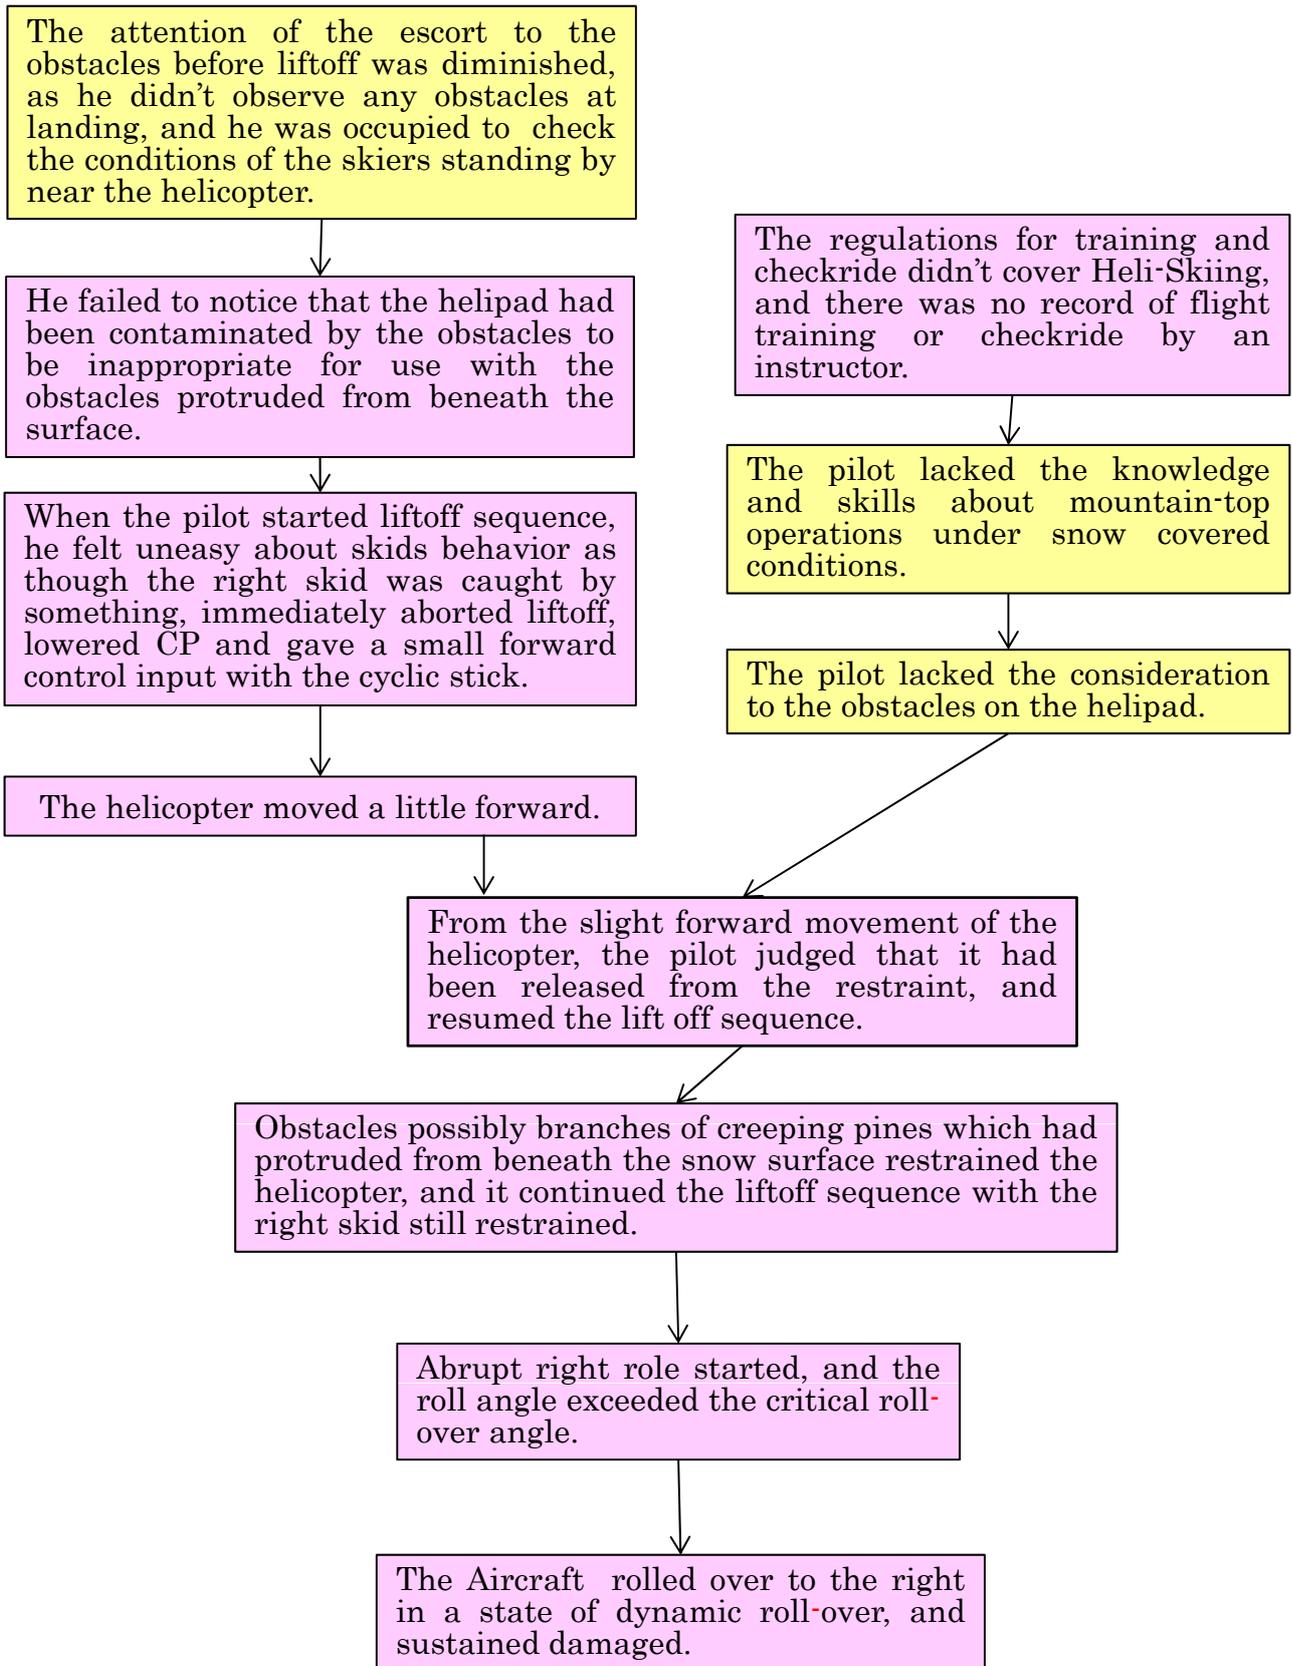
Figure 3: Chain of Probable Causes of the Accident

- b. The helicopter probably resumed the liftoff sequence with both skids restrained by branches of creeping pines and continued the sequence; the thick branch kept catching the right skid while the thin branch snapped and released the left skid. The continued liftoff most likely caused abrupt right rolling pivoting over the right skid, exceeding the roll-over critical angle (mentioned in 2.8.6 b), resulting in a dynamic roll-over and damaged the helicopter.

According to the statement in 2.1 b., at the time of the accident the assistant was not available; however, the escort was probably assisting the helicopter ground operation. Given this fact, the safety check against obstacles before takeoff was implemented as stipulated in the standards as described in 2.8.5. However, it is highly probable that the escort was unaware of the degraded helipad surface with the obstacles: possible pine branches protruded from beneath the surface. The following possible contributing factors are responsible for the escort's lack of attention to the ground obstacles:

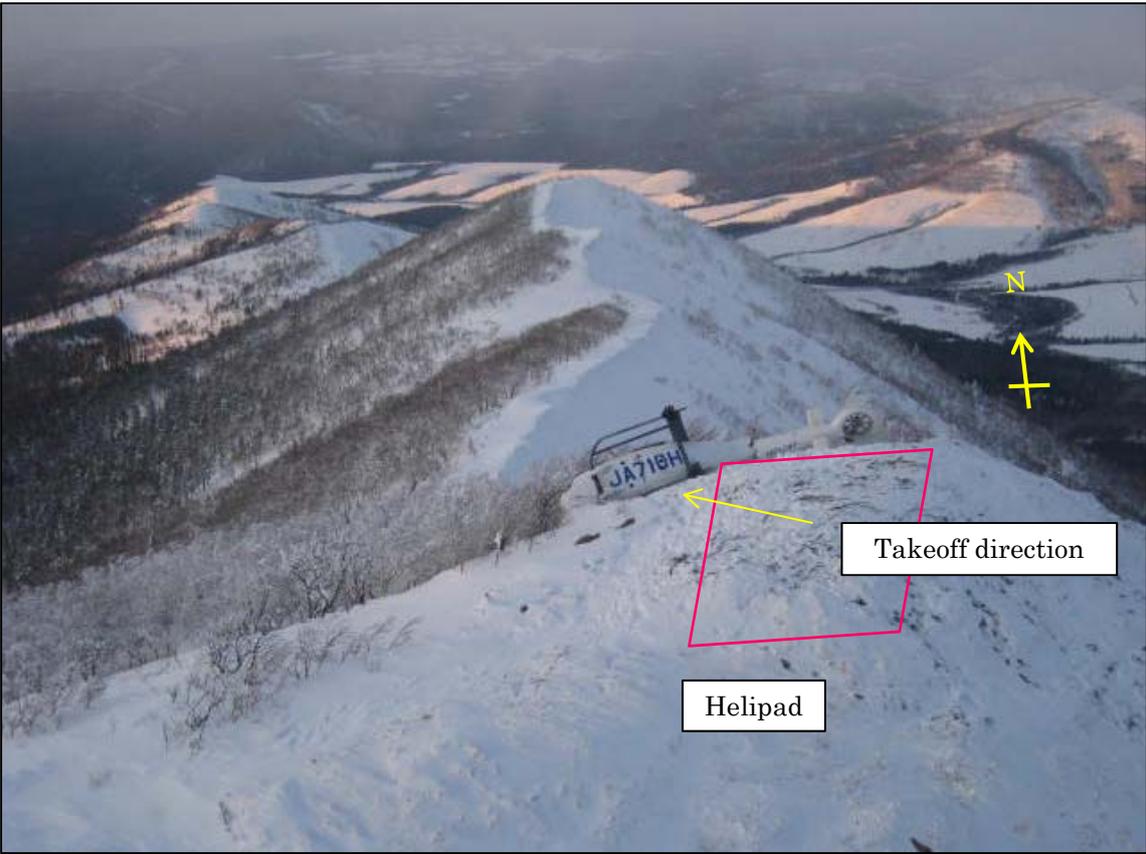
Photo 1: Accident Site

After the event Witness B found a broken branch of creeping pine as thick as about 10 cm lay 1.0-1.5 meters to the south of the triangulation point. He observed very few creeping pines protruding other than that. He thought that the location of the broken branch was almost consistent to where the right skid was planted.

(Situation on the day of the accident)

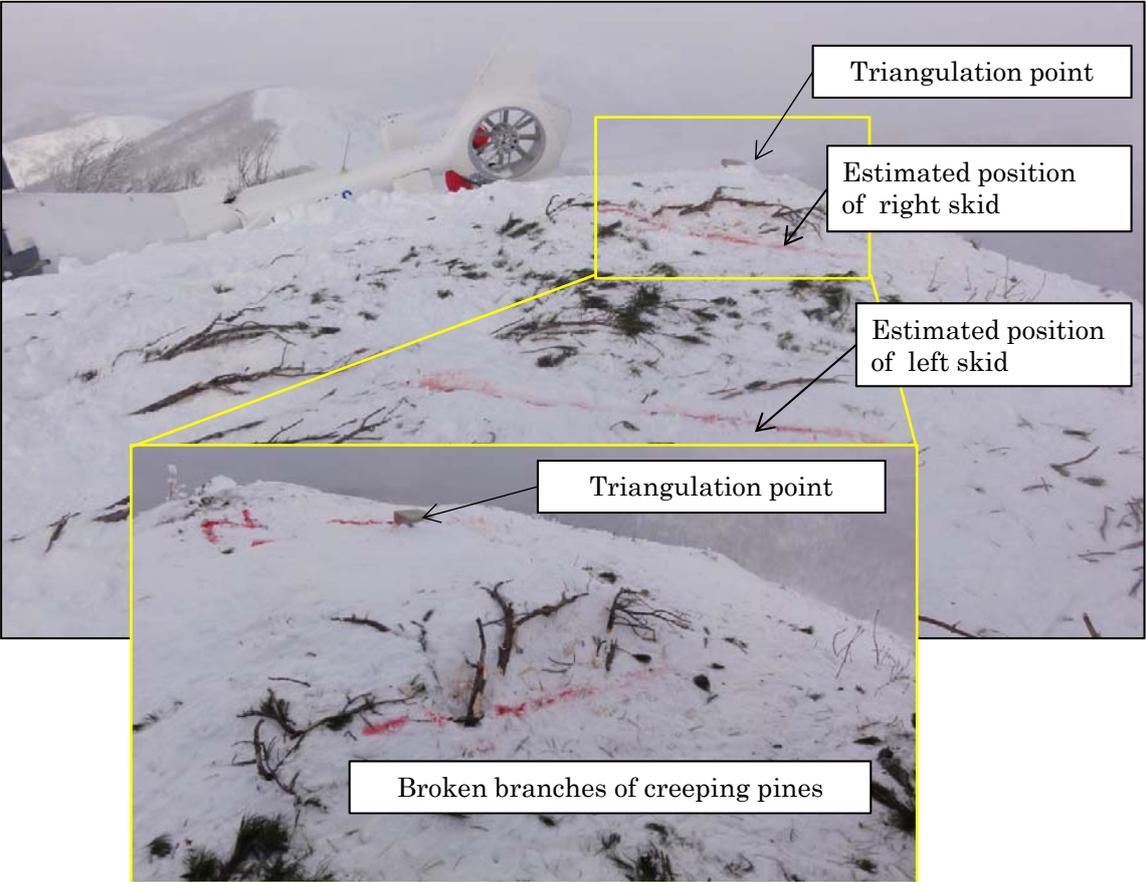
Three days after the accident, the helipad was covered with new snow.

While the snow surface of the helipad was hardened, the snow in the perimeter area was so soft that covered branches of creeping pine sprang up if people walk there.

(Situation three days after the accident)

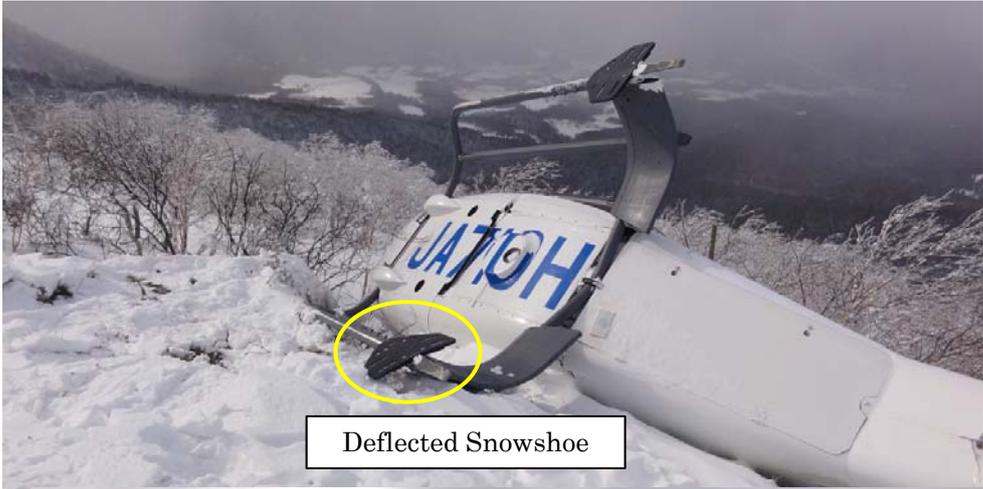
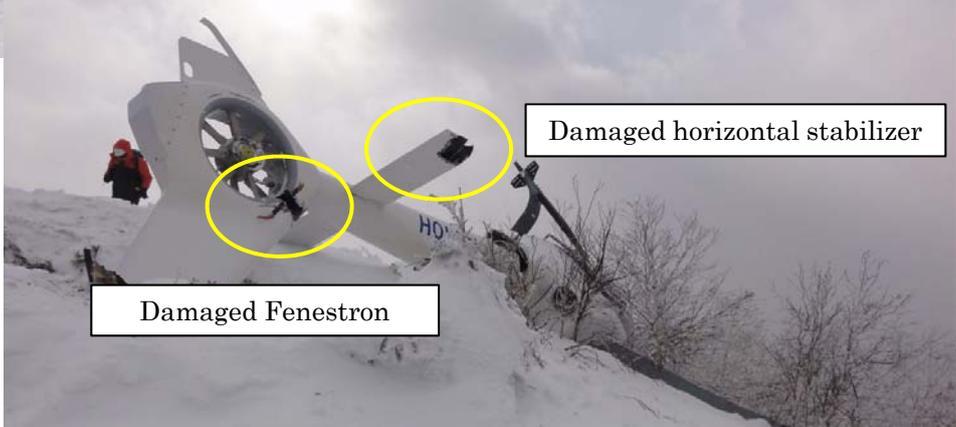
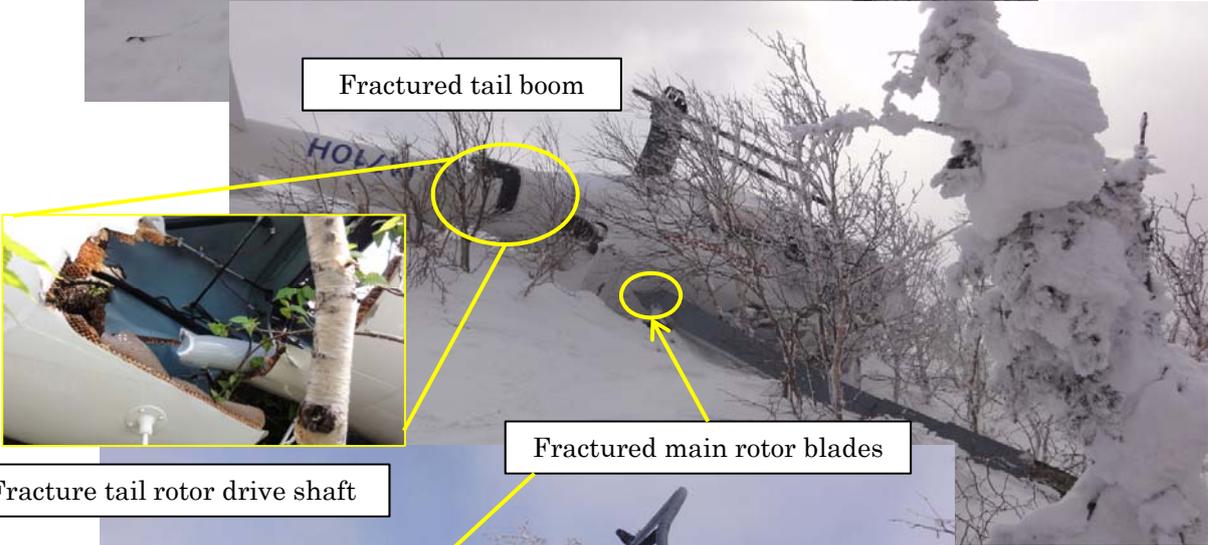
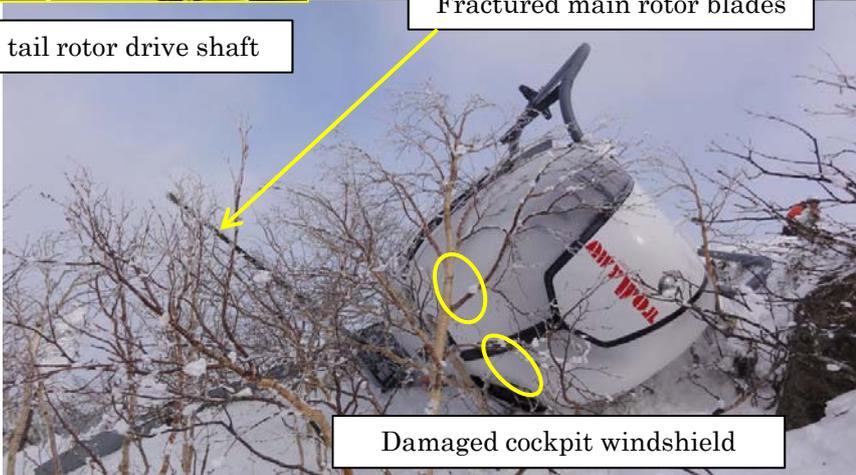
Photo 2: Accident Helicopter

- a. Fuselage: The cockpit windshield was damaged.
- b. Tail section: The tail boom was fractured with damaged horizontal stabilizers.
- c. Landing gear: The right snowshoe was deflected.
- d. Rotor blades: The main rotor blades were fractured.  
The Fenestron was partly damaged.  
The tail rotor drive shaft was fractured.

The helicopter rested with its right side on the northwest slope of the helipad heading to the southwest. The trees on the slope held the helicopter in place.
