**AIRCRAFT SERIOUS INCIDENT
INVESTIGATION REPORT**

April 22, 2021

AIRCRAFT CLEARED TO LAND IS APPROACHING A RUNWAY WHICH IS CROSSED BY OTHER AIRCRAFT TOKYO INTERNATIONAL AIRPORT AROUND 18:05 JST, JUNE 15, 2019

1. SKYMARK AIRLINES INC.
BOEING 737-800, JA73AB
2. ALL NIPPON AIRWAYS CO., LTD.
BOEING 787-9, JA885A

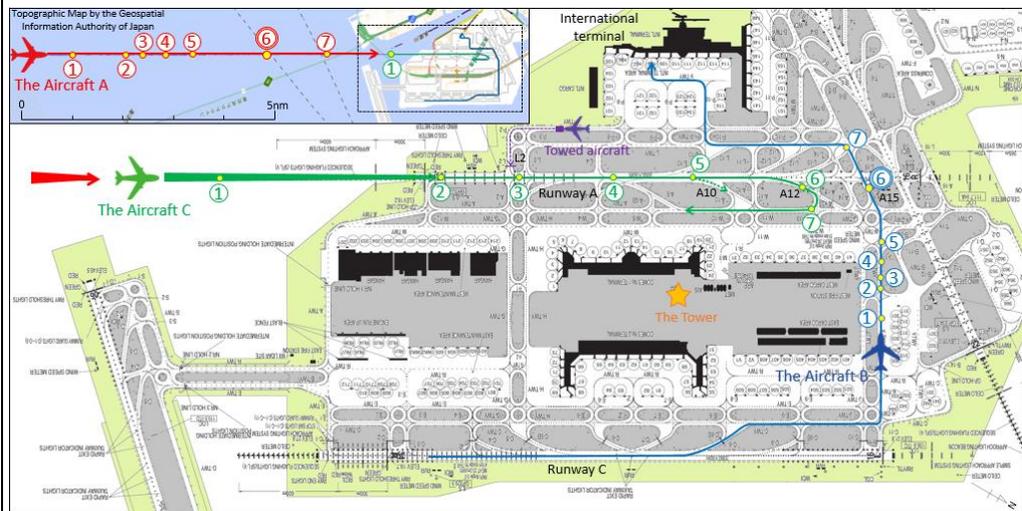
Figure 3: Situation at the time of occurrence of the serious incident

At 18:03:19 (Positional relationship, ① in Figure 3), after confirming that the Aircraft C, immediately before landing, had reached over the Approach Lighting System, the Trainee issued the landing clearance to the succeeding Aircraft A. The Trainee confirmed the read-back from the Aircraft A, and on the electronic strip*5, attached a LAND stamp*6. On the other hand, during this time the Supervisor A was coordinating with the ground control position (North) to its right in order to have the towed aircraft taxi to Taxiway L2, and listening to check whether the operations were carried out without delay according to the coordination. Therefore, the Supervisor A must have heard the landing clearance the Trainee issued to the Aircraft A and the read-back from the Aircraft A through the Supervisor A's headset, but failed to listen to them, and did not notice that the Trainee attach a LAND stamp on the electronic strip.

At 18:03:40 (Positional relationship, ② in Figure 3), the Aircraft B called the Tower West Position, when the Trainee noticed the existence of the Aircraft B for the first time, and instructed the Aircraft B to hold short of Runway A at 18:03:47 (Positional relationship, ③ in Figure 3). According to the Trainee, with little experience in issuing a clearance of crossing Runway A to the aircraft having landed on Runway C, the Trainee was not able to judge on the instant between which arrival aircraft the Trainee would be able to have the Aircraft B cross the runway. Subsequently referring to radar screen and others, the Trainee judged that the Trainee would be able to have the Aircraft

It is highly probable that the distance between the Aircraft A and the Aircraft B, when the Aircraft B entered the runway, was approximately 8,400 m (about 4.5 nm).

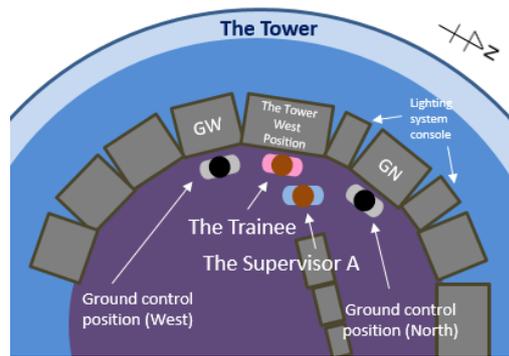
Figure 4: Situation of the Tower West Position and its next positions

According to the Trainee and the Supervisor A, at that time, the ground control position (West) to their left was continuously busy. Regarding the Aircraft C who was about to land, the Tower West Position received their coordination from that position to instruct the Aircraft C to vacate the runway via Taxiway A12, and thus the Trainee and the Supervisor A accepted it. At the same time, the Trainee was concerning about aircraft being towed* 4 on the taxiway on the international terminal side, but the Supervisor A judged that the Supervisor A should coordinate personally regarding the towed aircraft because the Trainee would have a high load with instructing the Aircraft C as coordinated and having the Aircraft B cross Runway A, and advised the Trainee not to concern about the towed aircraft at the moment.

The controllers at the aerodrome control facility carry out the operations of ATC services by scanning through the TAPS screen on the control console while widely scanning aircraft, runways and others seen outside the window of the ATC tower. In addition to these operations, the supervisor needs to monitor the operations by the trainee and usually stays behind the trainee so as not to come within sight of the trainee. As a result, it is probable that the supervisor will be a little away from the TAPS screen, which makes it difficult for the supervisor to grasp the situation of electronic strips and other information shown on the screen. Besides, it is somewhat likely that because changing from paper strips to electronic ones enabled the delivery of strips among control positions and all their strip-related operations to be electronically conducted, it might make difficult for the supervisor monitoring behind the trainee to grasp the trainee's behaviors.

- Established the guideline to manage training environment appropriately so that the OJT shall be interrupted and the supervisor shall carry out the operations of ATC services in case where the supervisor needs to coordinate with other positions.

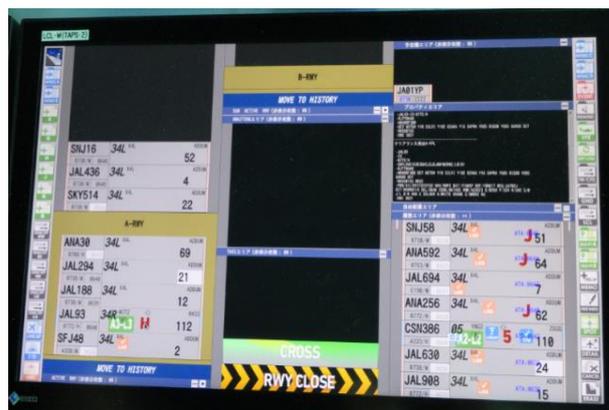
Figure 7: Display screen of TAPS electronic strips

shown as an image on a display. According to Tokyo Aerodrome Control Facility, in comparison with the paper strips which can be physically moved, when operating the electronic strips, there is no sound generated; therefore,

without seeing how the trainee operates them, the supervisor will not be able to notice when done so.
