**AIRCRAFT ACCIDENT
INVESTIGATION REPORT**

**SKYMARK AIRLINES INC.
J A 7 3 N M**

DAMAGE TO AIRFRAME FROM BIRD STRIKE

BOEING 737-800, REGISTERED JA73NM

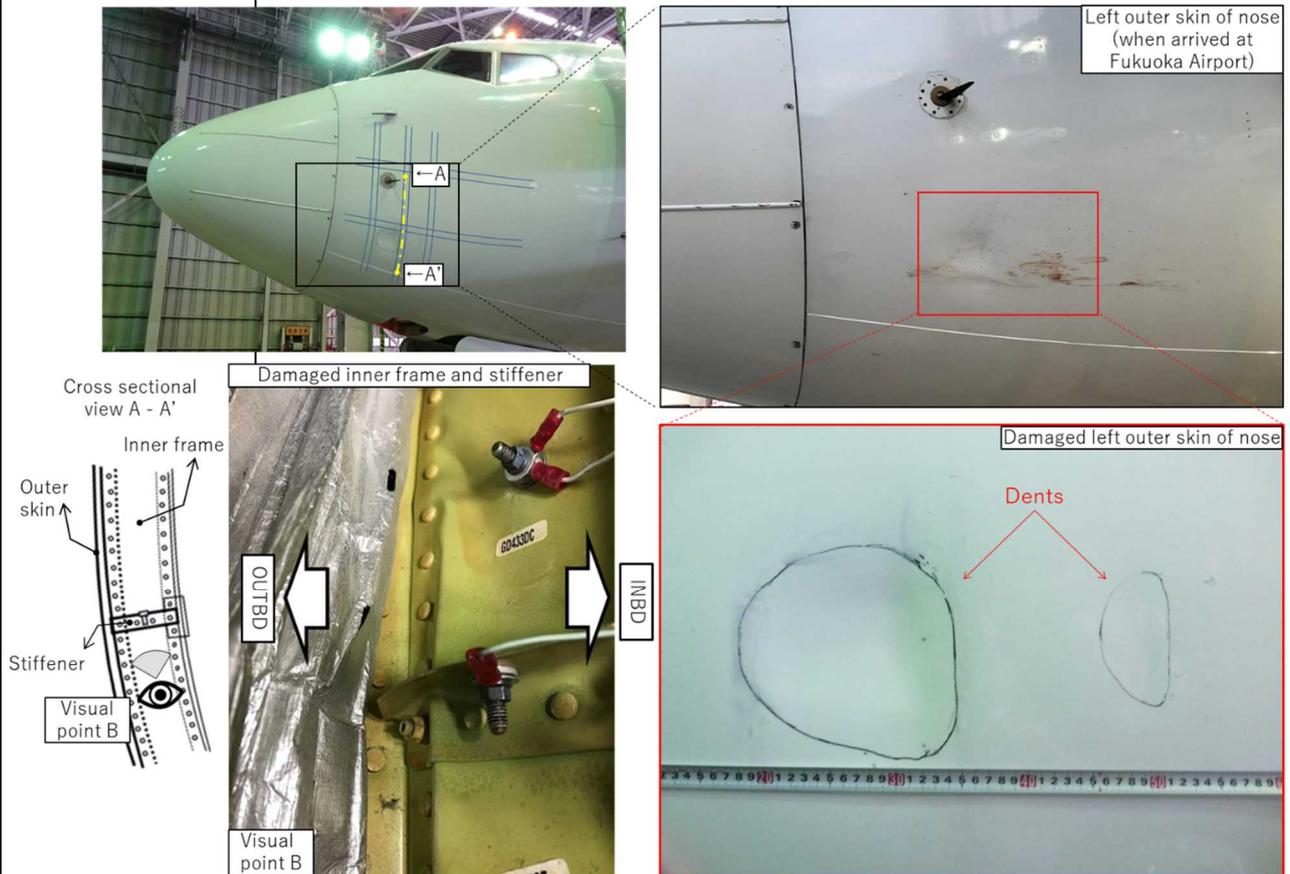
Figure 2 Conditions of damaged airframe

Extent of damage to the aircraft: Substantially damaged

Left outer skin of the nose: Dent with 16.5 cm long, 16.5 cm wide, and 0.95 cm deep

Dent with 10.2 cm long, 6.35 cm wide, and 0.16 cm deep

Inner frame and stiffener: Flections were recognized

3.1 Involvement of Weather	None
3.2 Involvement of Pilot	None
3.3 Involvement of Aircraft	None
3.4 Analysis of Findings	<p>(1) Collision with the bird</p> <p>From the impact sound in the left lower part of the captain seat at an altitude of 8,500 ft over approximately 17 km east-northeast of Tokyo International Airport while the aircraft was in takeoff-climb from the airport, the substance that was seemingly a bloodstain adhered to the left side of the nose of the aircraft and dents in the surrounding outer skin found in postflight inspection of the airframe, the JTSB concludes that it is highly probable that the airframe was damaged by the collision with the bird at the relevant portion at this moment. The abnormal smell transitorily felt after the impact sound is probable to have been a stink, which generated when fragments of the bird were sucked into the compression of the left engine and heated, penetrated the aircraft.</p> <p>The captain and FO are highly probable to have been unable to maneuver for avoidance since they were not aware of approach of the bird.</p> <p>Besides, the altitude of 8,500 ft is high as birds fly at and birds climb higher than normal in some cases depending on species of birds and weather conditions.</p> <p>(2) Response by flight crew</p> <p>The JTSB concludes that it is probable that flight crew decided to continue the flight based on their judgement that there probably occurred a bird strike and it did not hinder the flight after having confirmed that abnormal indication of instruments and vibration of the aircraft did not occur after occurrence of the impact sound and abnormal smell. Considering possible damage to the airframe at that time, the cruising altitude is probable to have been lowered than originally planned and flight speed set at the speed for passing through turbulence so that transition to the safety altitude could promptly be made in case of emergency and the load to the airframe structure in cruising mitigated. By lowering the cruising altitude, the time for the aircraft to descend to the safety altitude (10,000 ft) in case of emergency was shortened by 46 seconds from approximately 3 minutes 48 seconds to approximately 3 minutes 2 seconds, given the maximum descent rate feasible to be set in onboard</p>
