**AIRCRAFT SERIOUS INCIDENT
INVESTIGATION REPORT**

**JAPAN AIRLINES CO., LTD.
J A 7 4 3 J**

October 31, 2019

CASE EQUIVALENT TO DAMAGE TO ENGINE CASING JAPAN AIRLINES CO., LTD. BOEING 777-300ER, JA743J AT TOKYO INTERNATIONAL AIRPORT, JAPAN AROUND 11:00 JST, SEPTEMBER 5, 2017

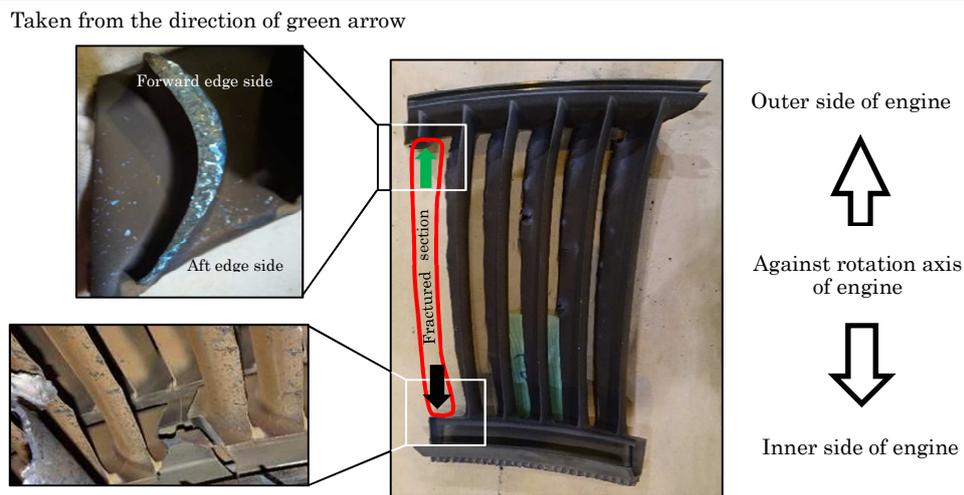
- (i) One of LPT fifth stage stator vanes was fractured (see Figure 2). No fracture was confirmed in other stator vanes, and the fractured stator vane airfoil could not be found.

Taken from the direction of black arrow Red line: Fractured section of a stator vane
(taken from the front side)

Figure 2: Condition of the fractured stator vane of LPT fifth stage stator vanes segment
Wearing caused by rubbing of adjacent segments was confirmed on slash-face of inner platform of multiple segments of LPT fifth stage stator vanes (see Figure 3 and 7).

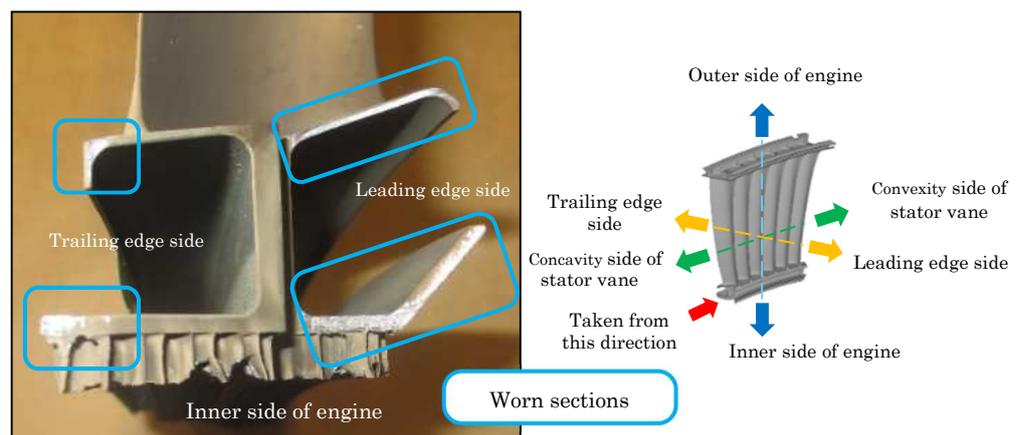
Figure 3: Worn LPT fifth stage stator vane segments

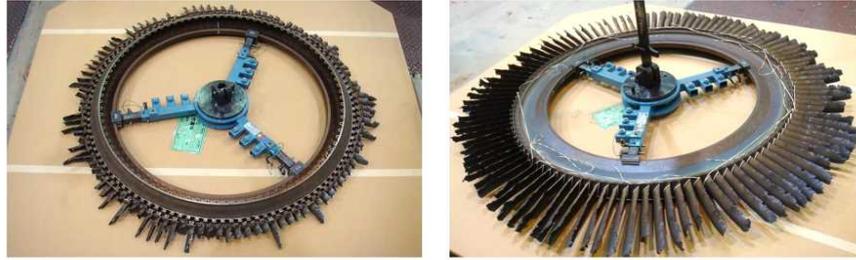
- (ii) Fifth and sixth stage turbine blades which were downstream from LPT fifth stage stator vanes were damaged all along the circumference (see Figure 4). Sixth stage stator vane was damaged except for a certain section.
- (iii) A hole in size of about 6 cm x about 1 cm, concave deformation (dent) and crack were confirmed on the lower section of TRF attached to the aft flange of the LPT case. (see Figure 5).
- (iv) No trace of damage was confirmed forward of the LPT fifth stage stator vanes. Besides, there was no trace of abnormal combustion confirmed inside the engine.

Figure 4: Damaged condition of LPT fifth stage disk and blades (left) and sixth stage disk and blades (right)

3.1 Involvement of Weather	None
3.2 Involvement of Pilot	None
3.3 Involvement of Aircraft	Yes
3.4 Analysis of Findings	<p>(1) Damage on LPT</p> <p>(i) Damage on multiple stages of LPT stator vanes and turbine blades</p> <p>It is highly probable that damages on fifth and sixth stage turbine blades which were downstream from LPT fifth stage stator vanes were triggered by fracture of one stator vane of the fifth stage stator vanes segment, then</p>

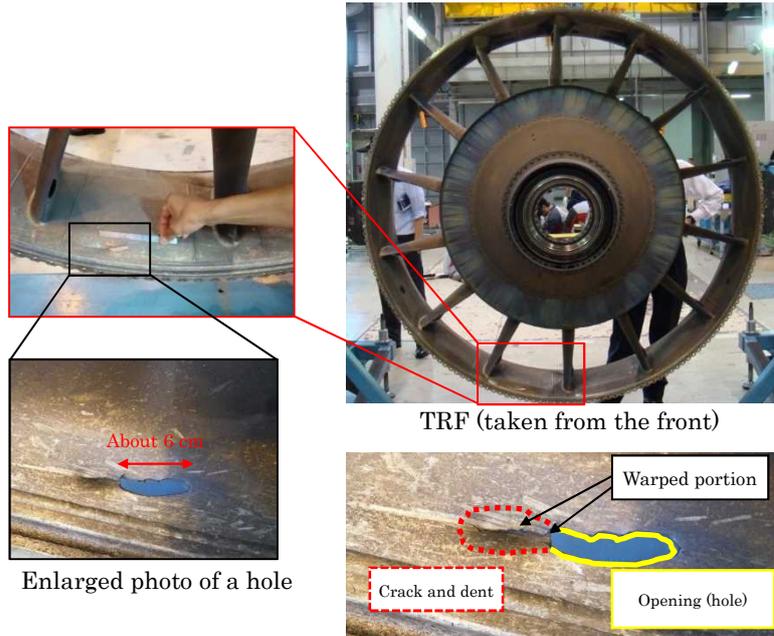
Figure 5: A hole on TRF

The analysis entrusted to NIMS of the hole generated on TRF obtained the result of high probability that the collided fragments did not penetrate the subject hole because warp on the edge of deformation did not generate on the edge of the hole and the fractured surface of the hole did not have traces of rubbing with substances (see Figure 5) although the section in contact with the hole had concavity deformation (dent) generated.

It is highly probable that the hole of TRF was caused by collisions of fragments generated by the damaged LPT.

It is probable that fragments did not penetrate the hole, because analytical results by NIMS and engine cowl did not show damage.

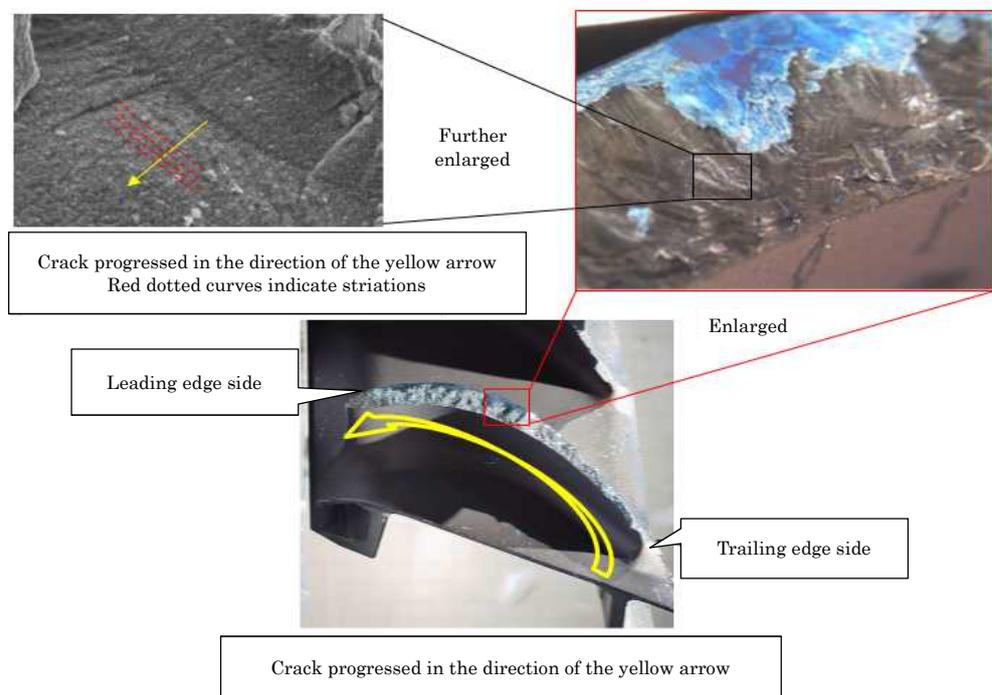
confirmed many strip-patterned traces (striations), which indicated fatigue fractures generated by repetitive stress. Besides, arrest lines* 4 were periodically confirmed between a mass of striations, which was presumed to have been affected by arch-binding. Although the initiating point of the crack could not be identified, the cracking progressed from trailing edge side to leading edge side, which reached the presumption that the crack initiating point was on trailing edge side. Traces indicating fatigue fractures on the trailing edge side of the fractured surface was erased by collisions of fragments at the time of fracture of fifth stage stator vanes or rubbing of fractured surfaces, or exposure to heat during the process of progressing the crack. The sections where striations and arrest lines were confirmed had suffered less heat affect, and thus, maintained the condition at the time of the occurrence of the fractures intact (see Figure 6).

Figure 6: Condition of the fractured surface of fifth stage stator vane

From the detailed investigation of LPT fifth stage stator vanes segments of the serious incident and the analysis of previous engine failures conducted by the engine manufacturer as detailed in 2.6(2), it was presumed that the fracture of LPT fifth stage stator vanes of the serious incident was caused by arch-binding that was generated on the slash-faces of platform of inner side of engine of adjacent segments of LPT fifth stage stator vanes, which then led to the crack due to the increased stress of the trailing edge side of the outer side of engine in the concavity side of the stator vane, and the crack then progressed to the fracture due to the repetitive stress by engine operations.

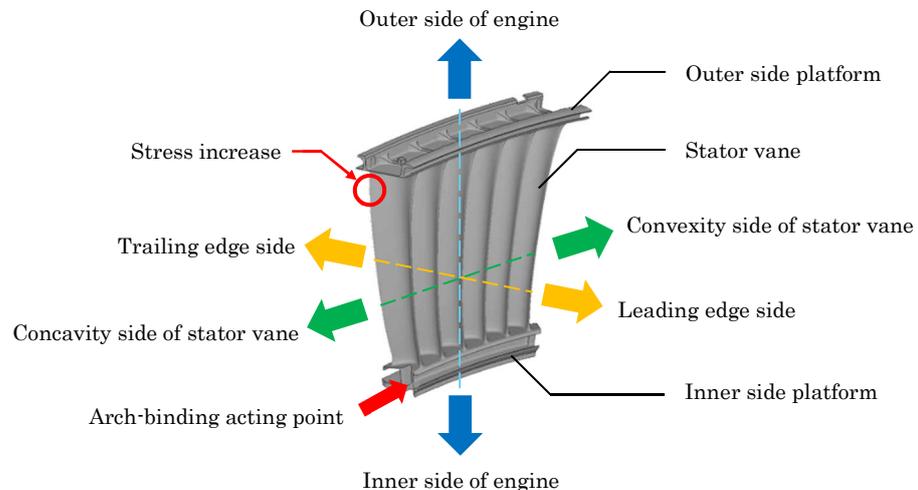
The stress analysis conducted by the engine manufacturer revealed that, if arch-binding occurred on the slash-faces of the inner side platform of adjacent segments of LPT fifth stage stator vanes, it increases stress of the trailing edge side of the outer side of engine in the concavity side of the stator vane (see Figure 7).

Figure 7: LPT fifth stage stator vane segment

It is probable that the crack of LPT fifth stage stator vane was caused by increased stress on the trailing edge side of LPT fifth stage stator vane caused by arch-binding, because wearing, which was a trace of arch-binding, was confirmed on the slash-face of LPT fifth stage stator vane segment on the inner side of engine and arrest lines were periodically confirmed through fracture analysis.

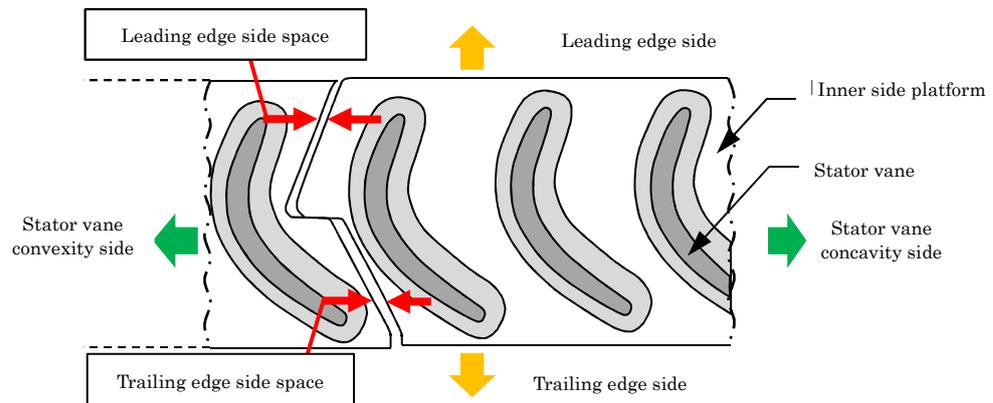
Figure 8: Space of LPT fifth stage stator vanes segments

The engine failure analysis described in (i) above induced the engine manufacturer to change the design in a way to widen the space of the leading edge side of the inner side of engine of adjacent segments of LPT fifth stage stator vanes in order to avoid the occurrence of arch-binding (see Figure 8).

The engine manufacturer published the service bulletin (SB72-0821) on August 16, 2019. The service bulletin (SB72-0821) is such that modification is conducted in order to widen the space of the each LPT fifth stage stator vane segments before the design change of the service bulletin (SB72-0637) when the LPT is disassembled.

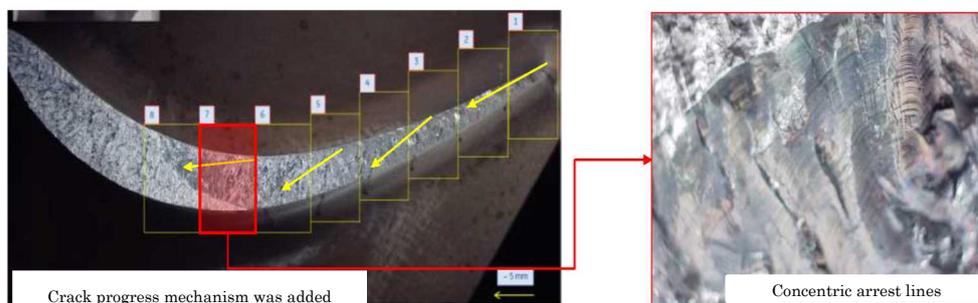
BSI conducted by the Operator confirmed cracks existing on stator vanes of three segments of LPT fifth stage stator vanes. Inspection conducted after disassembly of the engine confirmed cracks on stator vanes of another two segments of LPT fifth stage stator vanes.

The confirmed crack progressed from trailing edge side with length of 1.2 to 1.6 inches.

(1.6 inches long) was about 1,000 cycles based on a count of the striations at the fracture surface.

Figure 9: Condition confirmed crack

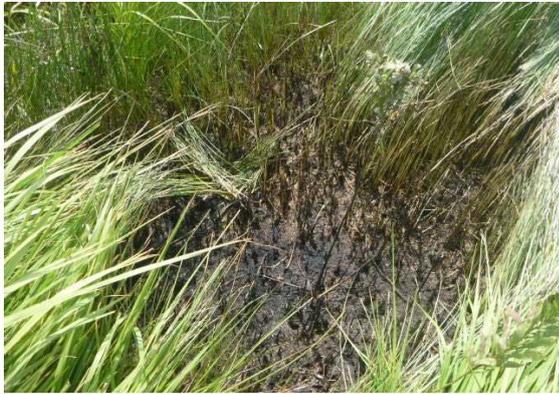
Point A about 1 m x 1 m

It is probable that burned grass area was caused by high temperature fragments exhausted from the engine aft due to damage of LPT and fell on the grass area on the side of runway near the taking off area of the Aircraft.

Appended Figure 2: Burned condition of grass area

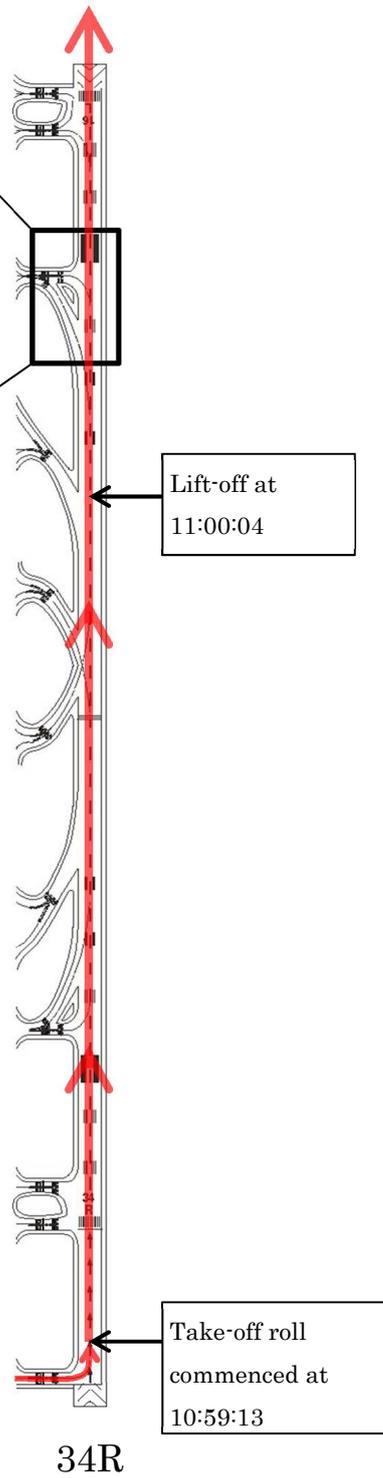
Appended Figure 1: Locations of burned grass area

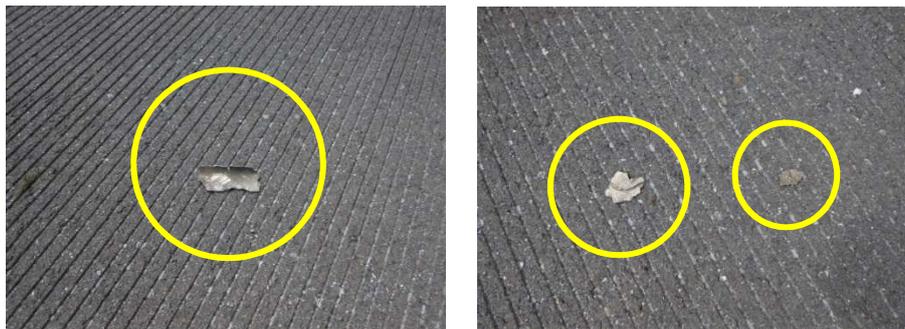
Appended Figure 4: Metal fragments scattered on runway
