AI2022-3

**AIRCRAFT SERIOUS INCIDENT
INVESTIGATION REPORT**

**PRIVATELY OWNED
JA76EL**

April 28, 2022

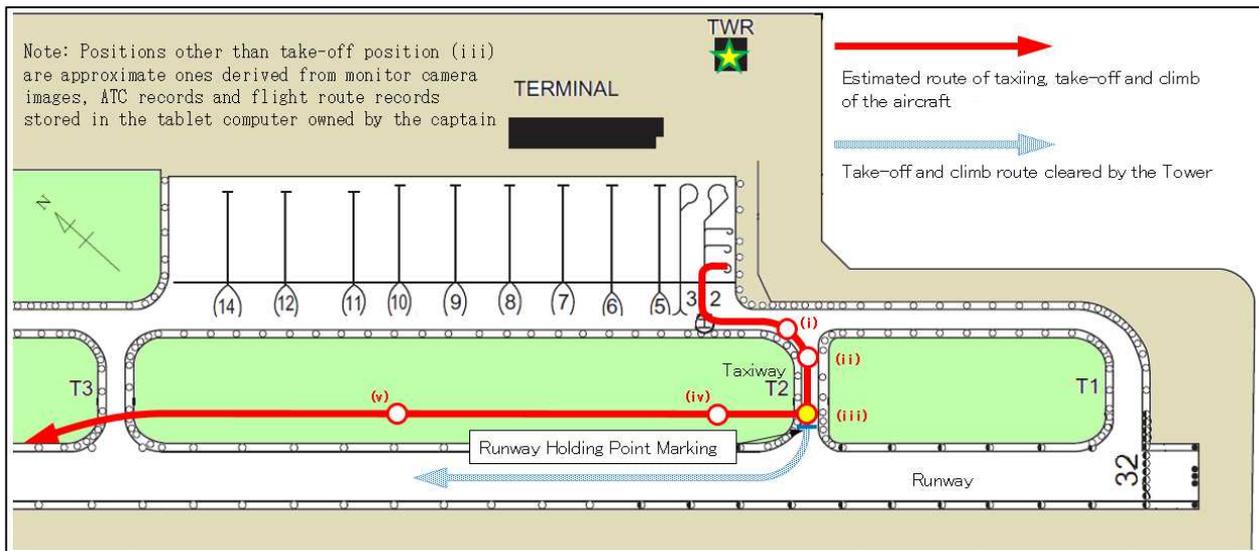
Figure 1 Movements of the aircraft (when departing from Nagasaki Airport)

The aircraft that commenced taxiing called the tower control position of the aerodrome control facility (hereinafter referred to as “the Tower”) (in the position of (i) in Figure 1) while taxiing to taxiway T2, and was cleared for take-off with the phraseology “RUNWAY32 AT T2, CLEARED FOR TAKE-OFF (take-off from T2 intersection at Runway 32 was cleared)” at 09:13 (in the position of (ii) in Figure 1). The captain read back what was told but interpreted to be cleared for take-off from Taxiway T2, and the aircraft took off from Taxiway T2 in parallel with the runway 32 direction at about 09:14 (in the position of (iii) in Figure 1).

The Tower, after issuing take-off clearance to the aircraft, visually recognized that the aircraft was turning to the right in the northwestern direction on Taxiway T2 (in the position of (iii) in Figure 1), and wondered if there occurred something wrong with it because of its unusual movement; however, the Tower did not suppose that the aircraft was taking off. The Tower, which visually recognized that the aircraft took off from Taxiway T2, was confused by its unexpected movement, and issued the take-off clearance from Runway 32 again to have the captain realize that the clearance was intended for take-off from the runway (in the position of (iv)). The captain read back again as the captain was told so, but continued climbing with moving forward in parallel with the Runway 32 direction as the captain missed the intention of the Tower to re-issue the clearance. As the Tower further instructed the aircraft to take off from the runway in Japanese (in the position

of (v) in Figure 1), the captain realized that the Tower warned that the aircraft took off from the incorrect take-off area. The aircraft then commenced left turn at some 800 m ahead of Taxiway T2 and moved to over Runway 32 to continue the flight.

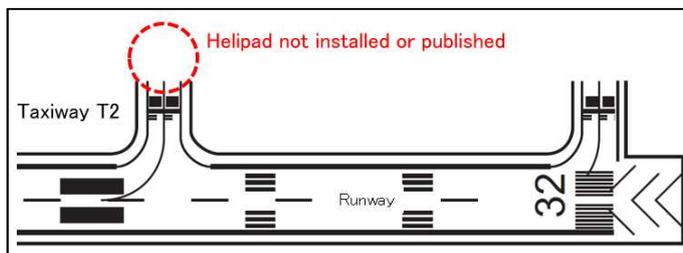
Figure 2 Taxiway T2 at Nagasaki Airport

While take-off and landing at an airport are performed on runway in principle, the ATC Operational Guidelines prescribed by Nagasaki Aerodrome Control Facility stipulates that take-off and landing area for helicopters under visual flight rules at Nagasaki Airport shall be runway or helipad. The helipads at Nagasaki Airport are installed and published in two locations on the parallel taxiway, but not on Taxiway T2.

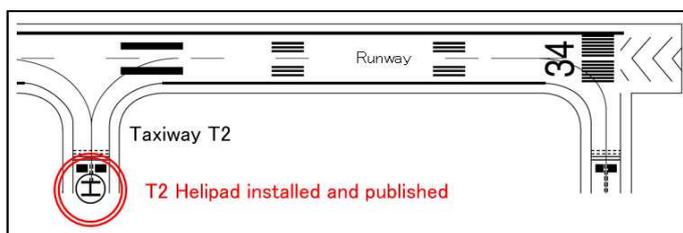
Figure 3 Taxiway T2 at Kagoshima Airport

On the other hand, at Kagoshima Airport, a helipad is installed and published on Taxiway T2, located close to the helicopter apron, and used for take-off and landing.
