AA2017-5

**AIRCRAFT ACCIDENT
INVESTIGATION REPORT**

**PRIVATELY OWNED
JA 7963**

**COLLISION INTO THE FACE OF THE MOUNTAIN SLOPE
PRIVATE OWNED ROBINSON R22 BETA (ROTORCRAFT),
JA7963
MATSUIDA-TOWN, ANNAKA-CITY, GUNMA-PREFECTURE,
JAPAN
AT ABOUT 10:56 JST, NOVEMBER 22, 2015**

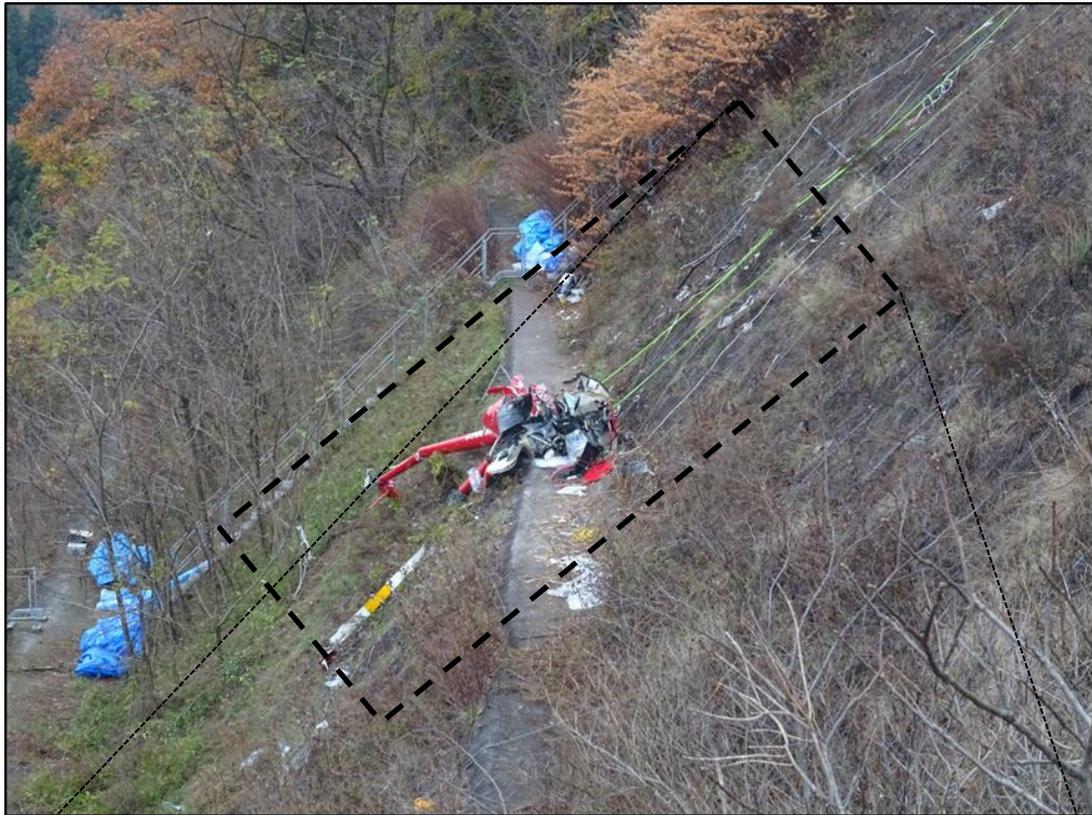
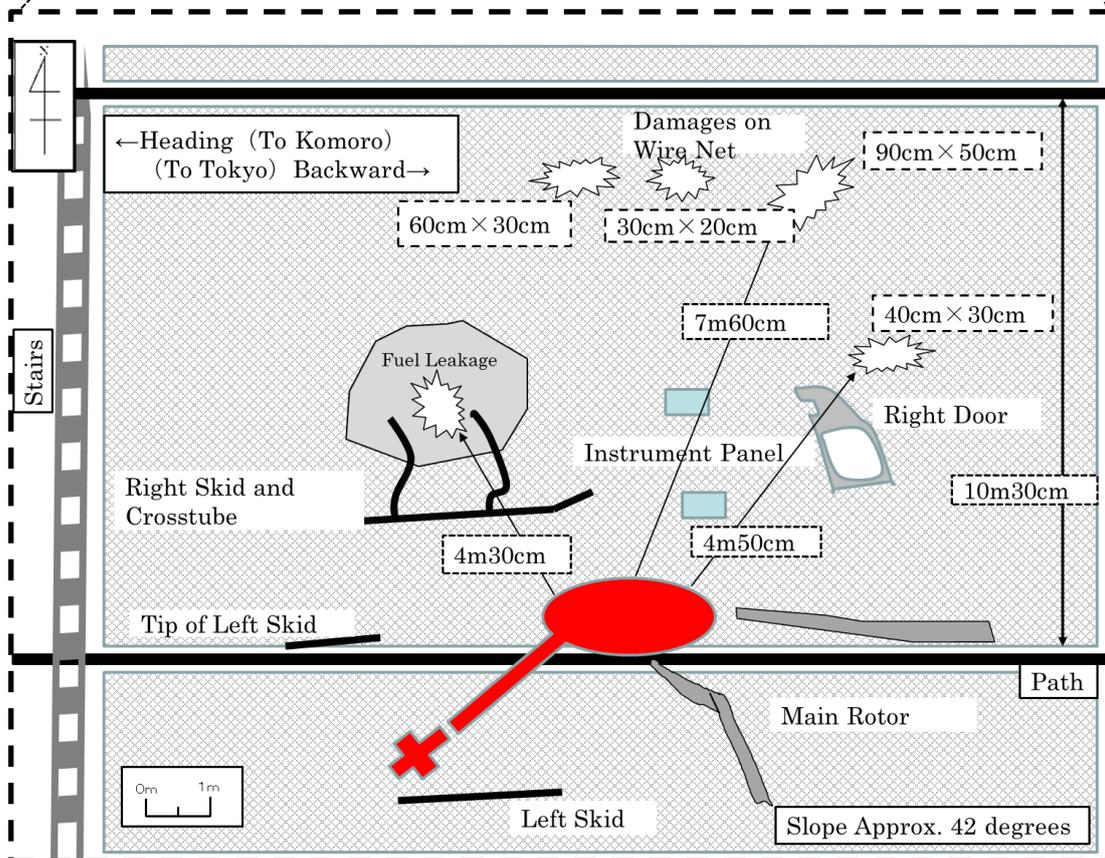
Appended Figure 5: Accident Site

The slope face is a land managed by East Nippon Expressway Company Limited, rhombus wire nets were installed on about 45 degrees tilted slope face in order to prevent earth damages like a slope failure or a landslide, and large rocks are dotted under the wire nets. Adding to this, there are concrete paved paths provided for maintenance at every approximately 10 m in perpendicular direction, and the rotorcraft stopped at the path with the nose facing east. Furthermore, there are cliff at about 60 m east from where the rotorcraft stopped, the north and east sides are lower and provide good views.

There were damaged wire nets on three places at about 7.6 m upward, one place at about 4.5 m right-upward and one place at about 4.3 m left-upward from a spot where the rotorcraft stopped at (at an elevation about 530 m), and there was the trace of fuel leakages near the damaged part at about 4.3 m left-upward from the spot.

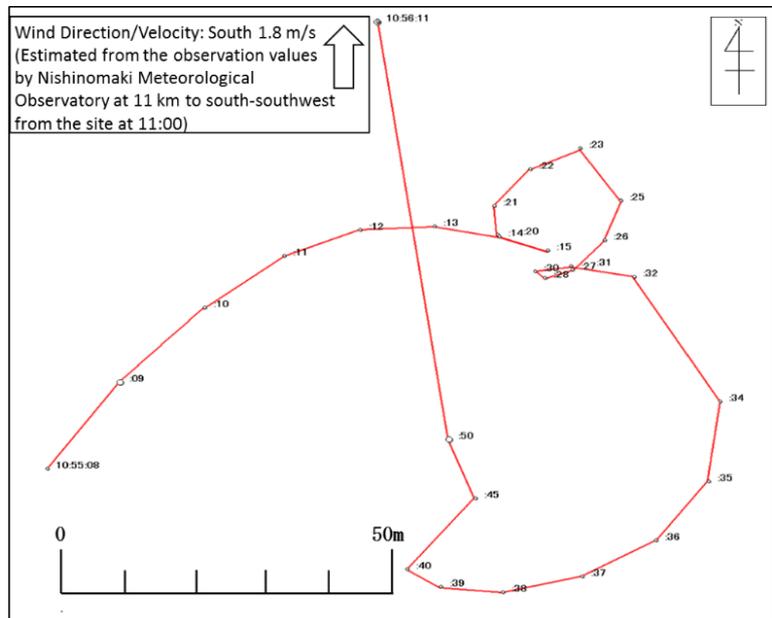
Appended Figure 7: GPS Records near the Accident Site

altitude records by the GPS as shown in Appended Figure 7 or was near the cloud and under a condition where VMC could not be maintained. Furthermore, it is probable that Mt. Asama at an elevation 2,568 m which was considered to be the guide to decide to continue the flight or not at the time of takeoff from Nagareyama Helipad could not be seen. Furthermore, it is somewhat likely that the cloud was almost standstill because of a gentle breeze condition in the vicinity as described in 2.6.2.

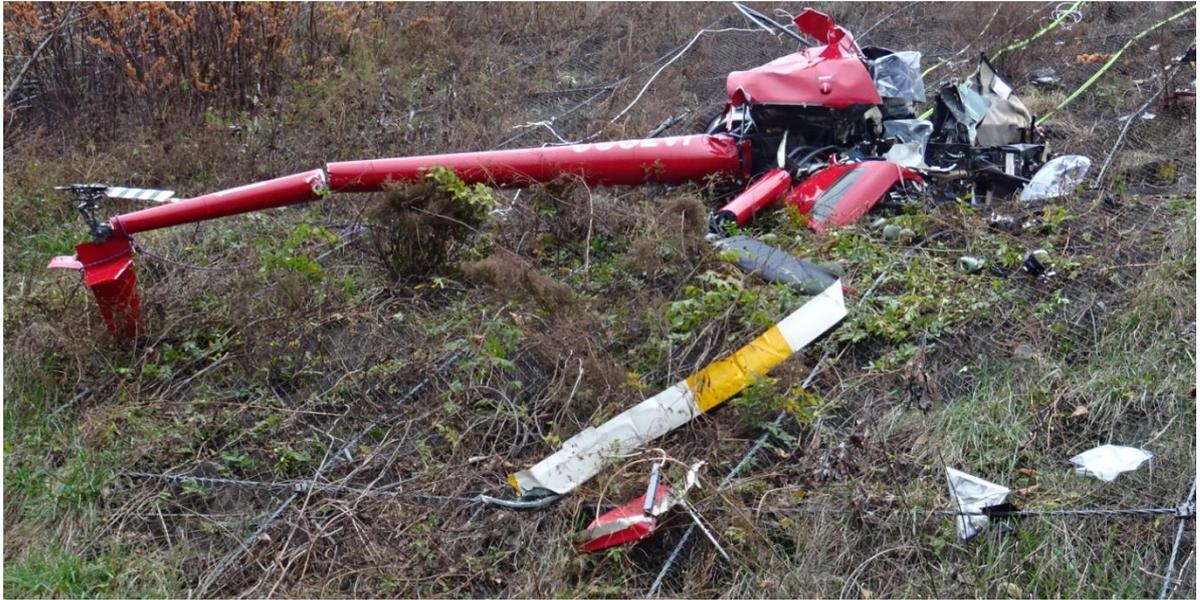
Photo 1: Accident Rotorcraft

The location where this accident occurred and where the rotorcraft was stopped was at the slope face (36°20'32"N 138°42'56"E) at an altitude about 530 m of a mountain on the north side of Tokyo Bound Expressway at Matsuida Town, Annaka City, Gunma Prefecture between Usui-Karuizawa Interchange and Matsuida-Myougi Interchange, and the date and time of the accident was at around 10:56 on November 22, 2015. (See Appended Figure 1: Estimated Flight Route, Photo 1: Accident Rotorcraft, and Photo 2: Accident Site Area)

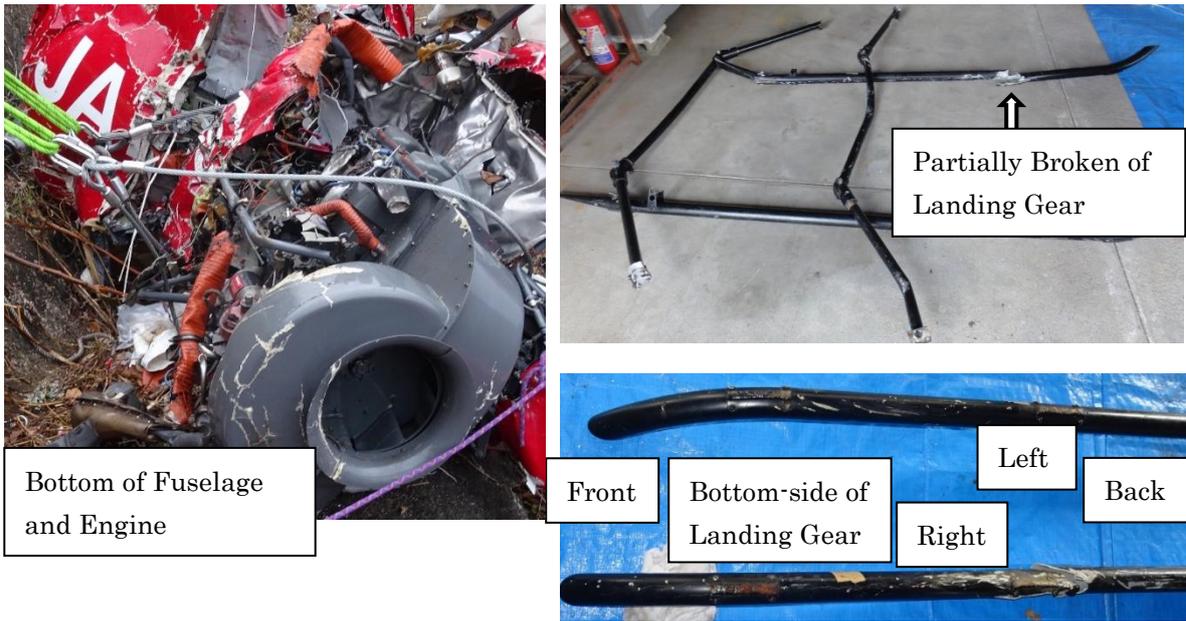
Photo 3: Damage Situation of the Rotorcraft

Fuselage	Broken, Bent, Ruptured
Tail Cone	Broken
Engine	Broken, Damaged
Main Rotor	Broken, Bent
Tail Rotor	Broken, Bent
Landing gear	Broken, Bent
Control system	Partial Ruptured

The battery equipped at the left side of engine compartment below the airframe was broken into pieces and the internal pole plates were separating individually.

Crankcase was broken at the forward section of the airframe.

The intake air-filter was damaged as being crushed.

The lower oil pan was damaged as a strong force pushing upward from the bottom.

The other blade was broken from the root.

One of two blades was broken from the root. Furthermore, the lower vertical stabilizer was bent backward.

Skids were broken near the mounting of the left front crosstube. The face touching the ground had a contact mark with the rhombus wire nets preventing earth-damage. The right side did not have a big damage.

As described in 2.1.2 (3) and (4), the statement described that the rotorcraft collided with the nose down, flying at the same altitude of the collided site and passing over the expressway at the time of collision. As described in 2.8.2, it is probable that the rotorcraft was flying and collided with a fixed forwarding speed as passing over the expressway because the left skid was broken near the mounting part of the front crosstube and the crosstube was bent like being pushed backward of the airframe. Adding to this, it is probable that receiving a load in diagonal direction, it collided into the slope face of the mountain beside the expressway as described in 2.8.1, the collision from the left front first, and it is somewhat likely that the impact force at the time of collision becomes bigger due to the rocks under the rhombus wire nets set up on the slope face.

At the time of contact, it is probable that because the front of the left skid was broken, the nose contacted at facing east, then, the crosstube bent and the bottom of the

fuselage was broken. Furthermore, based on the contact mark on the ground as described in 2.8.1, it is probable that the rotorcraft contacted the spot which was about 7.6 m upward from the location to stop, then the fuselage moved to the spot about 4.3 m upward and left from the location to stop and slid down to the last location where it parked while receiving repeated damages.
