AA2019-1

**AIRCRAFT ACCIDENT
INVESTIGATION REPORT**

ROLLOVER DURING AIR-TAXING
NEAR FUSESHITA, KASHIWA CITY,
CHIBA PREFECTURE, JAPAN
AT AROUND 13:35 JST, JULY 8, 2018

PRIVATELY OWNED
ROBINSON R22 BETA (ROTOR-CRAFT), JA7980

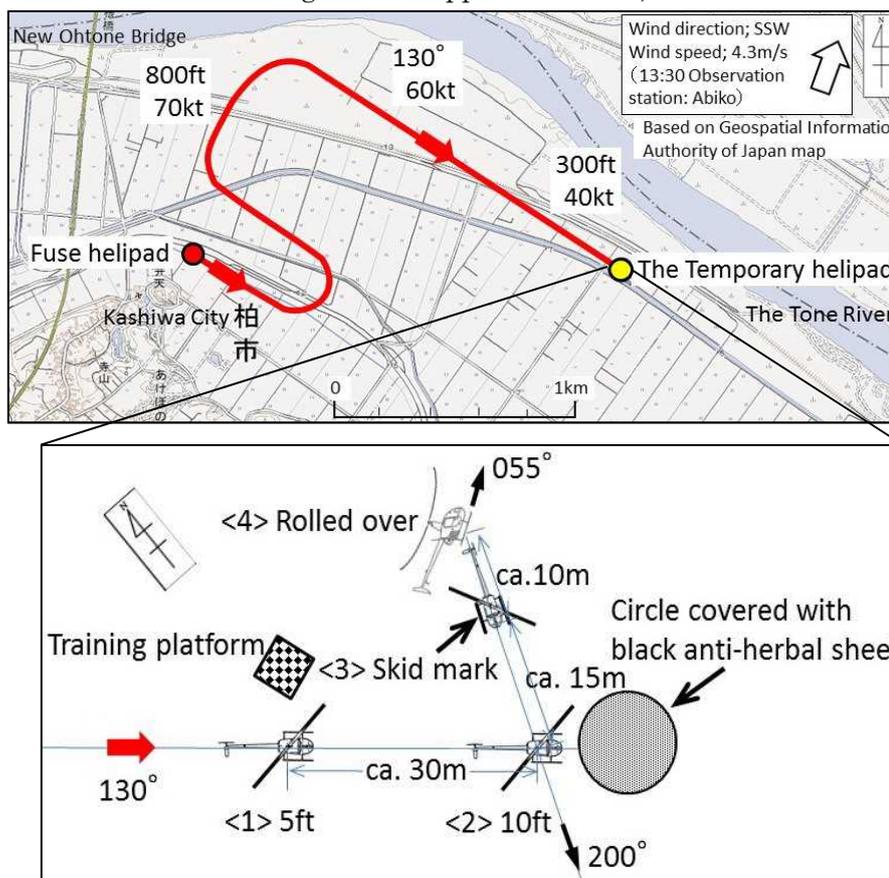
Figure 1: estimated flight route and the site sketch

<p>black anti-herbal sheet which is the target of landing at the Temporary helipad. The helicopter landed over to the grassland on the south side of the training platform as hovering at about 5 ft AGL (Above Ground Level) as usual (<1>, the number in Figure 1, same below).</p> <p>After that, the helicopter climbed to about 10 ft AGL and was air-taxing at a speed slower than walking towards the circle where the captain was going to ground. Near the edge of the circle place <2>, the captain tried to correct the helicopter's attitude because the nose was suddenly taken to the right, but he could not control as he expected. On the other hand, because the helicopter suddenly tilted to the left and the nose turned about 30 degrees to the right, and the altitude also dropped, the passenger tried to support the captain. But as a result, the helicopter became the situation where two pilots were maneuvering at the same time due to the captain tried to continue maneuvering as it was. The helicopter once grounded <3>, then floated up, and rolled over with the left side down when they noticed <4>.</p> <p>The passenger said, when the helicopter suddenly tilted to the left, he felt danger because the control stick also tilted to the left, and tried to tilt the control stick to the right, but he could not move as he expected because the captain still held the control stick strongly. At this time, the passenger raised the collective pitch control lever (hereinafter referred to as "CP lever"), but he did not remember whether or not he operated the rudder pedals. The helicopter eventually rolled over with the left side down while changing its attitude greatly. The passenger remembered that the low rpm warning sound started ringing in the middle, and the engine has been running until it rolled over. After the helicopter rolled over, the passenger turned off all switches and immediately escaped from the helicopter together with the captain.</p> <p>There was no abnormality in the helicopter during pre-flight inspection and flight.</p> <p>This accident occurred at around 13:35 on July 8, 2018, at Fuse number three temporary helipad near Fuseshita, Kashiwa City, Chiba Prefecture (35 ° 54' 01" N, 140 ° 01' 36" E).</p>														
<p>2.2 Injuries to persons</p>	<p>None</p>														
<p>2.3 Damage to Aircraft</p>	<p>Extent of damage:</p> <p style="text-align: center;">Substantially damaged</p>

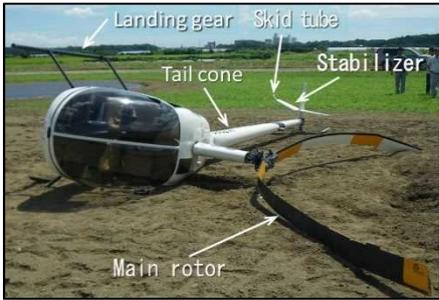
<table><tr> <td>Fuselage frame:</td> <td>Damaged</td> </tr><tr> <td>Main rotor blades:</td> <td>Damaged</td> </tr><tr> <td>Tail rotor blades:</td> <td>Broken</td> </tr><tr> <td>Tail rotor drive shaft:</td> <td>Broken</td> </tr><tr> <td>Landing gear:</td> <td>Broken</td> </tr><tr> <td>Stabilizer:</td> <td>Deformed</td> </tr><tr> <td>Tail cone:</td> <td>Deformed</td> </tr></table>

<p>Photo 1: over turned helicopter</p> </div>	Fuselage frame:	Damaged	Main rotor blades:	Damaged	Tail rotor blades:	Broken	Tail rotor drive shaft:	Broken	Landing gear:	Broken	Stabilizer:	Deformed	Tail cone:	Deformed
Fuselage frame:	Damaged														
Main rotor blades:	Damaged														
Tail rotor blades:	Broken														
Tail rotor drive shaft:	Broken														
Landing gear:	Broken														
Stabilizer:	Deformed														
Tail cone:	Deformed

The helicopter during air-taxing suddenly tilted to the left, the nose veered about 30 degrees to the right, and the altitude was also lowered. Regarding the fact that the nose veered to the right, it is somewhat likely that because the captain was unable to perform an appropriate corrective operation for stopping the movement of the helicopter that was veering to the right by a strong weathercock stability effect¹ caused by the gust of the wind from the right that was stronger than the captain predicted.

In this accident, it is somewhat likely that the helicopter rolled over while greatly changing the attitude because the captain was unable to perform an appropriate corrective action when the helicopter veered to the right during air-taxing due to a strong weathercock stability effect caused by a gust of wind from the right.

In order to grasp the wind direction and speed accurately, the captain should have strived to gather information as much as possible and taken avoidance action such as going around immediately if the helicopter take on the behaviors different from his assumption at takeoff and landing.

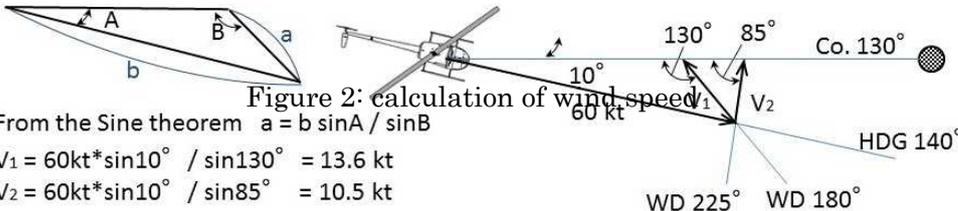
<p style="text-align: center;">Figure 2: calculation of wind speed</p> <p>From the Sine theorem $a = b \sin A / \sin B$</p> <p>$V_1 = 60 \text{kt} * \sin 10^\circ / \sin 130^\circ = 13.6 \text{ kt}$</p> <p>$V_2 = 60 \text{kt} * \sin 10^\circ / \sin 85^\circ = 10.5 \text{ kt}$</p> </div> <p>The following wind speed at which the wind correction angle becomes 10 ° to the right at an approach course of 130 ° and an airspeed of 60 kt is 13.6 kt when the wind direction is 180 ° (south) and 10.5 kt when the wind direction is 225 ° (southwest) as shown below.</p>	Time	Wind direction (°) / Wind speed (m/s) / Wind speed (kt)			Temp. (°C)	Precipitation (mm)	Sunshine hours (minutes)	Average	Maximum instantaneous		13:30	202.5 / 4.3 / 8.4	225 / 8.2 / 15.9	32.1	0	10	13:40	202.5 / 3.8 / 7.4	180 / 7.1 / 13.8	32.4	0	10
Time	Wind direction (°) / Wind speed (m/s) / Wind speed (kt)			Temp. (°C)	Precipitation (mm)				Sunshine hours (minutes)														
	Average	Maximum instantaneous																					
13:30	202.5 / 4.3 / 8.4	225 / 8.2 / 15.9	32.1	0	10																		
13:40	202.5 / 3.8 / 7.4	180 / 7.1 / 13.8	32.4	0	10																		
<p>2.7 Permission under Civil Aeronautics</p>	<p>Permission under the proviso of Article 79 (Places for landing and takeoff)</p> <p style="text-align: center;">Present</p> <p>(Regarding to the flight, permissions under the proviso of Article 79 of the</p>

that the actual average wind speed and direction at the Temporary helipad was approximately 13.6 kt from the south or 10.5 kt from the southwest. On the other hand, regarding the maximum instantaneous wind speed, from the fact that the instantaneous wind was blowing 1.9 times the average wind speed in Abiko about nine km away, it is somewhat likely that the instantaneous wind speed was also blowing at approximately 26 kt from the south or 20 kt from the south west in the Temporary helipad too. In that case, it is somewhat likely that the wind direction was more to the right and its speed stronger than 10 kt than the wind the captain expected. Moreover, it is somewhat likely that the wind at that time exceeded the limitation of the wind speed stated in the flight manual.
