**AIRCRAFT SERIOUS INCIDENT
INVESTIGATION REPORT**

**TAKUMI ENTERPRISE
HELICOPTER & AIRPLANE CO., LTD.
JA7981**

SHORTAGE OF FUEL REQUIRING URGENT MEASURES
AT AN ALTITUDE OF ABOUT 5,300 FT
OVER THE AREA 28 KM NORTHEAST OF OTSU CITY
SHIGA PREFECTURE, JAPAN
AT AROUND 17:05 JST, AUGUST 27, 2017

TAKUMI ENTERPRISE HELICOPTER & AIRPLANE CO., LTD.
ROBINSON R44(ROTORCRAFT), JA7981

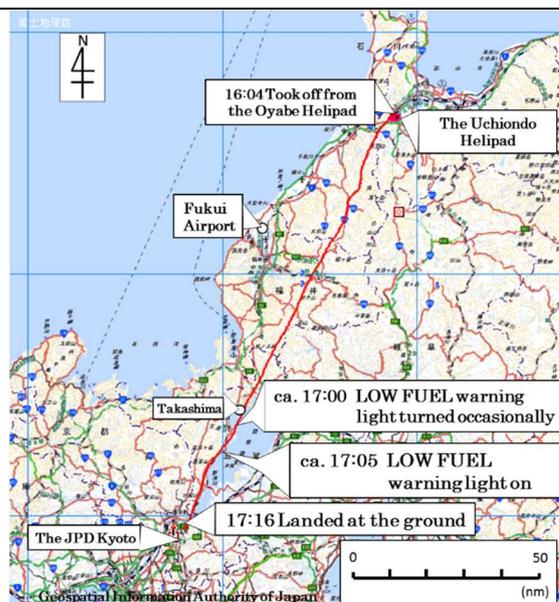
Figure 1: Estimated flight route of JA7981

A portable GPS receiver brought in the helicopter had recorded the flight data from the time when the helicopter took off from the JPD Kyoto on one day before to the serious incident occurrence till when it landed at the ground. Figure 1 shows the helicopter’s estimated flight route from taking off from the Oyabe Helipad to landing at the ground.

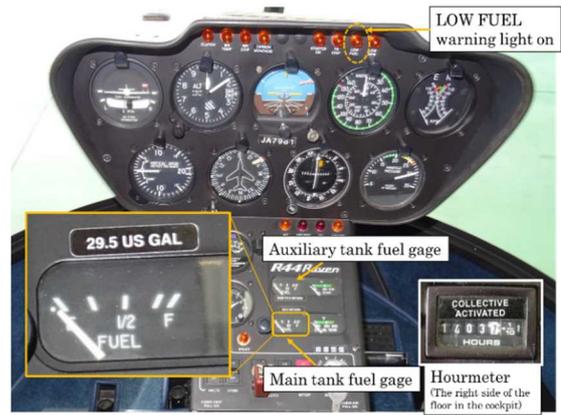
Photo 1: Instrument panel of JA7981

The fuel gages that show the quantity by fractions are mounted below the instrument panel and electrically operated by float-type transmitters in the fuel tanks.

The “LOW FUEL warning light” on the instrument panel is operated by a separate electric sender located on the bottom of the main tank. According to the flight manual, an illuminated low fuel warning light indicates that the usable remaining fuel quantity is about 3 gallons (US) (11.3 liters) and the fuel will run out within about 10 minutes if the helicopter continues flying at a cruise power; and it is also noted as follows:

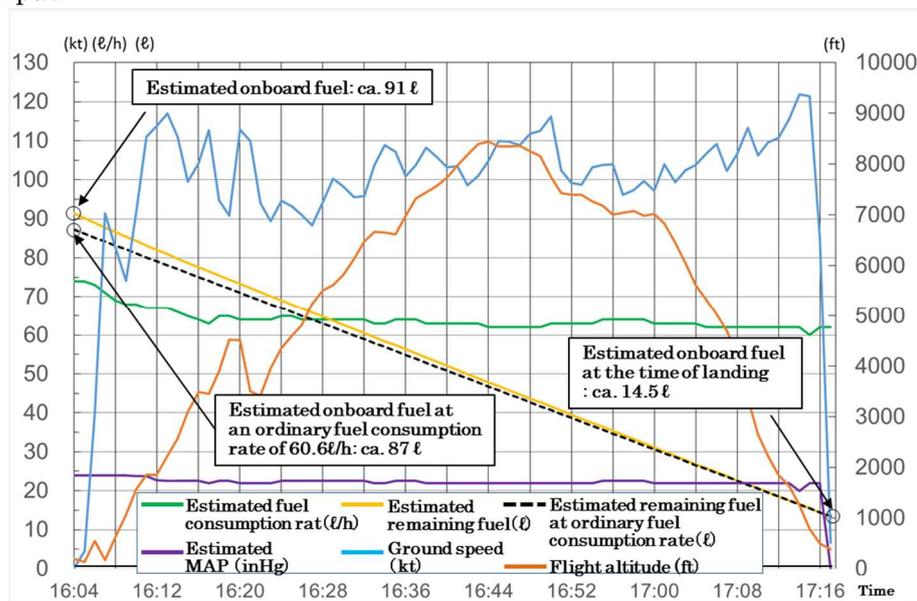
Figure 2: The Change of Ground Speed, Flight Altitude and Consumed Fuel of JA7981

The change of consumed fuel corresponding to the output calculated by the manufacturer of the helicopter was created into a graph, based on the estimated remaining fuel quantity, the helicopter weight, the wind direction and velocity, the outside air temperature, the flight altitude, the air speed and utilized power output at the time of landing at the ground.

It is probable that the fuel consumption rate had come to become particularly higher until around 16:20 because the helicopter, as shown in Figure 2, took off from the Oyabe Helipad and then climbed at a high power (about 22.5 inHg) and flew at a ground speed of 100 kt or more; and furthermore, after 16:44, the fuel consumption was larger than usual because the helicopter kept flying at a high power and increased the speed even when

starting descending. In addition, it is somewhat likely that its flight against headwind increased the fuel consumption. The remaining fuel quantity of the helicopter at the time of landing at the ground was about 14.5 liters. It is probable that with the consumed fuel that was accumulated during the flight added to this 14.5 liters, the estimated quantity of fuel onboard at the time of take-off was about 91 liters; additionally, the estimated quantity of onboard fuel, if calculated at an ordinary fuel consumption rate, was about 87 liters.
