**AIRCRAFT ACCIDENT
INVESTIGATION REPORT**

OSAKA AVIATION INC.

J A 7 9 8 7

**OSAKA AVIATION INC.
ROBINSON R22 BETA (ROTORCRAFT), JA7987
NEAR RUNWAY 27 OF YAO AIRPORT, JAPAN
AT ABOUT 15:32 JST, APRIL 27, 2009**

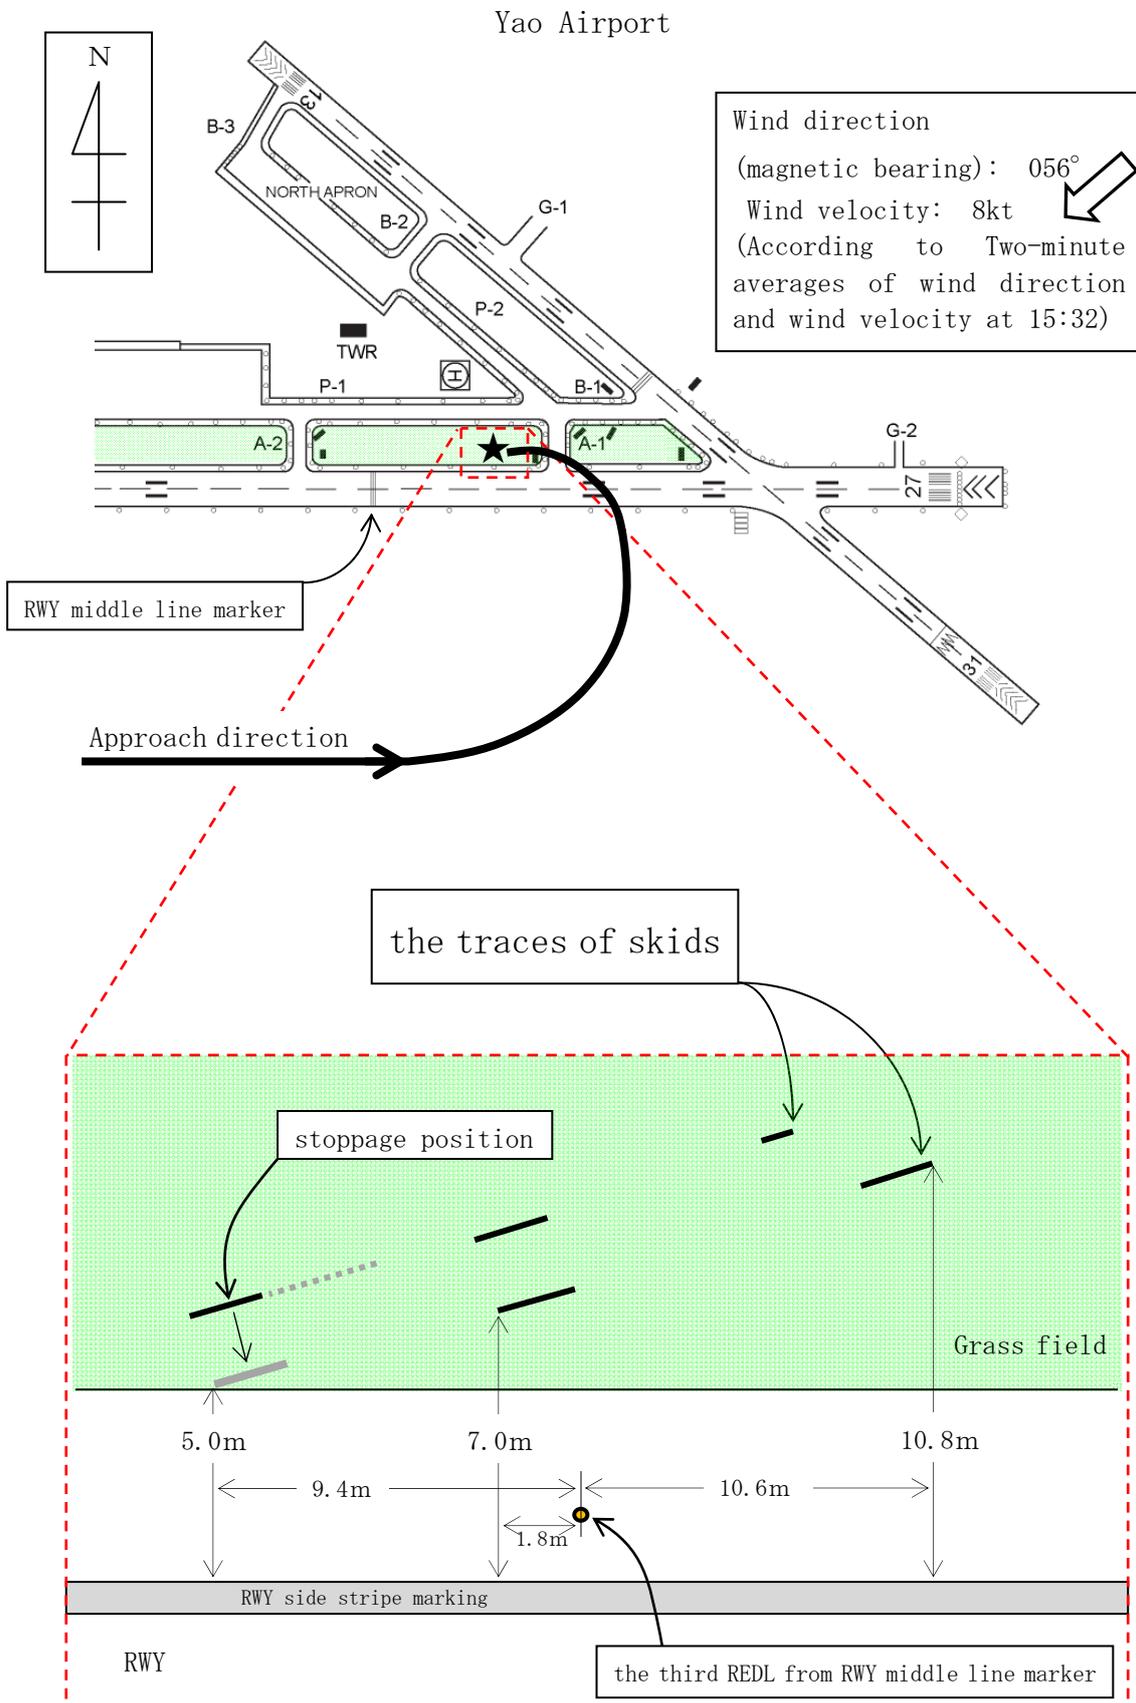
Figure 1 Estimated Flight Route and Layout of Traces of Touchdown

Traces of touchdown which are almost identical to the shape of the Aircraft's skids were found at three different places about 20 meters apart on a grass field between taxi ways A-1 and A-2 on the northern side of runway 27 at Yao Airport.

There is a runway edge light at a point about 128 meters eastward along the northern side of the runway side stripe marking (hereinafter referred to as “the Side Marking”) from the eastern end of the runway middle line marker on runway 27. The runway edge light is the third one to the east from the runway middle line marker. The traces, which are believed to be those of the left skid of the Aircraft, were found from a place about 10.6 meters east of the runway edge light and 10.8 meters from the outer edge of the Side Marking to a place about 9.4 meters west of the runway edge light and about 5 meters from the outer edge of the Side Marking.

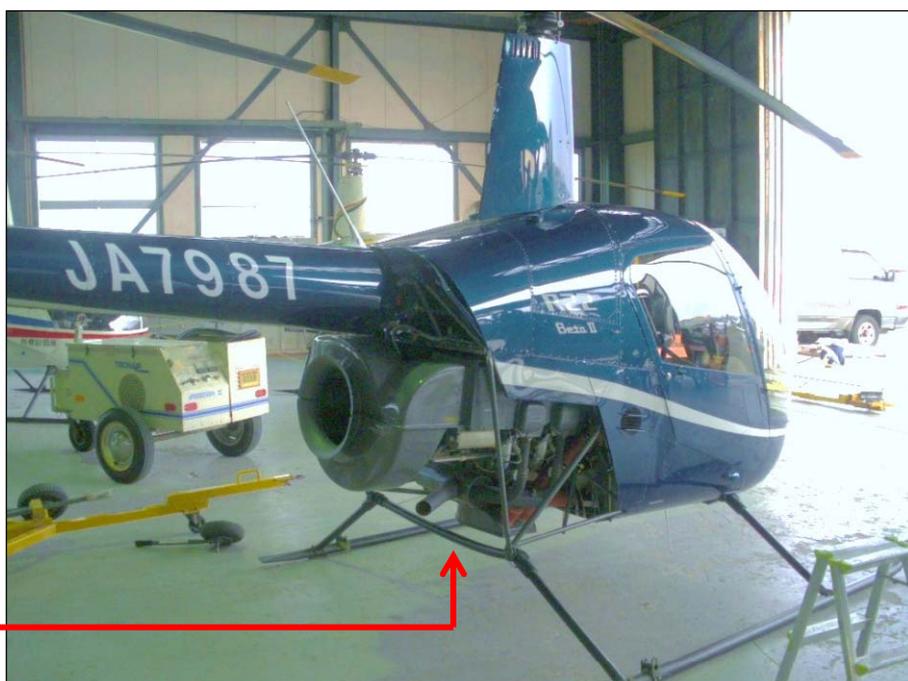
Photo 1 Accident Aircraft and Damaged Portions

- (1) In the landing gear assembly, the cross tube was bent and the skids were deformed with their interval widened by about 20 centimeters laterally.
- (2) The lower part of the mast fairing and the cowling in the right aft section of the fuselage were deformed.
- (3) The frames of the right side and left side doors, the outer skins on both sides of the fuselage and the base of the tail cone buckled.
- (4) The bottom side of one main rotor blade was wrinkled.

- (1) The impact that the landing gear assembly received on landing exceeded the limit load which can be absorbed with bending because the load with descent was added to the gross weight of the Aircraft. As a result, the cross tube was bent and the skids were widened laterally.

the bent cross tube

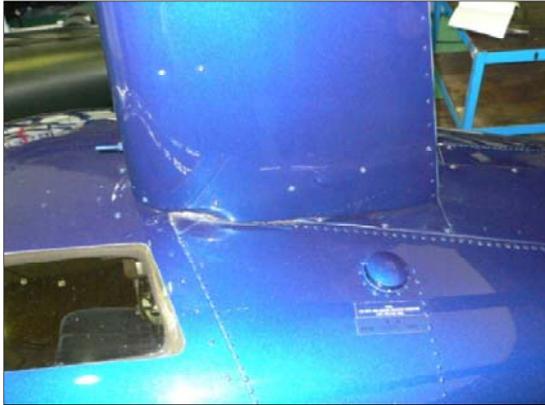
- (2) The lower part of the mast fairing and the cowling in the right aft section of the Aircraft were distorted by upward force created on landing and relayed from the landing gear to the sections affected through the frames and by a load applied forward and backward by a sudden deceleration.

Deformity of the left lower part of the mast fairing

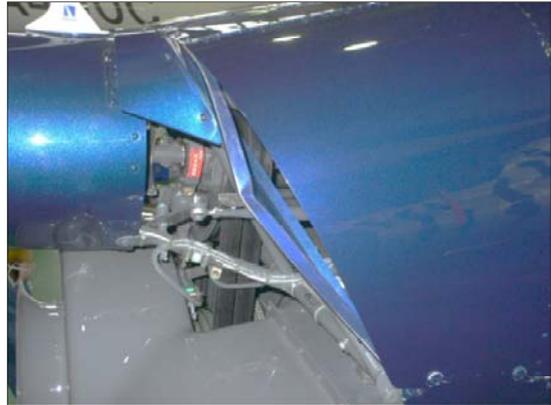
Deformity of the cowling in the right aft section

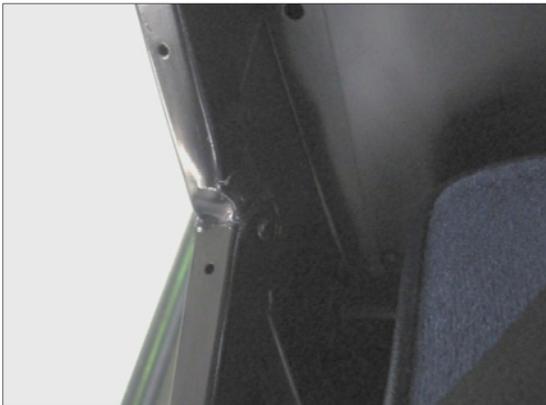
- (3) The frames of the right side and left side doors, the outer skins on both sides of the Aircraft and the base of the tail cone buckled due to an upward impact which came from the landing gear on landing through the frames.

Corn buckle of the frame of the right side door

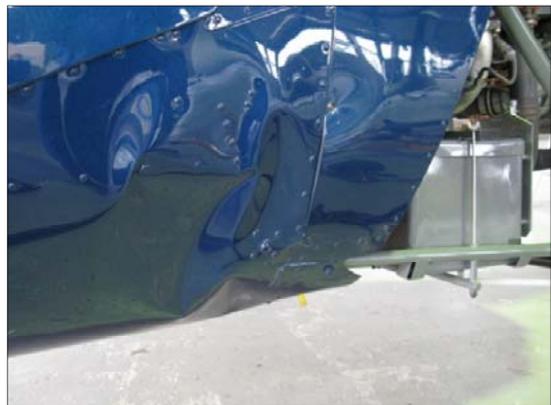
Corn buckle of the outer skin on left side of the fuselage

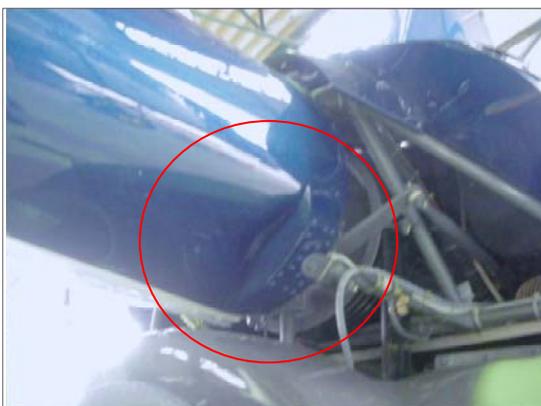
The tail corn buckled in the direction at five o'clock

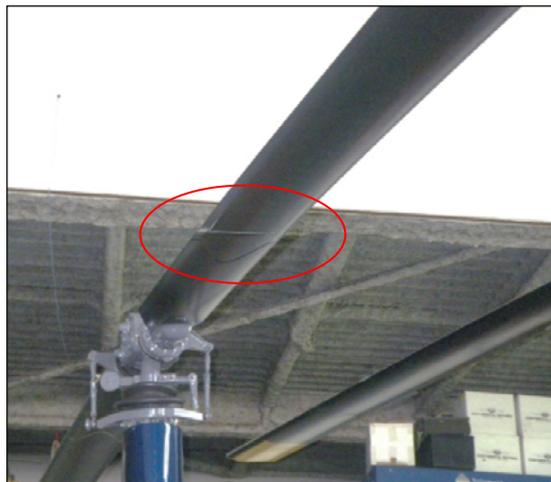
- (4) The bottom side of one main rotor blade was wrinkled due to upward force created on landing and relayed to the mast from the landing gear through the frames and a load applied forward and backward by a sudden deceleration.

Wrinkle of the bottom side of one main rotor blade

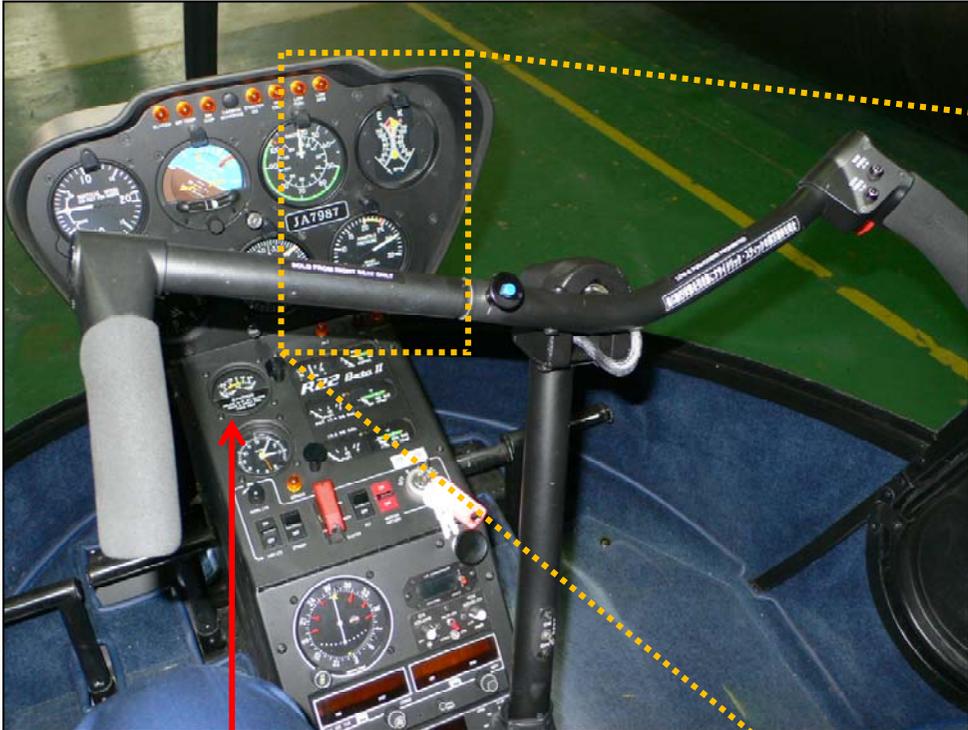
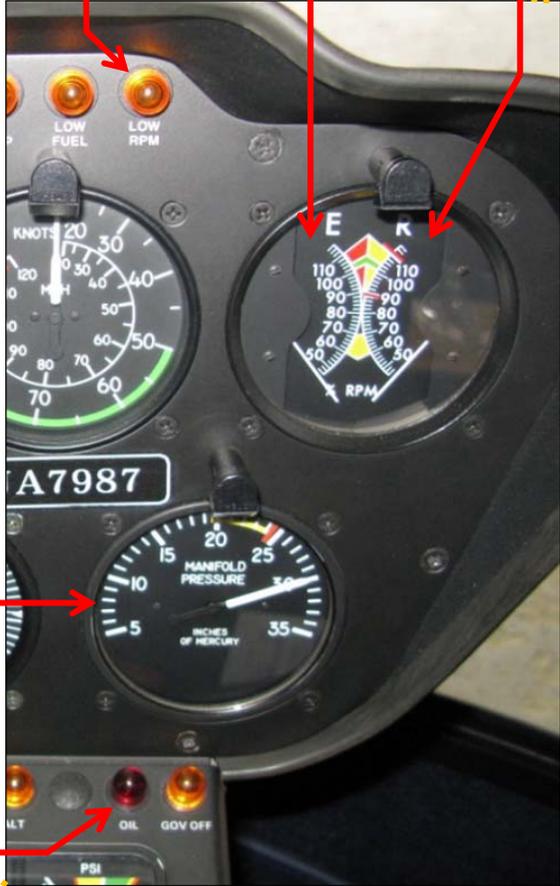
Photo 3 Instruments of the Aircraft

- (2) The captain flared to reduce the ground speed and the rate of descent up to the touchdown on the ground, but due to the existence of a tail wind component as described in 3.3, it is considered possible that the effect of the flare was not enough due to low air speed. When the captain flared, he heard the low rotation warning sound. Therefore, it is considered probable that the collective was raised and the rotor rotation decelerated. The captain and the trainee lack clear memories about the maneuvering of the collective, but the trainee stated that he was taking a posture to prepare for an impact of touchdown and holding the collective with his body tightened. Therefore, it is considered possible that the captain failed to operate the collective in the best possible manner to reduce the rate of descent of the Aircraft.
