**AIRCRAFT ACCIDENT
INVESTIGATION REPORT**

J A 8 0 D G

Japan Transport Safety Board

PRIVATELY OWNED
DG-800B (MOTOR GLIDER, ONE-SEATER), JA80DG
HOKUEI TOWN, TOHAKU DISTRICT, TOTTORI PREFECTURE
AT ABOUT 14:00 JST, JUNE 24, 2010

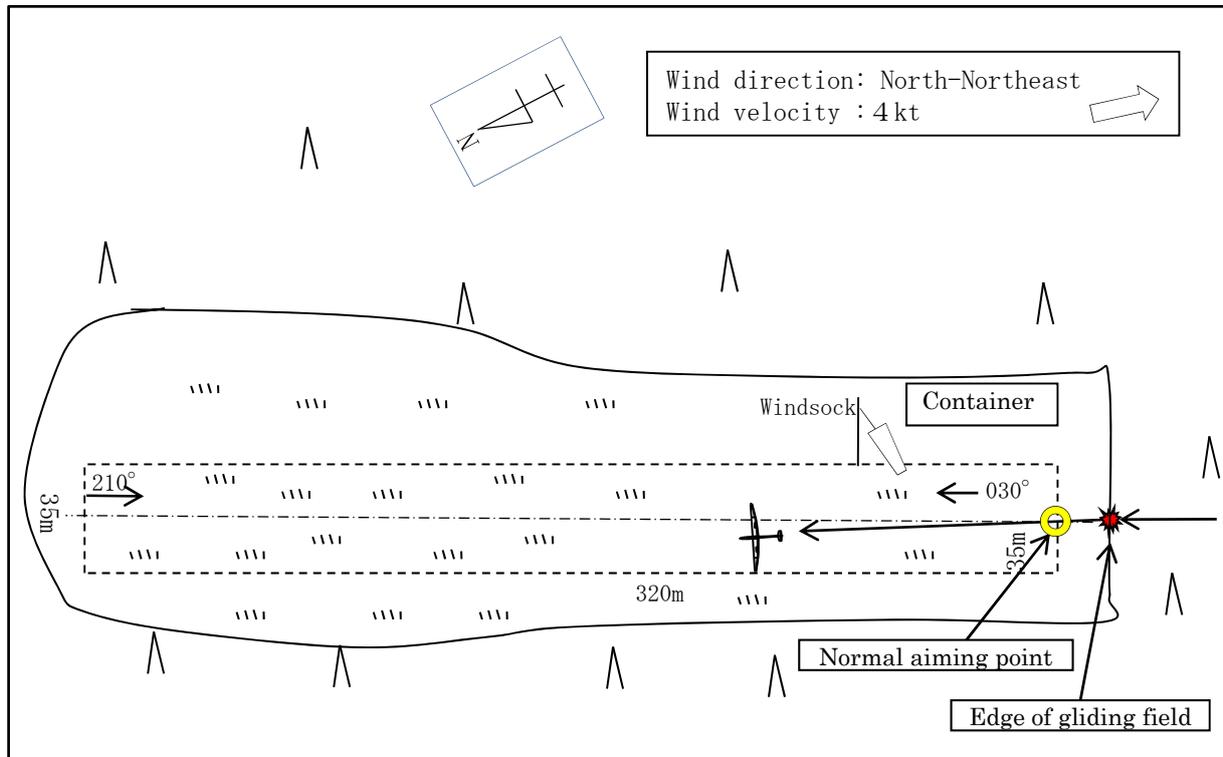
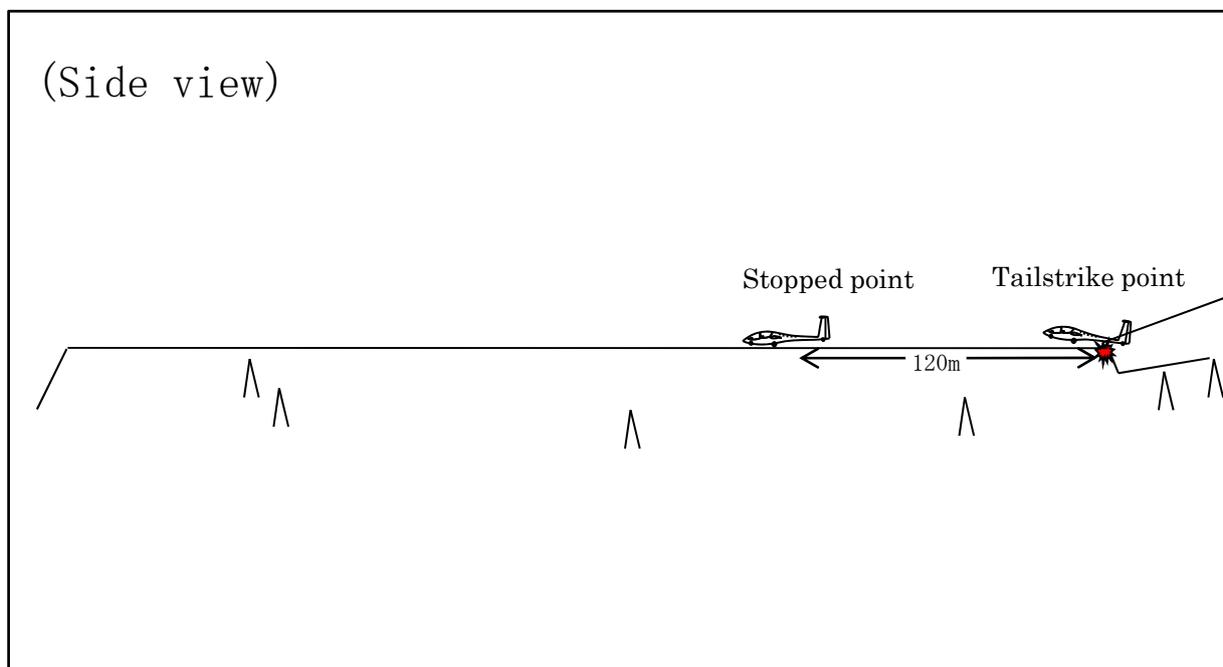
Figure 2 Estimated Flight Route and Accident Site

The edge of the ground on the side used for the Aircraft's approach is an angular part where the flat area of the Gliding Field and the steep slope of the plateau meet each other. The height of the steep slope of the plateau is about 4 meters. The area ahead from the bottom of the slope gradually becomes higher toward the south.

When the on-site investigation was conducted, there was no trace of tailstrike left in the area around the edge where the captain felt a strong impact. But broken pieces of the canopy were found at a point about 7 meters within the central part of the edge.

The place where the captain stated that the Aircraft stopped was about 3 meters to the left from the center line of the flat area as the landing and take-off area and about 120 meters within the edge.

The grass is less grown in the southern part about one third of the flat area of the Gliding Field while the grass is thickly grown at places to the north. The height of the grass was about 30 centimeters at some places in areas which are 8 meters or more away to both sides from the center line of the landing area.

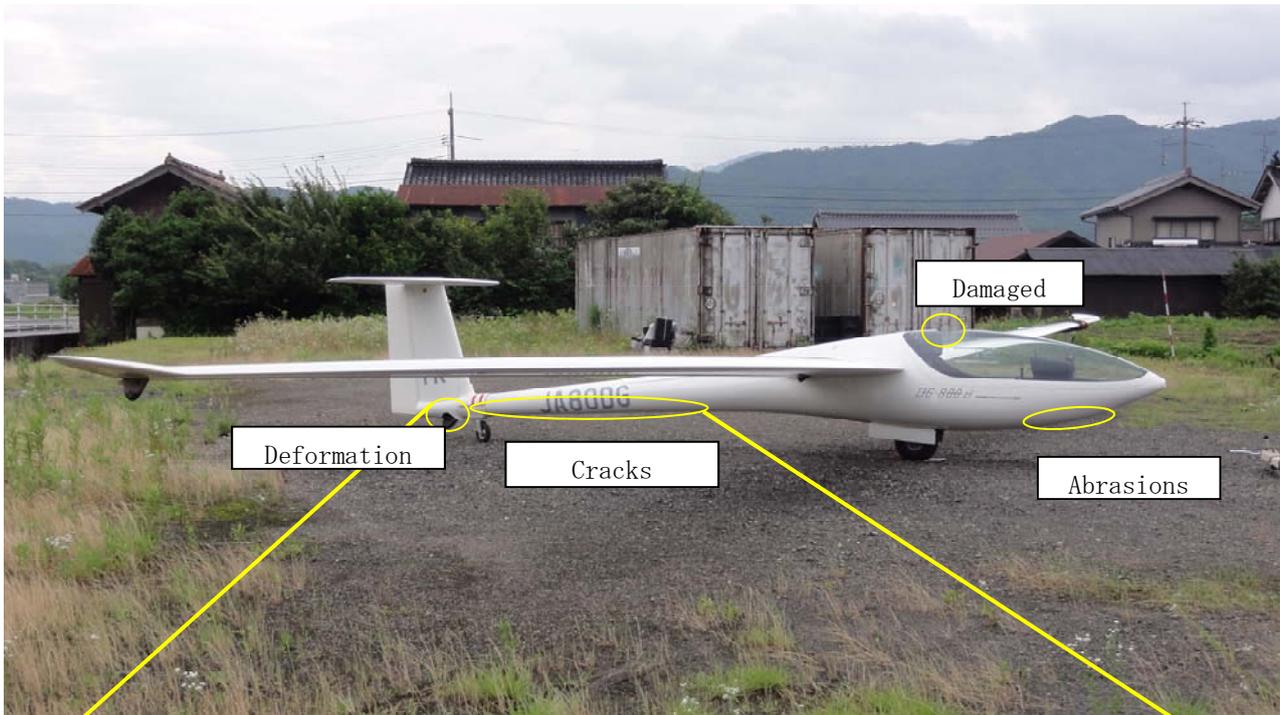
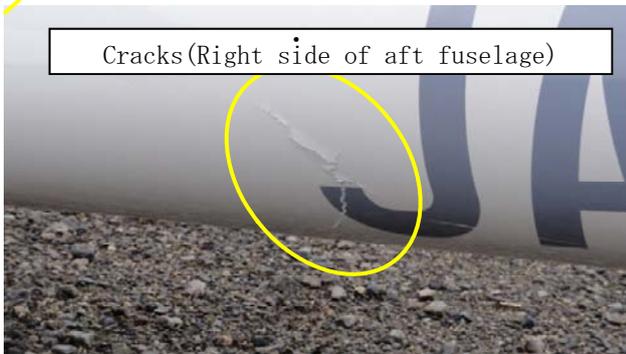
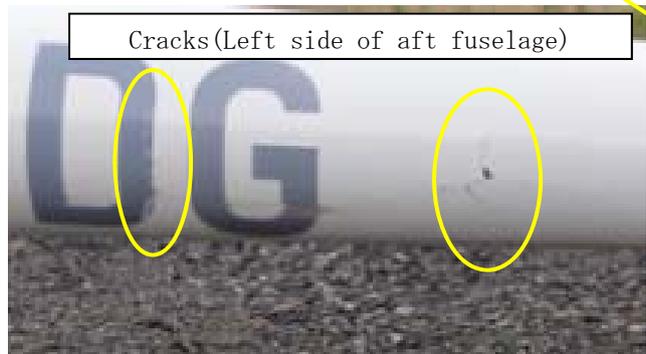
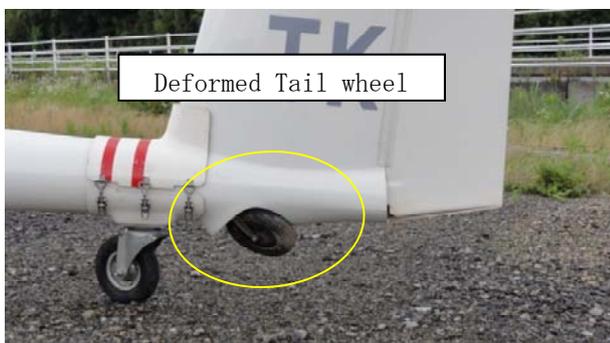
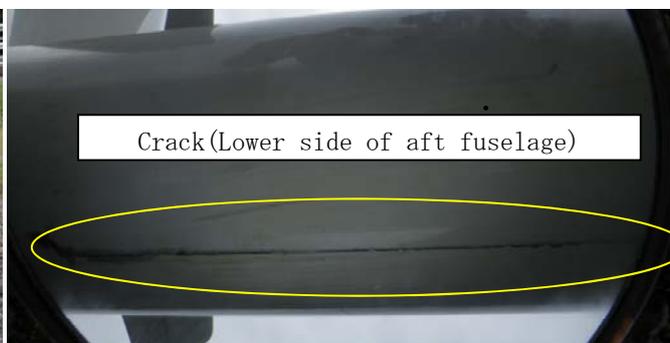
Photo 2 Accident Aircraft

- (1) Abrasions on the lower nose
- (2) A round breakage hole in the canopy (over the cockpit)
- (3) A crack in the lower fuselage (about one centimeter wide, about 2 meters long)
- (4) Three cracks in both sides of the aft fuselage (about one centimeter wide, 15 to 20 centimeters long)
- (5) Deformation of the tail wheel fork

Among components for the flight control system, there were no abnormalities except the inoperative rudder system linked to the tail wheel sticking to the fuselage due to the deformation of the tail wheel fork.

It is considered highly probable that the crack in the lower aft fuselage was caused when the aft fuselage struck the edge. The three cracks found in both sides of the aft fuselage were seen around the middle of the long crack left on the lower fuselage in the front to rear direction. Therefore, it is considered highly probable that this area had been hardest struck when the aft fuselage struck the edge .

It is considered highly probable that the abrasions on the lower nose were caused because the lower nose struck the ground when the Aircraft touched down with a loud sound while leaning the nose downward, after the aft fuselage struck the edge.

where the cockpit existed when the aft part of the fuselage struck the edge of the boundary. Therefore, it is considered highly probable that the captain's headset struck the canopy, partially damaging it, when the Aircraft nearly fell forward and the nose leaned downward in reaction to the impact caused when the aft fuselage struck the edge of the boundary.
