# AIRCRAFT INCIDENT INVESTIGATION REPORT

JAPAN ASIA AIRLINES FLIGHT 201  
BOEING 747-200B, JA8129  
OKINAWA PREFECTURE, JAPAN  
FEBRUARY 13, 2003

November 28, 2003

Aircraft and Railway Accidents Investigation Commission  
Ministry of Land, Infrastructure and Transport

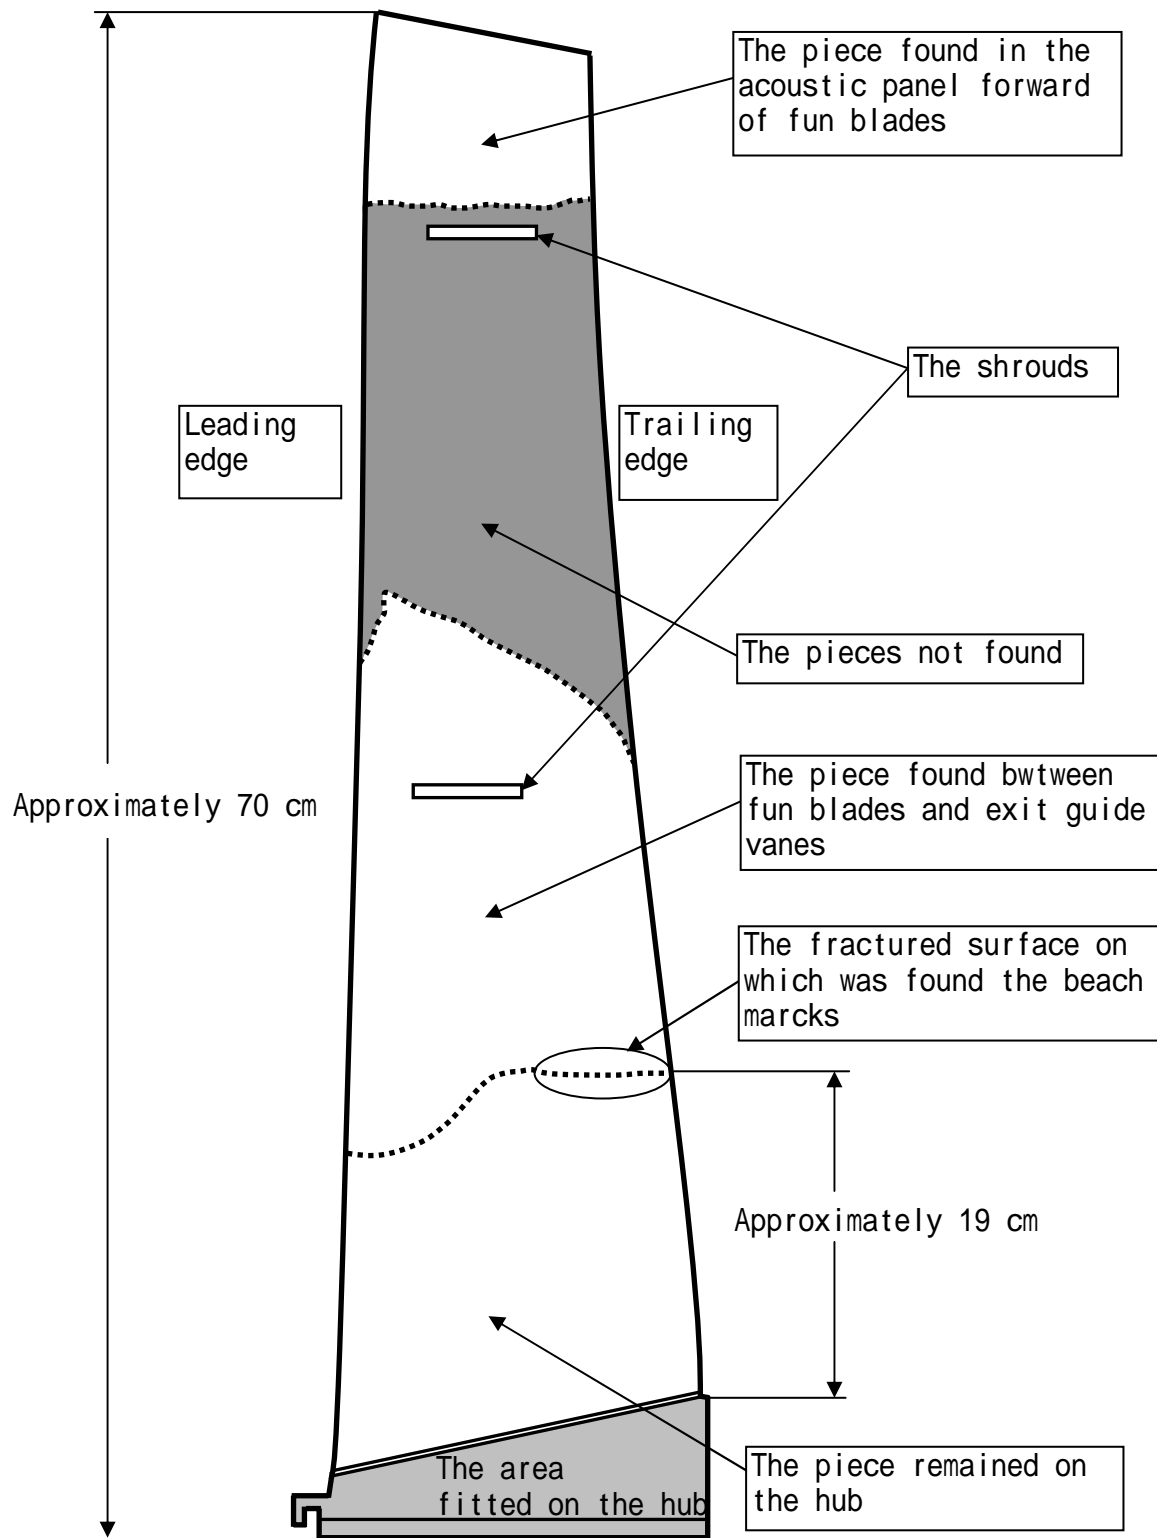
Figure 2 The figure of No.35 fun blade

- (1) A portion of the No. 35 fan blade from approximately 19 cm outboard of the platform had broken off, and the separated portion had broken into at least three fragments. The fragment nearest the root with a length of 20 cm was found between the fan blades and exit guide vanes. A 10 cm long fragment including the blade tip was found stuck into the acoustic panel on the inner wall of the nose cowl forward of the fan at a three o'clock position looking from the rear of engine. Of the total 70 cm length of the fan blade, fragments with a total length of approximately 21 cm were not recovered.

As mentioned 2.3(1), although the fan blade had broken into at least four pieces, only three pieces, including the piece that had remained attached to the hub, were recovered. These three pieces were examined. (See Figure 2 and Photograph 3.)

The beach marks originated at the trailing edge of the blade approximately 19 cm outboard of the platform and extended approximately 6 cm toward the leading edge. Beyond this, the remainder of the fracture surface indicated instantaneous tearing.

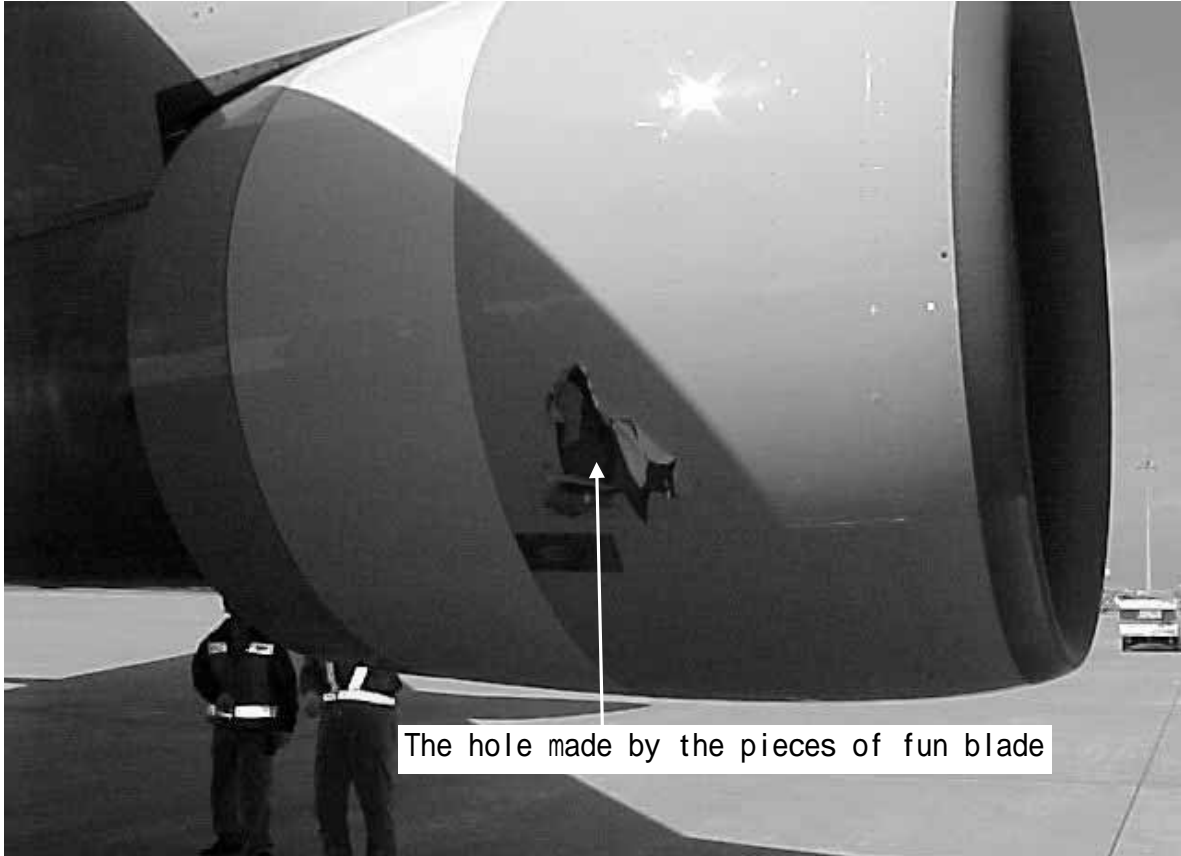
Photograph 1 Damage on No.2 engine ( 1 )

- (2) A hole that breached the nose cowl was found in the 4 o'clock position. Its greatest size in the direction of the engine axis was approximately 34 cm and circumferentially approximately 44 cm.

- (3) The acoustic panel on the inner wall of the nose cowl was damaged.
- (4) Some bolts that attached the engine tail cone were fractured.
- (5) Apart from the broken No. 35 fan blade, most of the 45 other fan blades were damaged.  
(See Fig. 2 and Photographs 1, 2, 3)

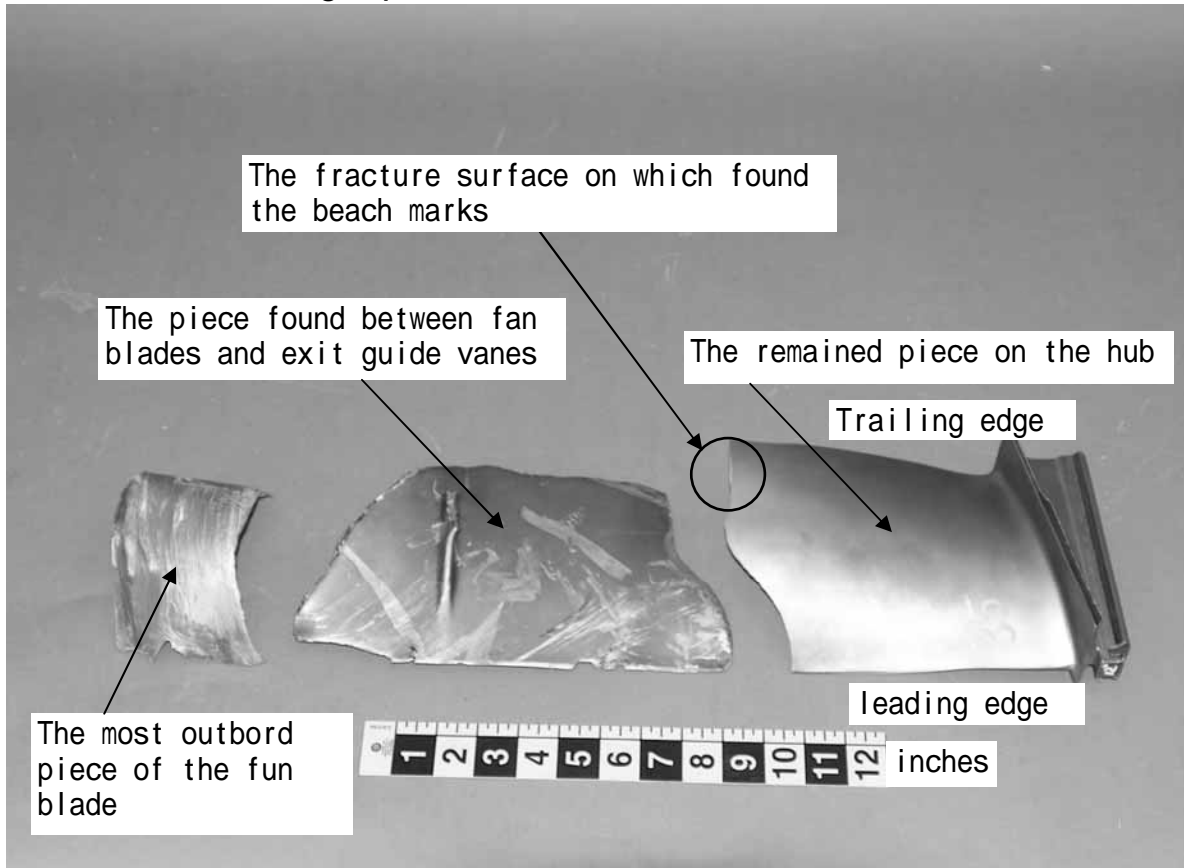
Photograph 3 Pieces of No.35 fun blade

Examination of the fracture surfaces of these fragments found beach marks, indicative of fatigue fracture, on the fracture surface of the fragment that had remained on the hub. On the other hand, the condition of the fracture surfaces of the other fragments indicated that they had been torn off by shear forces due to impact etc. or the surfaces were considerably worn.

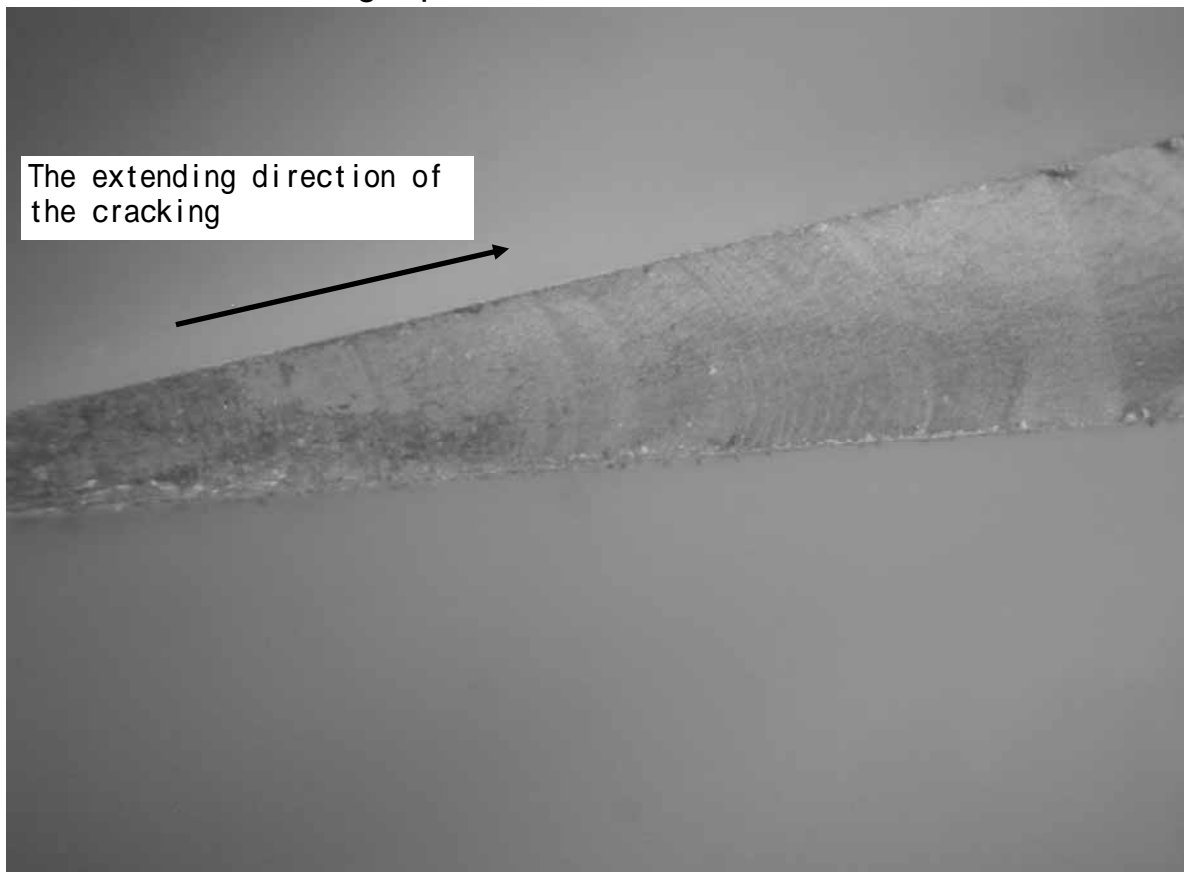
Photograph 4 The beach marks

**3.1.4** From the discovery of beach marks, which are characteristic of fatigue fracture, on the fracture surface of the piece of the No. 35 fan blade remaining on the hub, it is estimated that a crack which originated at the trailing edge approximately 19 cm outboard of the platform was propagated. Judging from the length of the beach marks, it is estimated that when the crack caused by fatigue, the fracture was propagated approximately 6 cm due to high cycle fatigue, the remainder was instantaneously fractured.

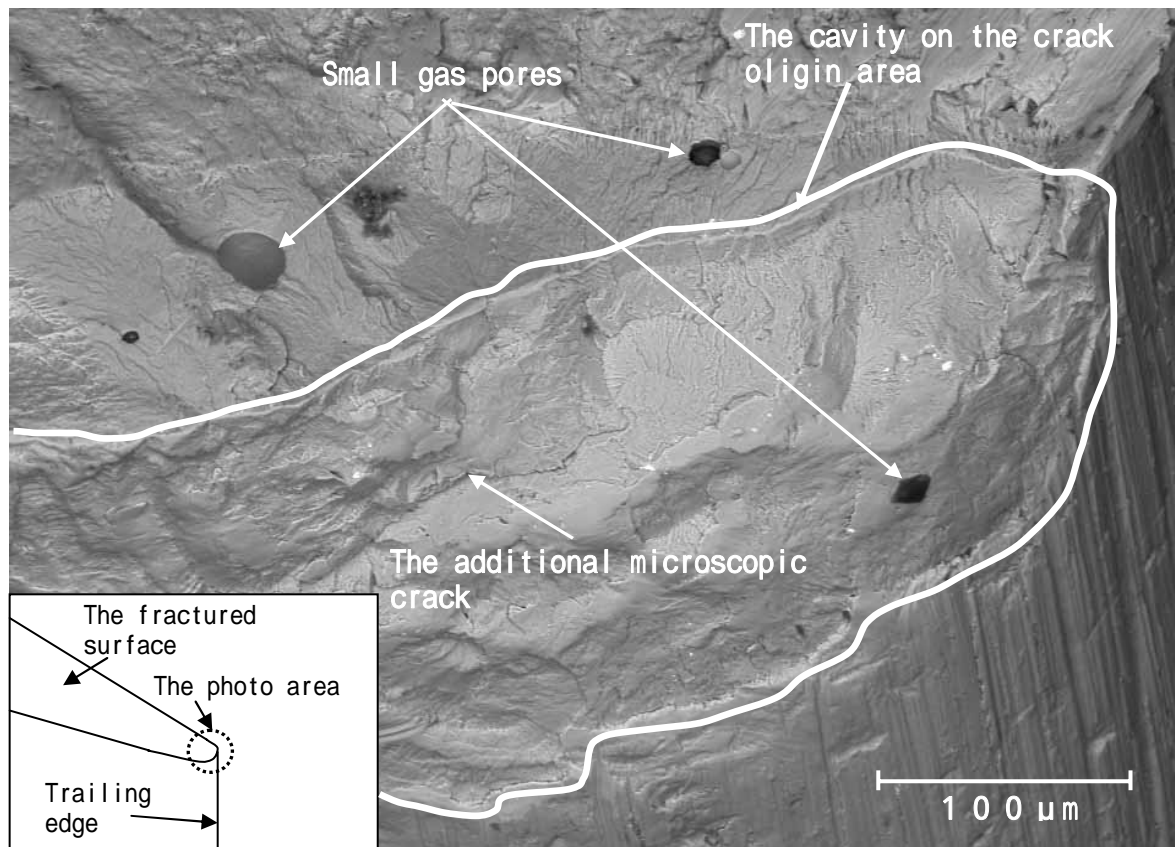
Photograph 5 The enlarged photo the cracking origin area

SEM examination of the starting point of the crack at the trailing edge convex corner revealed traces of a cavity in which there was an additional microscopic crack.

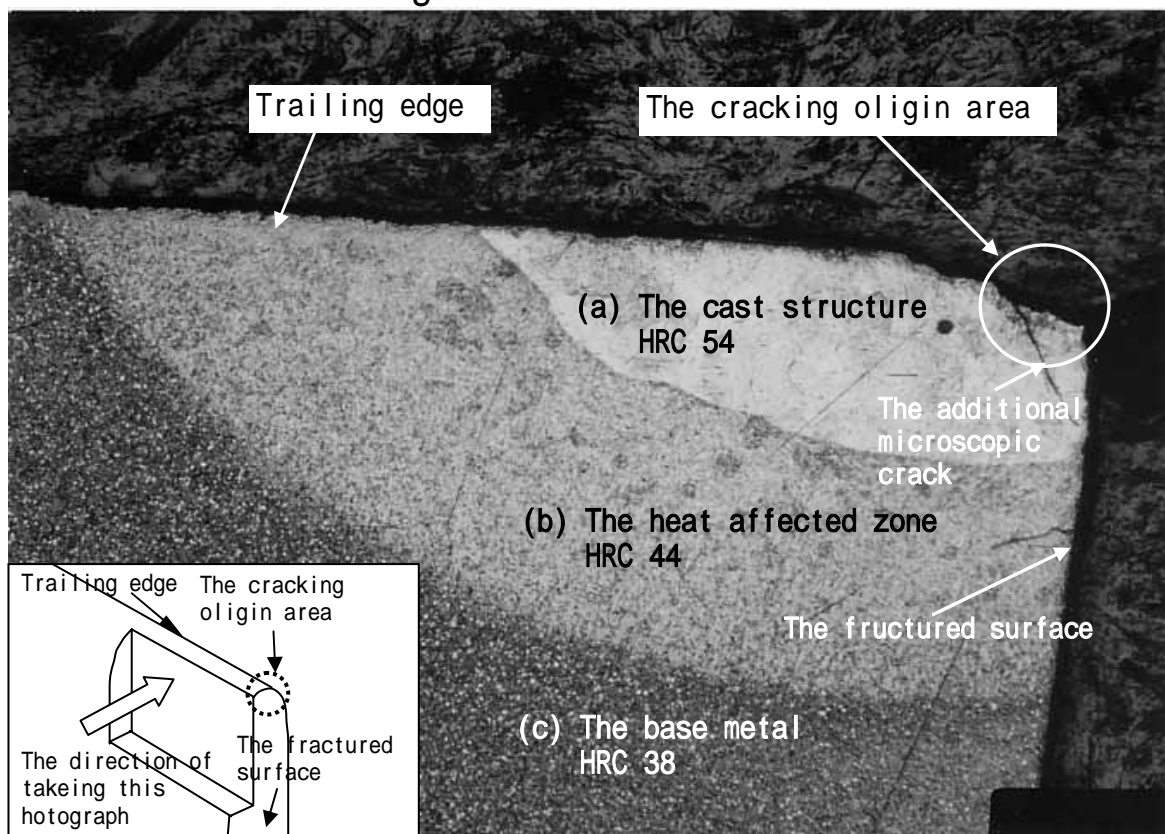
Photograph 6 Three different region at the cracking origin area

- a) A needle-shaped region of abnormal microstructure evidently different to the base material microstructure, which extended approximately 0.4 mm from the crack origin towards the leading edge, and approximately 1.2 mm towards the platform.
- b) A heat-affected microstructure surrounding the region approximately 2.0 mm wide by 1.0 mm deep.
- c) The normal microstructure of the base material.

The abnormal microstructure in a) was created from melting and resolidification and contained several microscopic pores that were not present in the base material microstructure.

A cavity mentioned in a) above had an abnormal microstructure, and an additional microscopic crack extended from the region of abnormal structure.

Measurement of the hardness of the three layers—the abnormal microstructure, the heat-affected microstructure, and the base material microstructure —gave Rockwell Hardness (HRC: Note 1) values of HRC 54, HRC 44, HRC 38 respectively. Therefore, the surface layer region was the hardest and the most brittle.

(1) A small area of the trailing edge of No. 35 fan blade was melted by arc burn, and as it re-solidified rapidly in the air a brittle region with changed microstructure was created.
