AIRCRAFT ACCIDENT INVESTIGATION REPORT

ALL NIPPON AIRWAYS FLIGHT 569
BOEING 767-300, JA8274
OVER THE SEA 16 NM S.E. OF KOCHI AIRPORT, JAPAN
SEPTEMBER 27, 2002

March 26, 2004

Aircraft and Railway Accidents Investigation Commission
Ministry of Land, Infrastructure and Transport

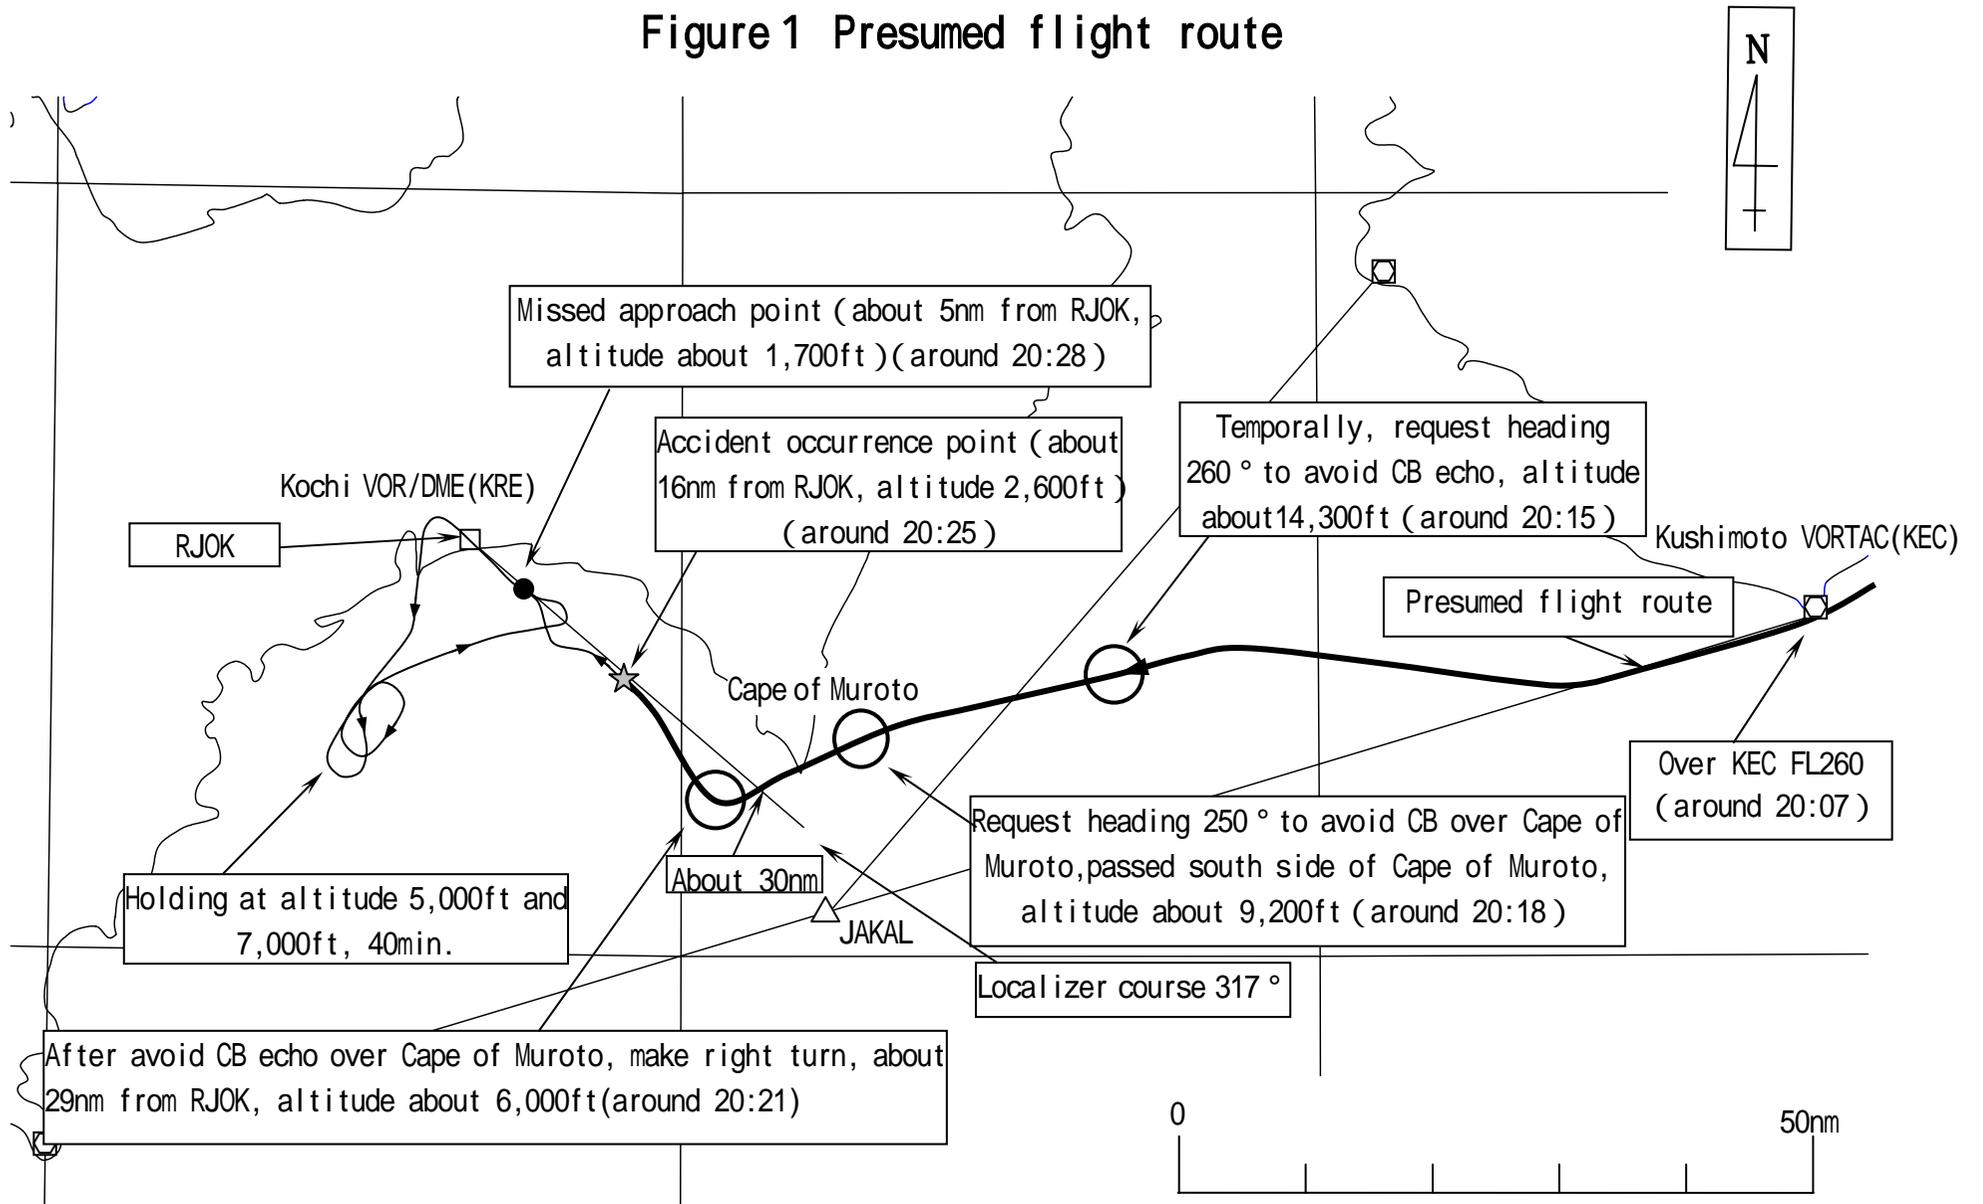
Figure 1 Presumed flight route

Between 20:25:02 and 20:25:03, the DFDR recordings showed that the aircraft descended approximately 100ft from 2,600ft to 2,500ft in the one second interval . At 20:25:03, while the aircraft was approximately 16nm from the runway of Kochi airport at an altitude of 2,600ft and descending, DFDR recordings indicated that lateral acceleration was as 0.4G to the left, vertical acceleration was 1.6G upward, and roll angle was 8.1° right. One second later at 20:25:04, the recordings indicate that lateral acceleration was 0.1G to the right, vertical acceleration was 0.6G downward and the roll angle was 9.7° left.

Considering overall the significant acceleration changes recorded by the DFDR and the contents of the statements described in section 2.1.2, it is concluded that the accident occurred at around 20:25.

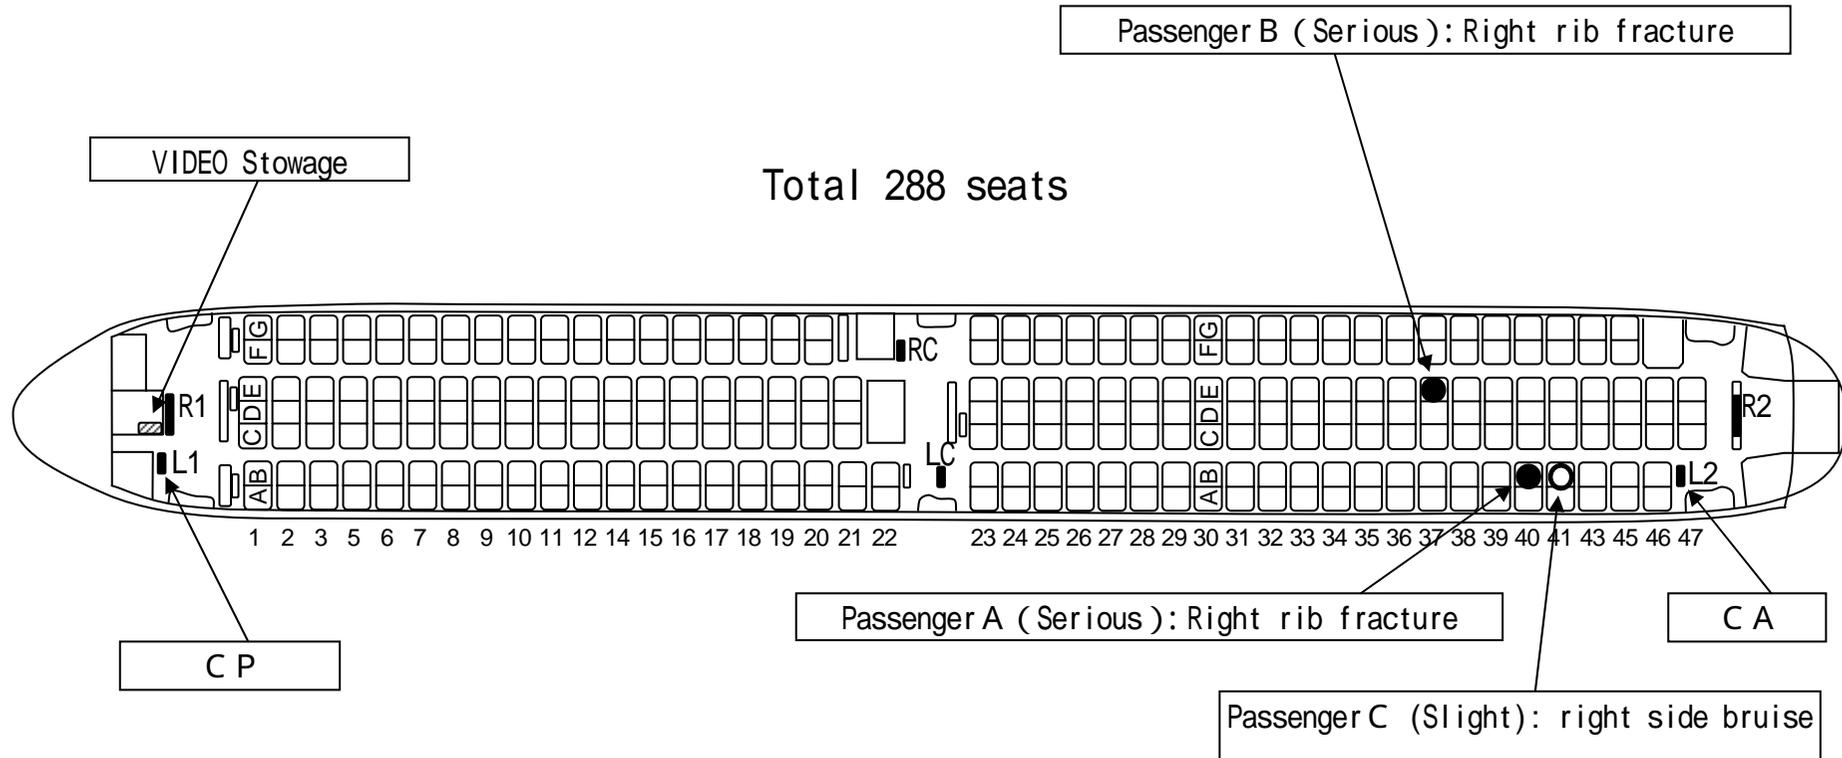
Figure 3 Injuries layout

Of the two hundred and eighty eight passengers, including one infant, on board the aircraft, only Passengers A and B sustained serious injuries, and Passenger C was slightly injured. Passenger A was examined by a hospital on the night of the Friday 27 September and was diagnosed with a bone fracture. Passenger B consulted with a travel agent on the afternoon of the Saturday 28 about "what to do about a pain in her chest", and because a medical diagnosis was necessary she went to a hospital on Monday 30 and was diagnosed with a rib fracture. A travel agent telephoned passenger C on Saturday 28 and he informed of an ache when breathing, so he was recommended to go to a hospital. As a result of diagnosis by a hospital on Monday 30, he was diagnosed with bruising.

It is considered that even after Passenger A in seat 40B had reported that she had hit her right side on the armrest when the aircraft moved sideways, Passenger B in seat 37E had sustained injuries in a similar manner but was enduring the pain. There was no experience to get damages on passengers who had their seatbelts fastened. It is believed that the CP didn't have any

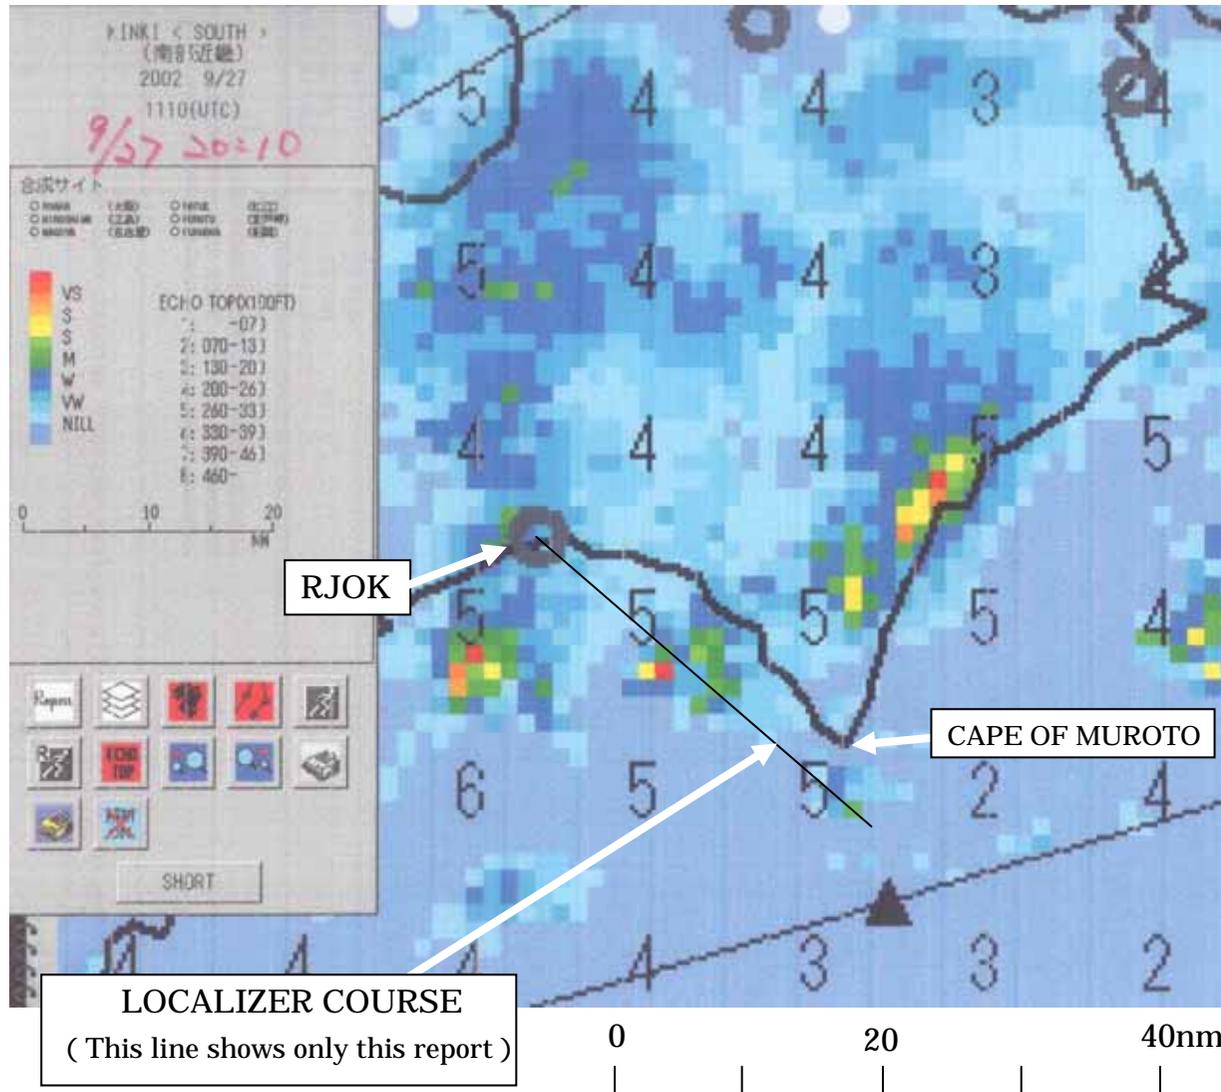
Figure 7 - 2 Radar Echo Information chart showing a tendency to bad weather which was not reported to the aircraft by Assistant Flight Dispatcher of RJOK (September 27, 20:10JST)

Although the flight crew could not directly see the Weather Bureau radar echo strength charts in the case of this accident, the Kochi assistant dispatcher had received the radar echo information chart which synthesized the Weather Bureau radar echo strength charts and radar echo top altitude chart (as attached Fig.7-2) several minutes later than the observed time. The forementioned assistant dispatcher had adequately provided the information about the echo situation around the final approach course to the aircraft's flight crew. It is considered that the Captain should have considered the weather conditions along the flight course including this echo information.

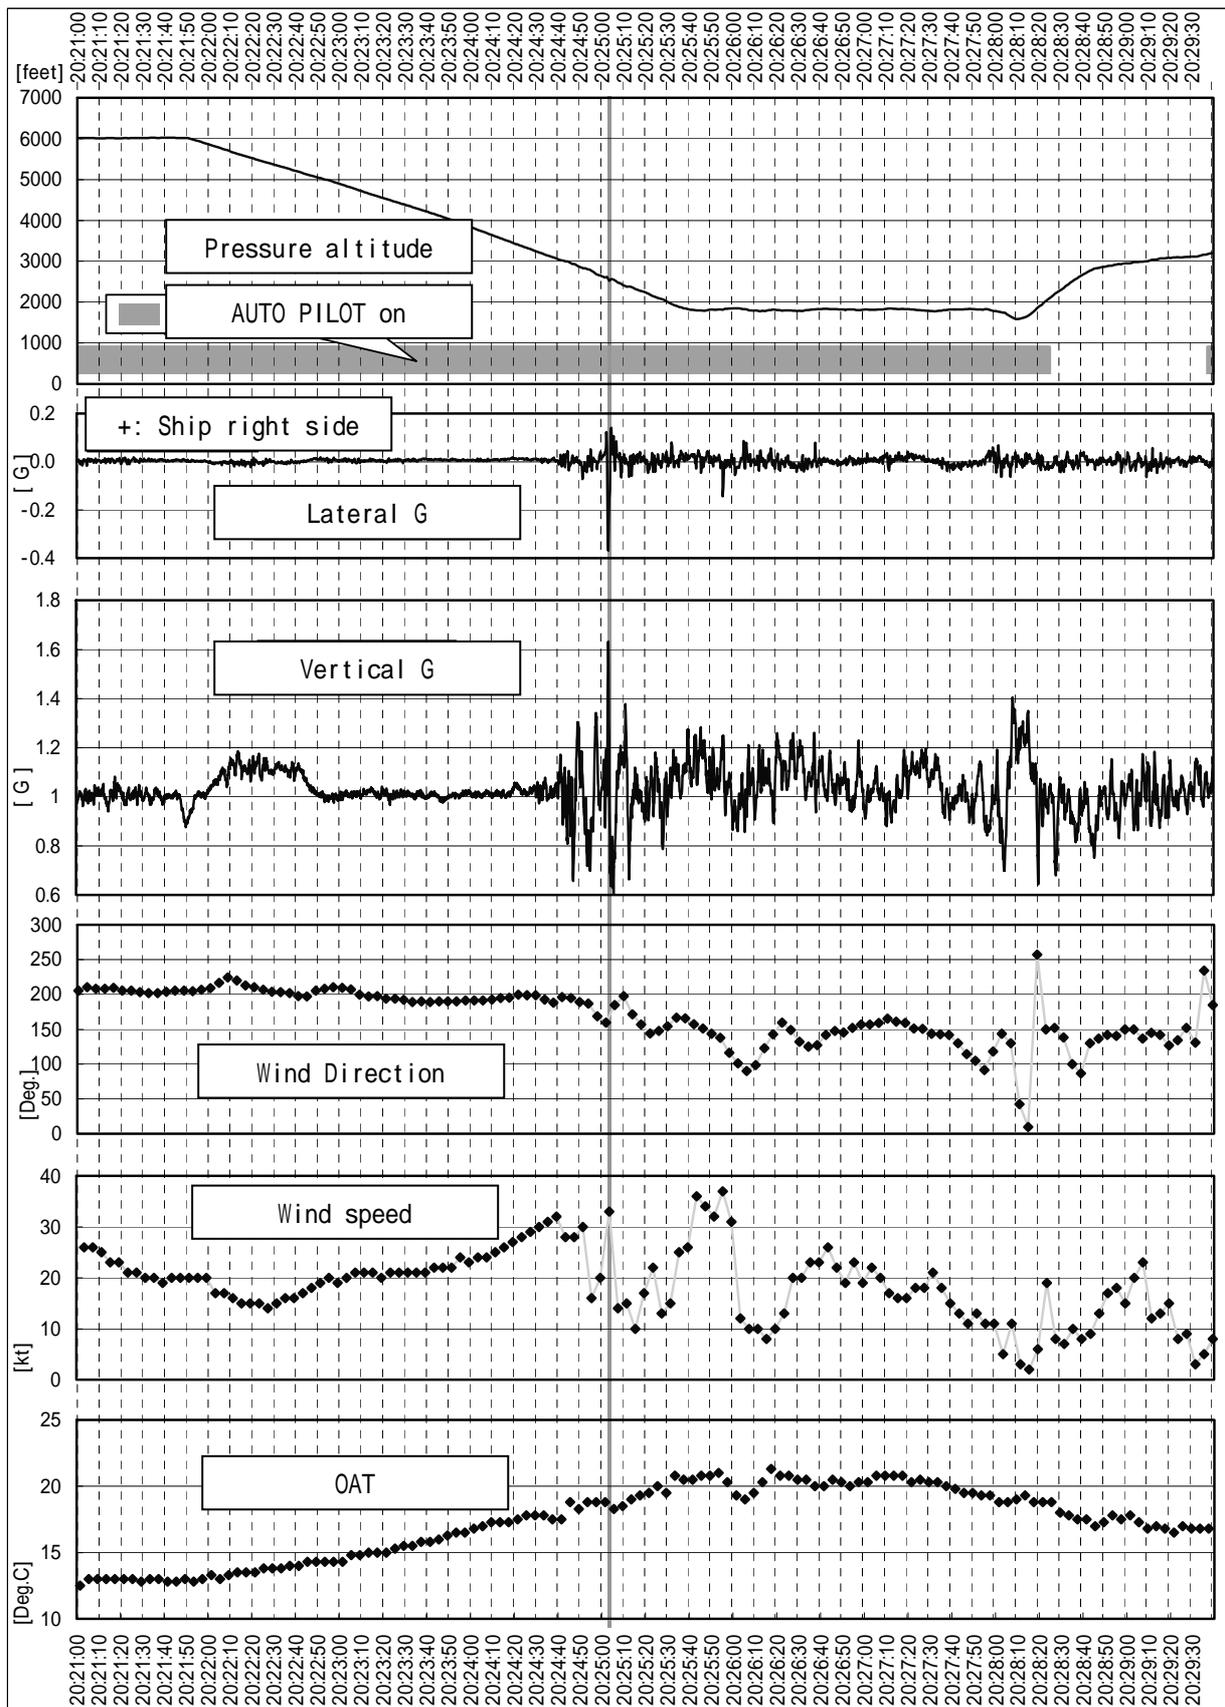
Figure10-1 DFDR Recorded Data (1)

From 20:24:40 changes began to the aircraft's lateral and vertical accelerations, and thereafter the DFDR continuously recorded significant changes.

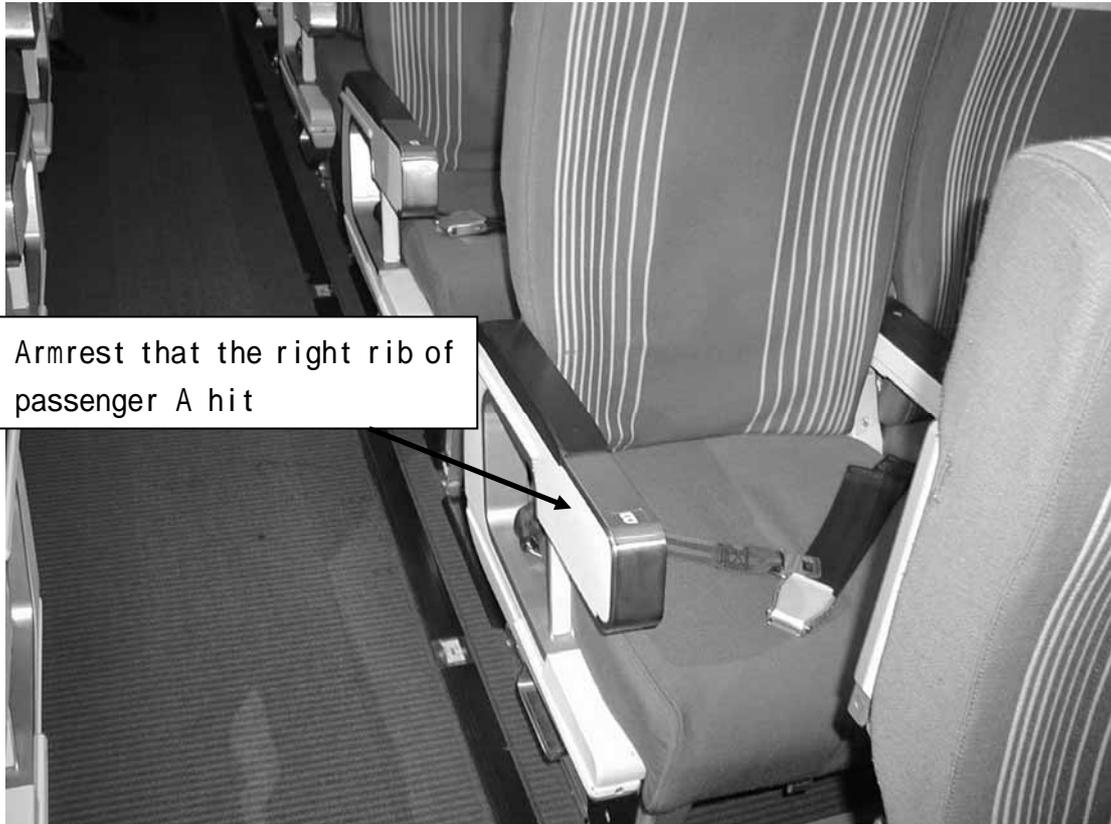
Photograph1 Seat

- (3) From the above, it is estimated that the aircraft abruptly descended around 100ft at 20:25:02, and immediately afterward at 20:25:03, when the aircraft was banked to the right, the upper bodies of the passengers leaned to the right together with the aircraft's attitude, and the sideways motion of the upper bodies of the three passengers whose seatbelt were loosely fastened was increasing towards the right. In the next instant, when the aircraft banked to the left, the right sides of their upper bodies that were inclined towards the right struck the armrests, and it is estimated that Passengers A and B fractured their ribs sustaining serious injuries, and Passenger C sustained bruising and was slightly injured as a result.

Armrest that the right rib of passenger A hit
