**AIRCRAFT SERIOUS INCIDENT  
INVESTIGATION REPORT**

**ALL NIPPON AIRWAYS CO., LTD.  
J A 8 2 8 A**

## CASE EQUIVALENT TO MULTIPLE MALFUNCTIONS IN ONE OR MORE SYSTEMS EQUIPPED ON AIRCRAFT IMPEDING THE SAFE FLIGHT OF AIRCRAFT ALL NIPPON AIRWAYS CO., LTD. BOEING 787-8, JA828A, AT FL 430 ABOUT 280 NM NORTHEAST OF NARITA INTERNATIONAL AIRPORT, JAPAN AT ABOUT 14:02 JST, JUNE 1, 2019

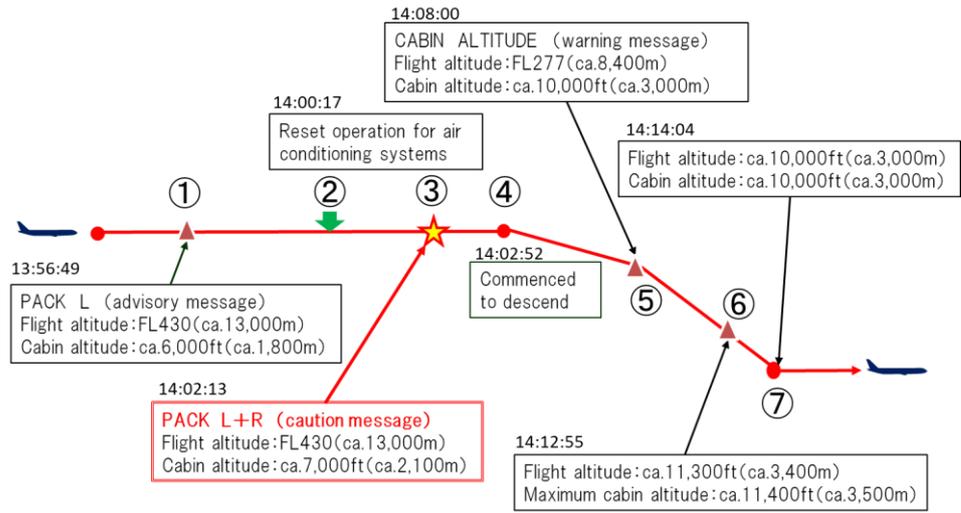
Figure 2: History of the flight

After that, at 14:00:17, according to the procedure to be followed when the PACK is inoperative, which is stipulated in the Company's aircraft operations manual, the PIC attempted to reset the air conditioning systems by pushing its reset switch (See Figure 2 ②).

This enabled to restart the air conditioning systems of the Aircraft, but at 14:02:13, EICAS displayed the "PACK L+R" message indicating that both of PACKs had become inoperative (See Figure 2 ③). The PIC checked the operating condition of the air conditioning systems with the MFDU and found that all of four CACs (L1 CAC, L2 CAC, R1 CAC and R2 CAC) shut down and the air conditioning systems on both left and right sides had been inoperative.

Therefore, at 14:02:52, the Aircraft started to descend from FL 430 (See Figure 2 ④), continued to descend while watching the climb rate of cabin altitude.

And then, at 14:08:00, at FL 277, EICAS displayed the "CABIN ALTITUDE" message indicating that the cabin altitude had reached at an altitude of about 10,000 ft (See Figure 2 ⑤), thus the PIC declared an emergency, made an emergency descent until an altitude of about 10,000 ft, continued to fly (See Figure 2 ⑦), and the Aircraft landed at Narita International Airport at 14:56.

At 14:12:55, when the Aircraft reached at an altitude of about 11,300 ft during the emergency descent, the cabin altitude hit the highest, about 11,400 ft (See Figure 2 ⑥).
