AIRCRAFT SERIOUS INCIDENT INVESTIGATION REPORT

AIR NIPPON CO., LTD.
BOEING 737-500, JA8419
OVER THE SEA APPROXIMATELY 60 NM SOUTHEAST OF
KUSHIMOTO VORTAC
JULY 5, 2006

Aircraft and Railway Accidents Investigation Commission
Ministry of Land, Infrastructure, Transport and Tourism

**AIR NIPPON CO., LTD.
BOEING 737-500, REGISTRATION JA8419
OVER THE SEA APPROXIMATELY 60 NM SOUTHEAST OF
KUSHIMOTO VORTAC
AROUND 08:10 JST, JULY 5, 2006**

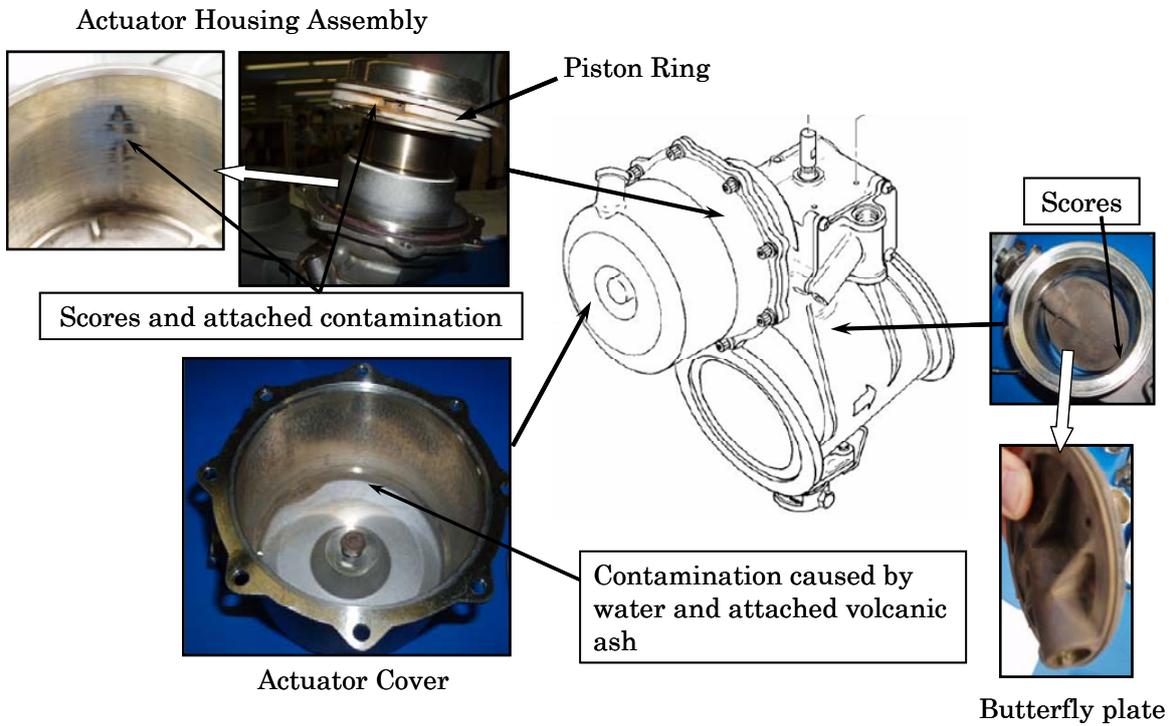
Photo 1 Dismantled No.1 PRSOV

Shallow scores were found on the valve body and the lower section of the butterfly plate. The damage was attributable to contamination that filled the groove in the butterfly plate seal ring and prevented the seal ring from being compressed.

The inner surface of the actuator housing had scores that were caused by a piston ring set stuck due to contamination.

The valve linkage hinge was corroded with granular contamination on it.
(See Figure 2 and Photographs 1 and 2.)

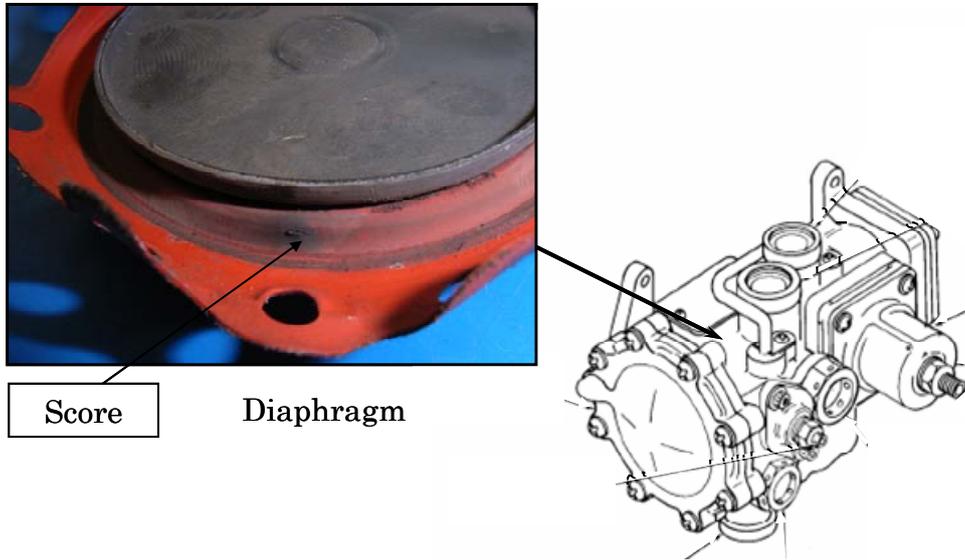
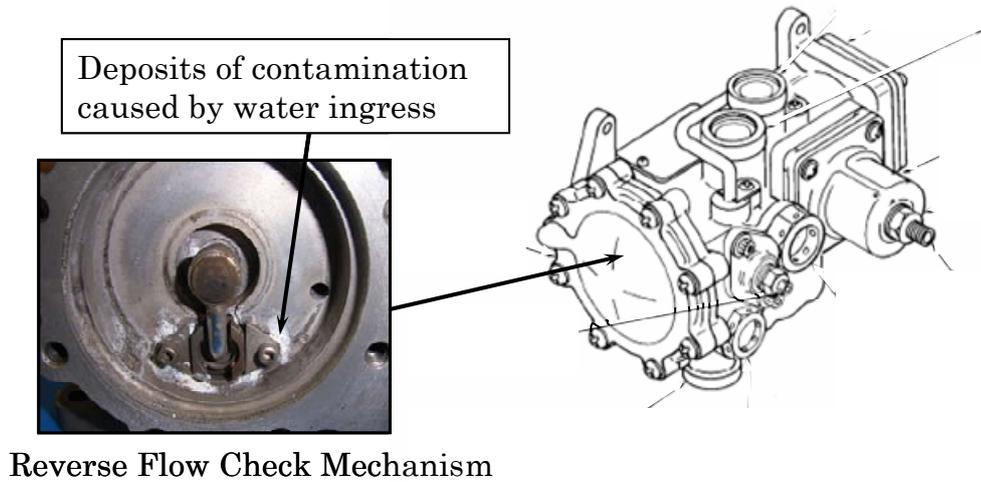
- (1) The No. 1 regulator had a small score on the diaphragm mounting area.
- (2) The No. 2 regulator had deposits of contamination in the area around the reverse flow check mechanism on the diaphragm end side, where traces of water ingress were also found.

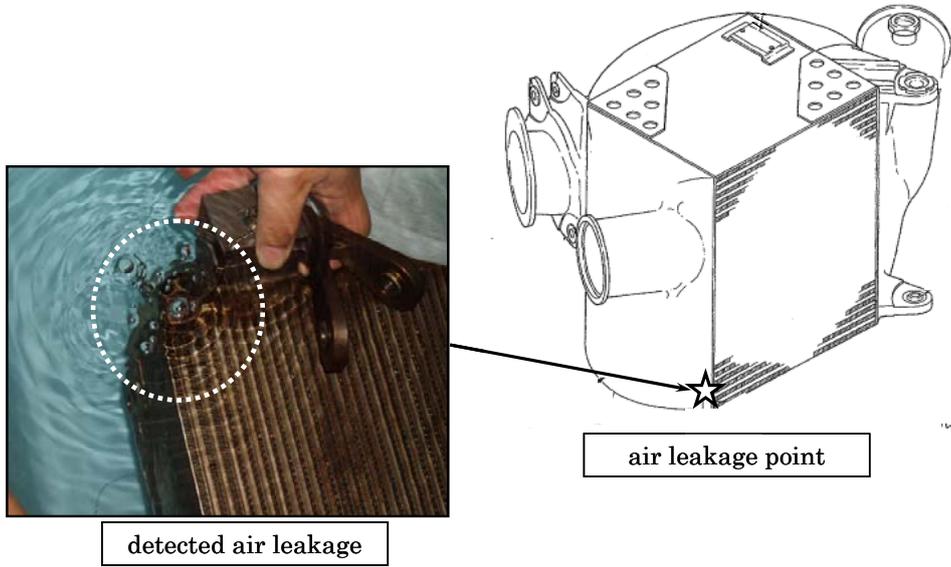
Photo 7 Test of No.1 Pre-cooler

Air leakage was found from a welded corner.

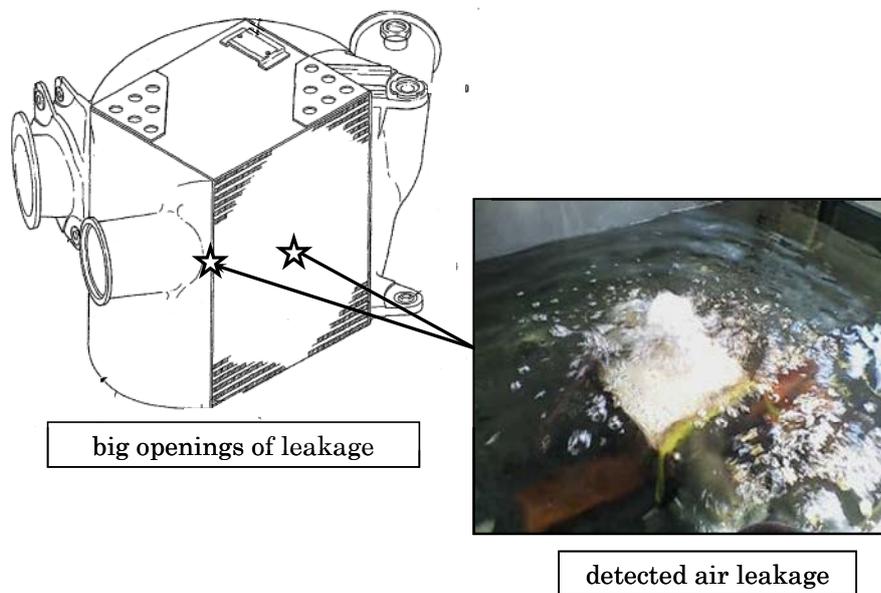
Photo 8 Test of No.2 Pre-cooler

There were openings both near the center of the ram air outlet core and in a straight-line weld, from where heavy air leakage was detected.

- (3) As a result of the functional tests conducted on the No. 1 and No. 2 pre-coolers at the manufacturer, the pressure drop of the No. 1 unit (0 psi pressure drop within 10 seconds) and that of the No. 2 unit (27 psi pressure drop within 10 seconds) were both found to conform to the design standard (33 psi or smaller pressure drop within 10 seconds after applying 50 psi initial pressure).

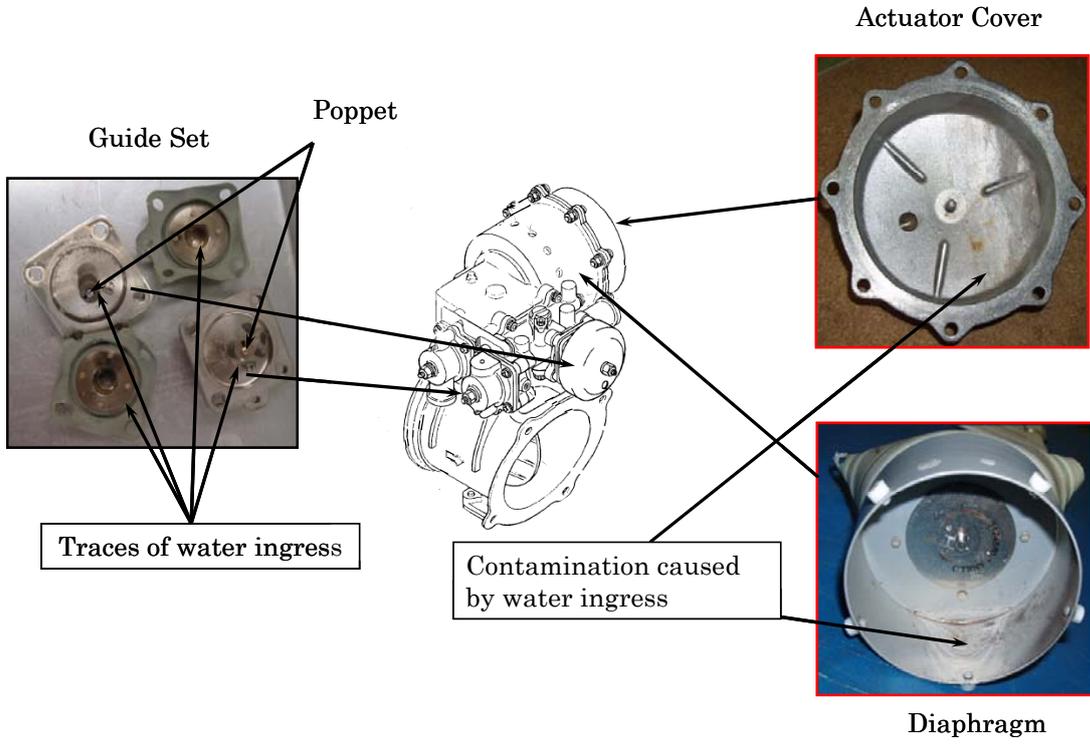
Photo 9 Dismantled No.1 PCV

In addition, the butterfly plate was found to have shifted toward the “open” side from the normal position.

- ① Traces of water ingress and contamination deposits were found inside the actuator housing.

- ② The vent hole in the servo body assembly was found to be narrowed due to contamination.

③ The retainer of the actuator reference pressure regulator diaphragm was found broken into three pieces.

It is estimated that, when higher-temperature 9th-stage bleed air flowed into the pre-coolers, both the No. 1 and No. 2 PCVs, the role of which is to control the fan air, operated sluggishly due to contamination deposits and thus failed to allow sufficient fan air to flow to the pre-coolers, causing insufficient cooling and the No. 1 and No. 2 overheat switches to trip, which then caused both bleed valves to close (as indicated by illumination of both BLEED TRIP OFF lights), resulting in an abnormal drop in cabin pressure.

As to contamination deposits inside the PCVs, it is estimated that the cause was a significant amount of detergent having entered the bleed related valves and other components during water washing of the engines for gas path cleaning, which was conducted at the time of C-check of the aircraft as described in 2.8.5.

In addition, since the aircraft was parked for about three days after the engine test run, it is estimated that detergent in the remaining water dried out to form a solid residue, which subsequently constituted contamination that would have caused sluggish movement of the PCVs.

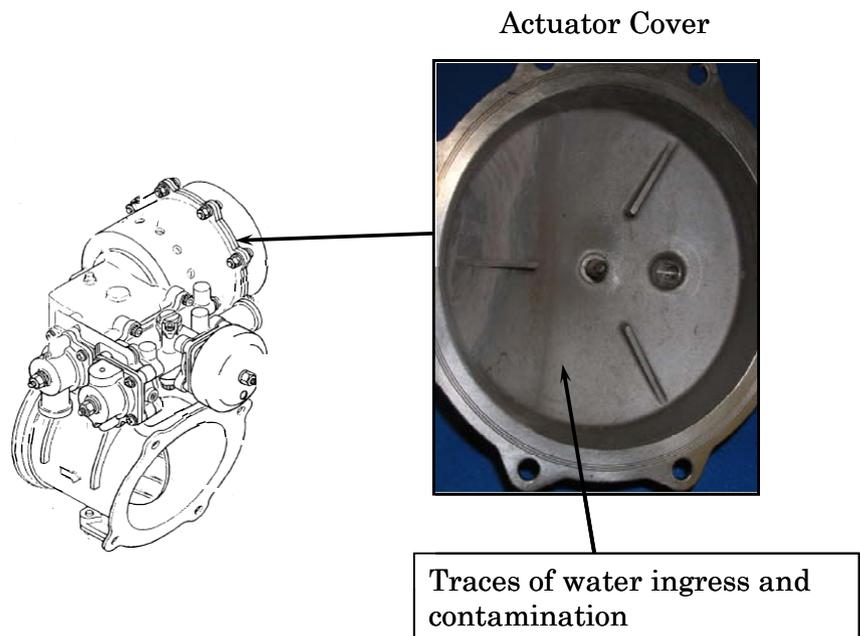
Photo 10 Dismantled No.2 PCV

The butterfly plate was found to have shifted toward the “closed” side from the normal position.

Traces of water ingress and contamination deposits were found inside the actuator housing.

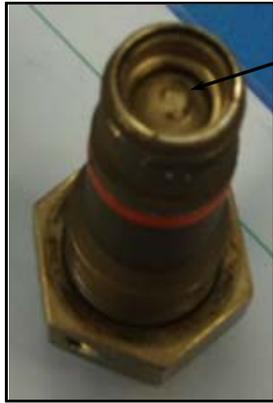
Photo 13 Dismantled No.1 Pre-cooler Sensor

(1) The results of the functional test on the No. 1 sensor showed that the signal pressure level exceeded the limit when the bleed duct air temperature was lowered to 387°F. Due to the insufficient drop in signal pressure level, the PCV was in a condition difficult to close.

The ball was not free to move and the sensor was fouled with contamination deposits.
