AIRCRAFT SERIOUS INCIDENT INVESTIGATION REPORT

AIR NIPPON NETWORK CO., LTD.
BOMBARDIER DHC-8-402, JA841A
KOCHI AIRPORT,
NOVEMBER 21, 2004

March 30, 2007

Aircraft and Railway Accidents Investigation Commission
Ministry of Land, Infrastructure and Transport

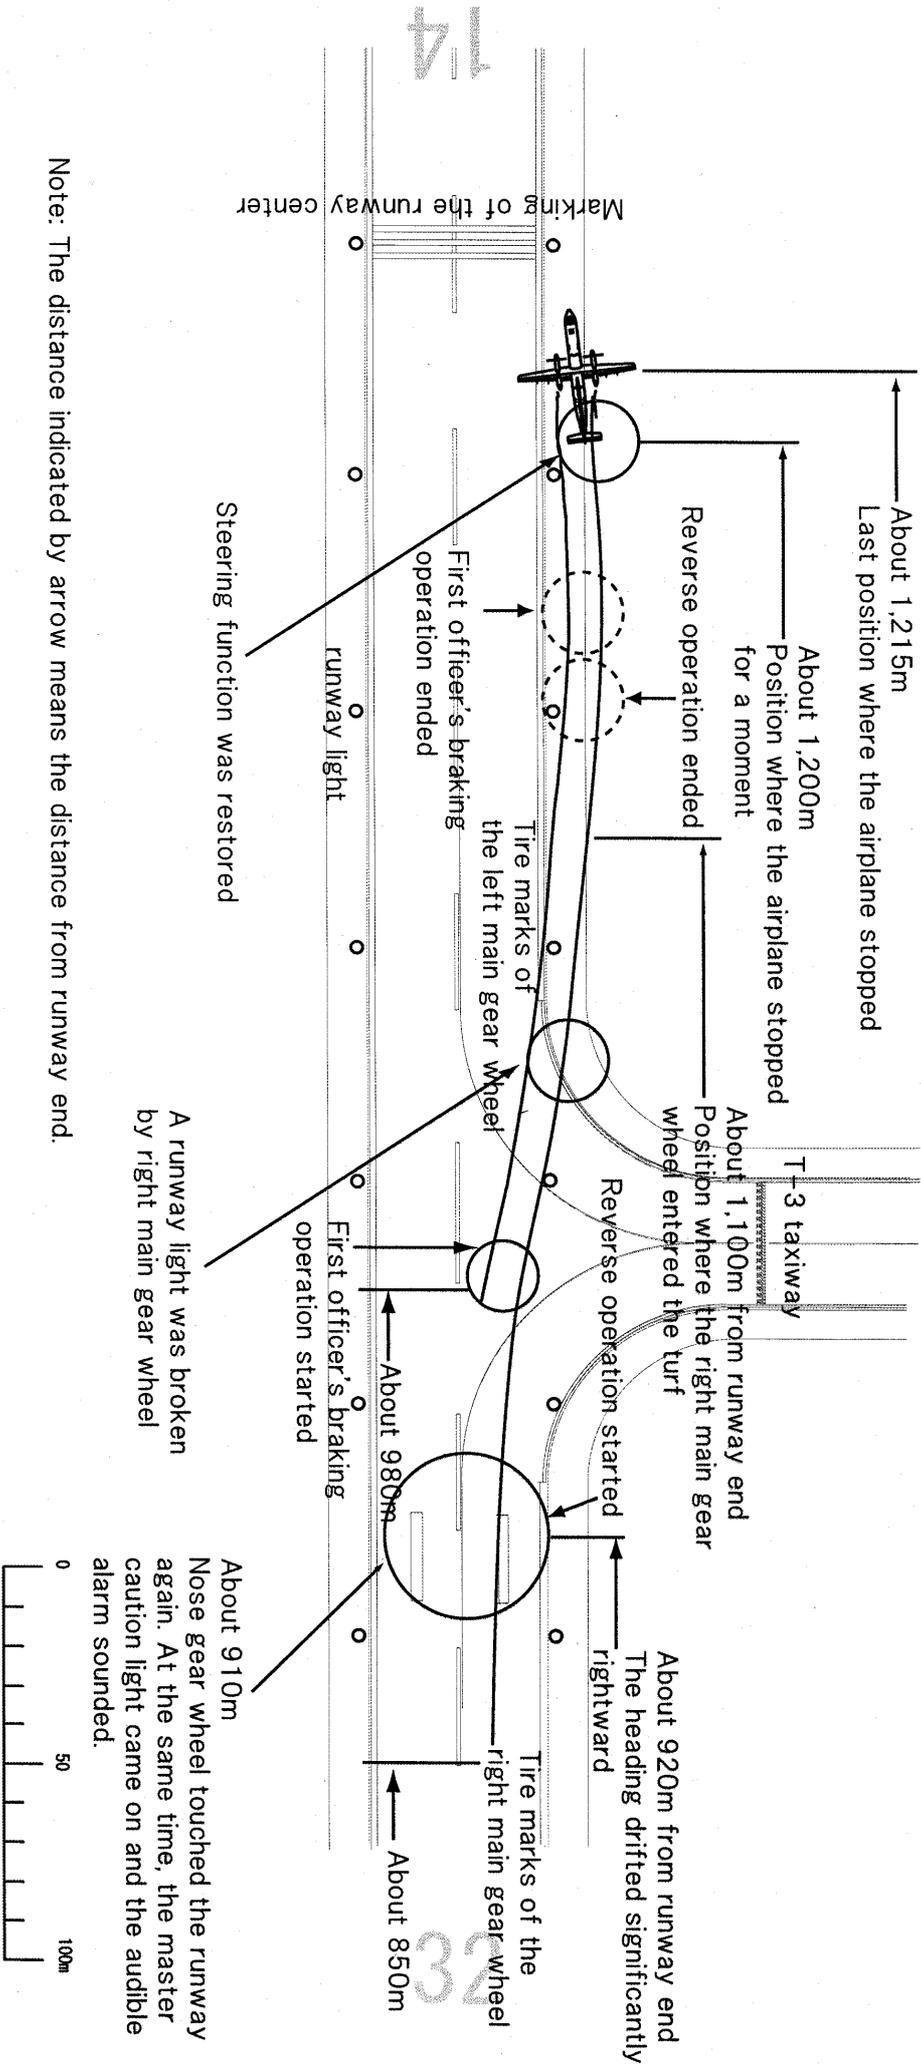
Figure 2 Sketch map where the incident happened (magnified)

Note: The distance indicated by arrow means the distance from runway end.

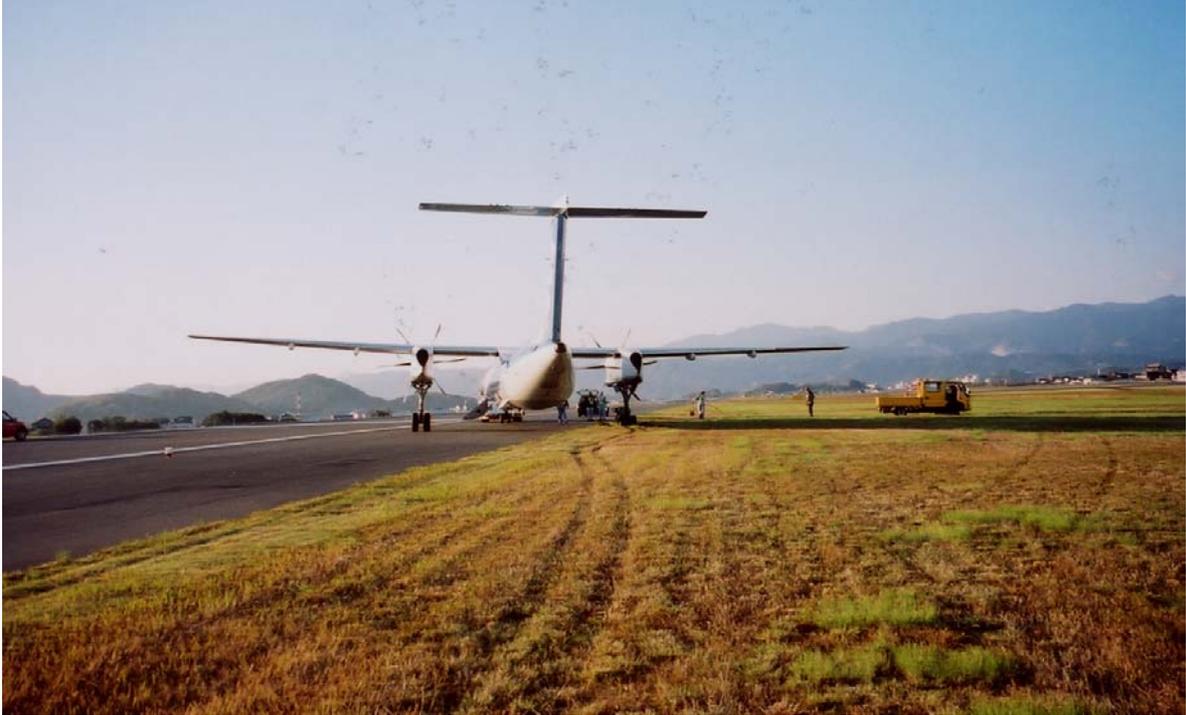
Photo 1 Aft View (Right Main Wheel Track)

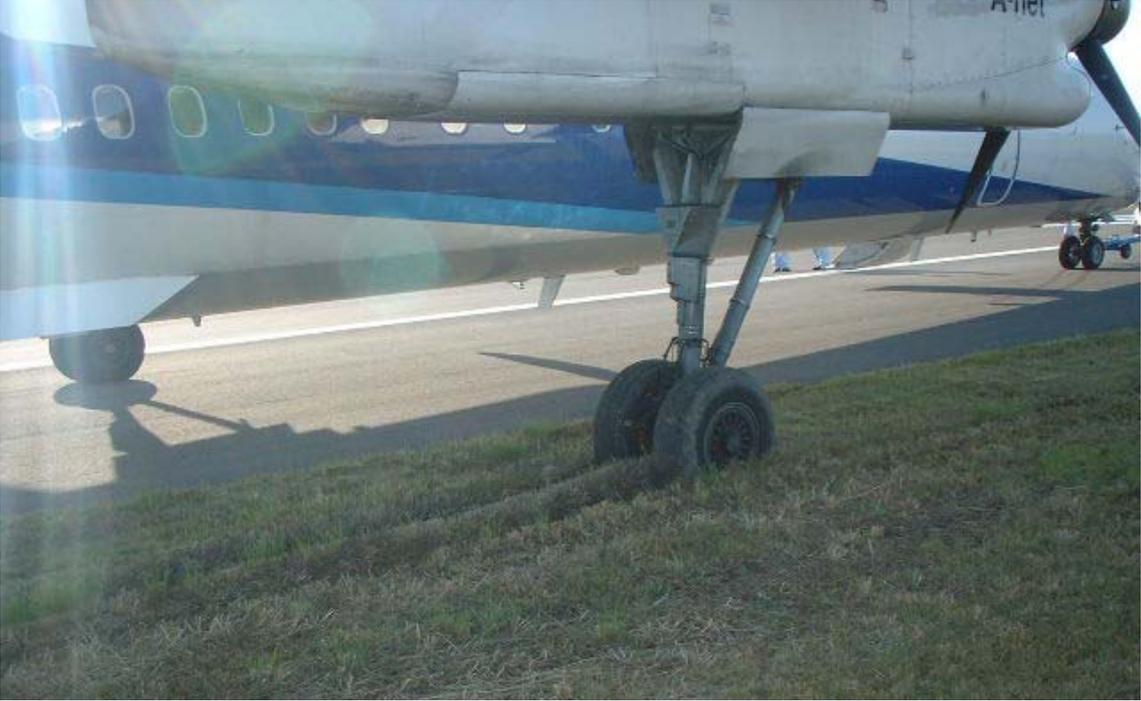
Based on the first officer's advice and his own experience, the PIC recycled the steering switch at 14:26:29. This action restored the steering function and caused the steering light to go out. After the steering became operative, the first officer advised the captain to use only the right engine power in order to bring the right main wheels back onto the pavement. However, the PIC used both engines evenly for the purpose of preventing the wheels from damaging runway lights, thereby taxiing the aircraft almost in parallel with the runway from 14:27:12 to 14:27:22. However, it is estimated that the surface of the grass area was so soft and the right main wheels sunk by one third of the wheel diameter, making the aircraft unable to taxi any further.

Photo 3 Right Main Wheel buried in the grass area
