**AIRCRAFT SERIOUS INCIDENT
INVESTIGATION REPORT**

**JAPAN TRANSOCEAN AIR CO., LTD.
J A 8 5 2 5**

October 26, 2017

ABNORMAL DECOMPRESSION INSIDE AN AIRCRAFT OPERATED BY JAPAN TRANSOCEAN AIR CO., LTD. BOEING 737-400, JA8525 AT ABOUT 55 KM EAST-NORTHEAST OF TANEGASHIMA AIRPORT AT AN ALTITUDE OF APPROXIMATELY 37,000 FT AT ABOUT 8:20 ON JUNE 30, 2015

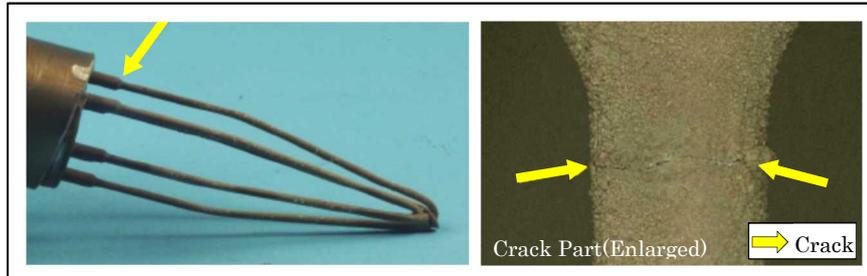
Photo 1 Cracks at 450 °F Thermostat

On the both of No.1 and No.2 systems of 450 °F Thermostats, the malfunctions that the output does not response to the change of temperature were found.

Later on, cracks were found on the sensor section at the time of teardown inspection.

If the output of 450 °F Thermostat did not change corresponding to the temperature change of bleed air, PRSOV could not adjust the valve for the opening/closing corresponding to the temperature change.

The both of No.1 and No.2 systems of 450 °F Thermostats were not the improved type.

<p>(2) 450°F thermostat failure</p> <p>When the cooling air cools the Bleed Air sufficiently at Pre-cooler, 450 °F Thermostat would not be activated, therefore, even if a failure exists, the failure could not be found.</p> <p>It is probable that the malfunction of 450 °F Thermostat was existed prior to the occurrence of this incident, based on the contents of the Service Bulletin by Parts Manufacturer and use results.</p> <p>(3) Prevention of similar incident</p> <p>Failures of 450 °F Thermostat could not be found during a normal flight or at a maintenance work, therefore it is desirable for operators to improve based on the Service Bulletins from Parts Manufacturer as soon as possible.</p>
--	---

<p>It is highly probable that the serious incident occurred because the supply from the both Bleed Air systems were stopped, abnormal decompression was occurred in the cabin.</p> <p>As for the stoppage of the both Bleed Air supply, it is highly probable that PRSOV was closed because the Bleed Air temperature was rising and exceeding the specified values in a state of occurrence of failures due to the cracks in the both systems of 450 °F Thermostat, and malfunctions were generated due to deteriorations at the both systems of Pre-cooler Control Valve.</p>

On 2008, there was a report regarding 450 °F Thermostat which had been removed in short time use, and as the results of the investigation by the Parts Manufacturer, because cracks were found within, the Service Bulletin was issued to improve the 450 °F Thermostat to the improved type. The level of urgency was “Recommended”.

<p>The company implemented the repairs according to the Service Bulletin regarding 450 °F Thermostat and soundness confirmation of Pre-cooler control valve on the type of aircraft operated by the company. Furthermore, the company decided to implement the soundness confirmation of Pre-cooler Control Valve at every periodic inspection (C check) repeatedly, replace 450 °F Thermostat at every 16,000 flight hours and inspect it.</p>
