**AIRCRAFT ACCIDENT
INVESTIGATION REPORT**

ALL NIPPON AIRWAYS

J A 8 5 6 9

ACCIDENT CATEGORY : CABIN ATTENDANT INJURY BY TURBULENCE

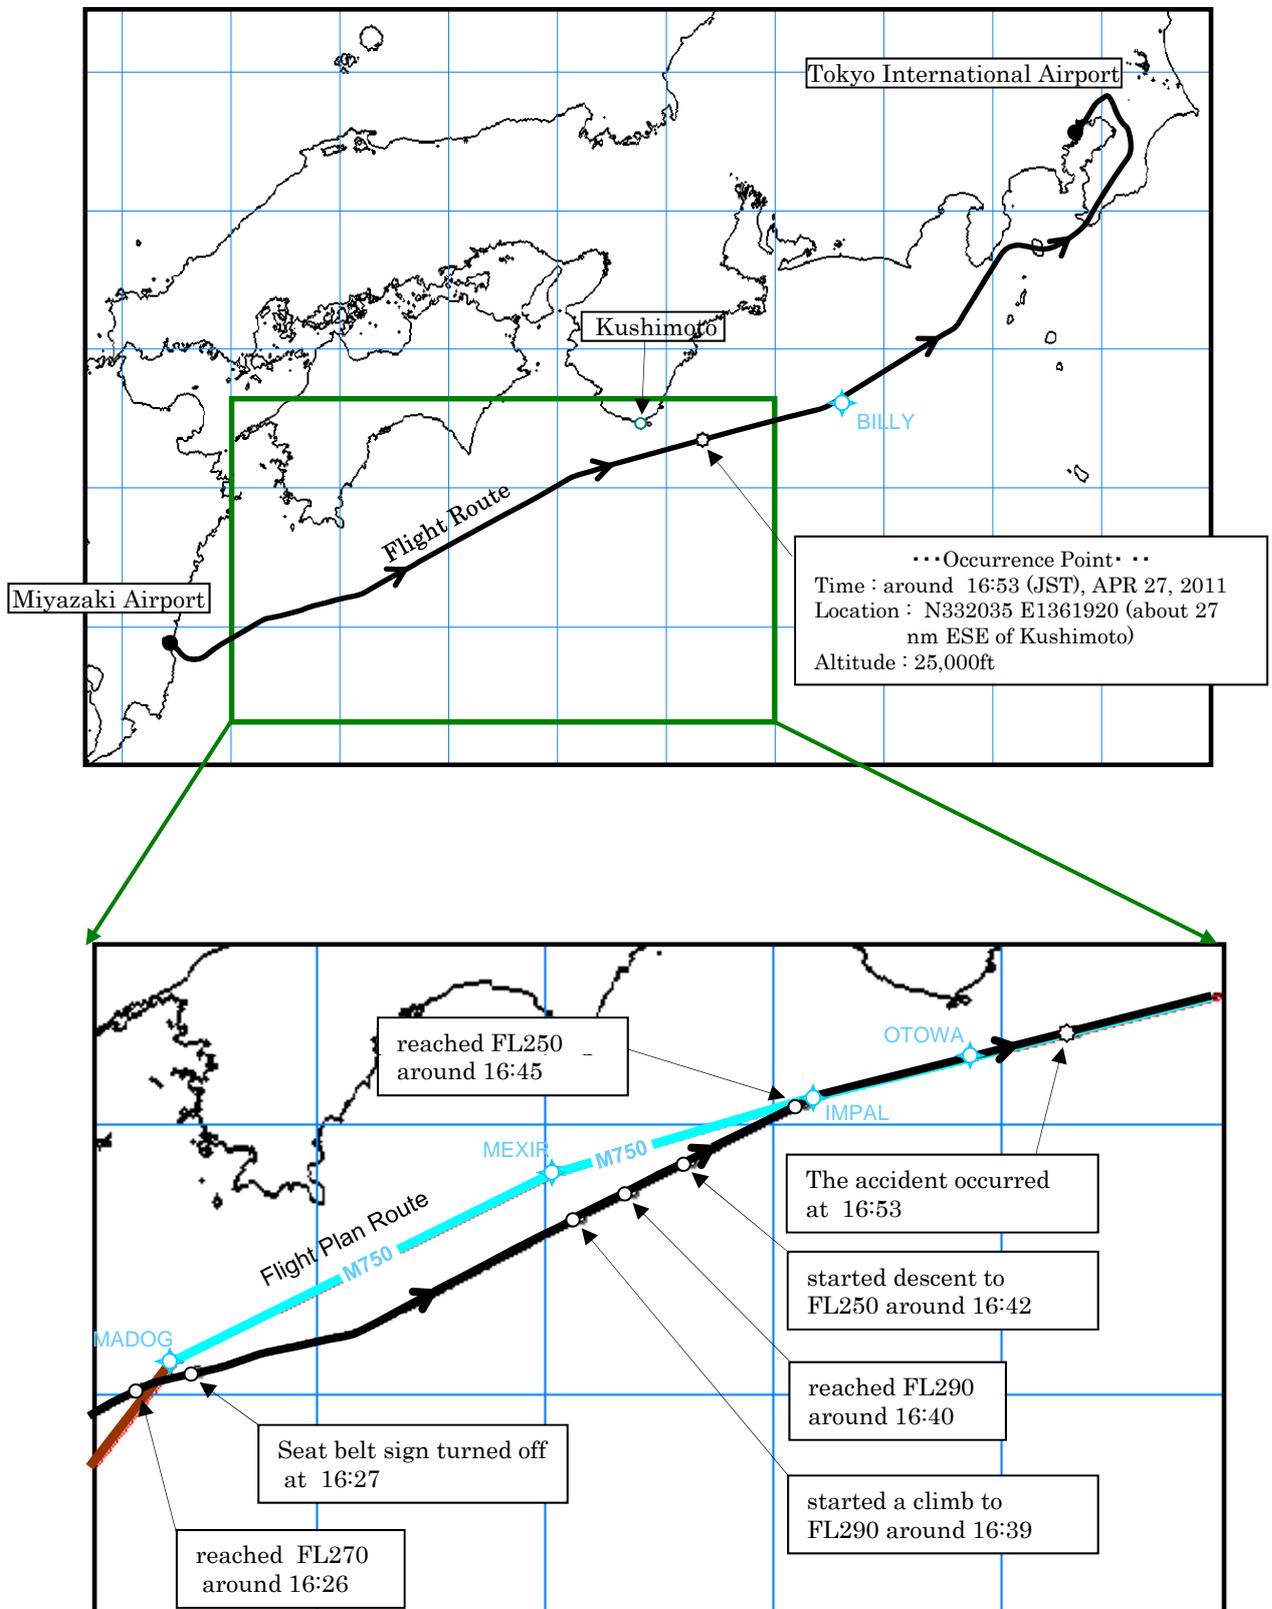
Figure 1 Estimated Flight Route

The aircraft took off from Miyazaki Airport at 16:16, and maintained the cruising altitude of FL270 from around 16:26 detouring the echo area detected by the weather radar over Shimizu to the south. The following is the summary of the events until its landing at Tokyo International Airport after its climb to FL290 and descent to FL250 followed by an encounter of strong turbulence at 27nm east-southeast of Kushimoto.

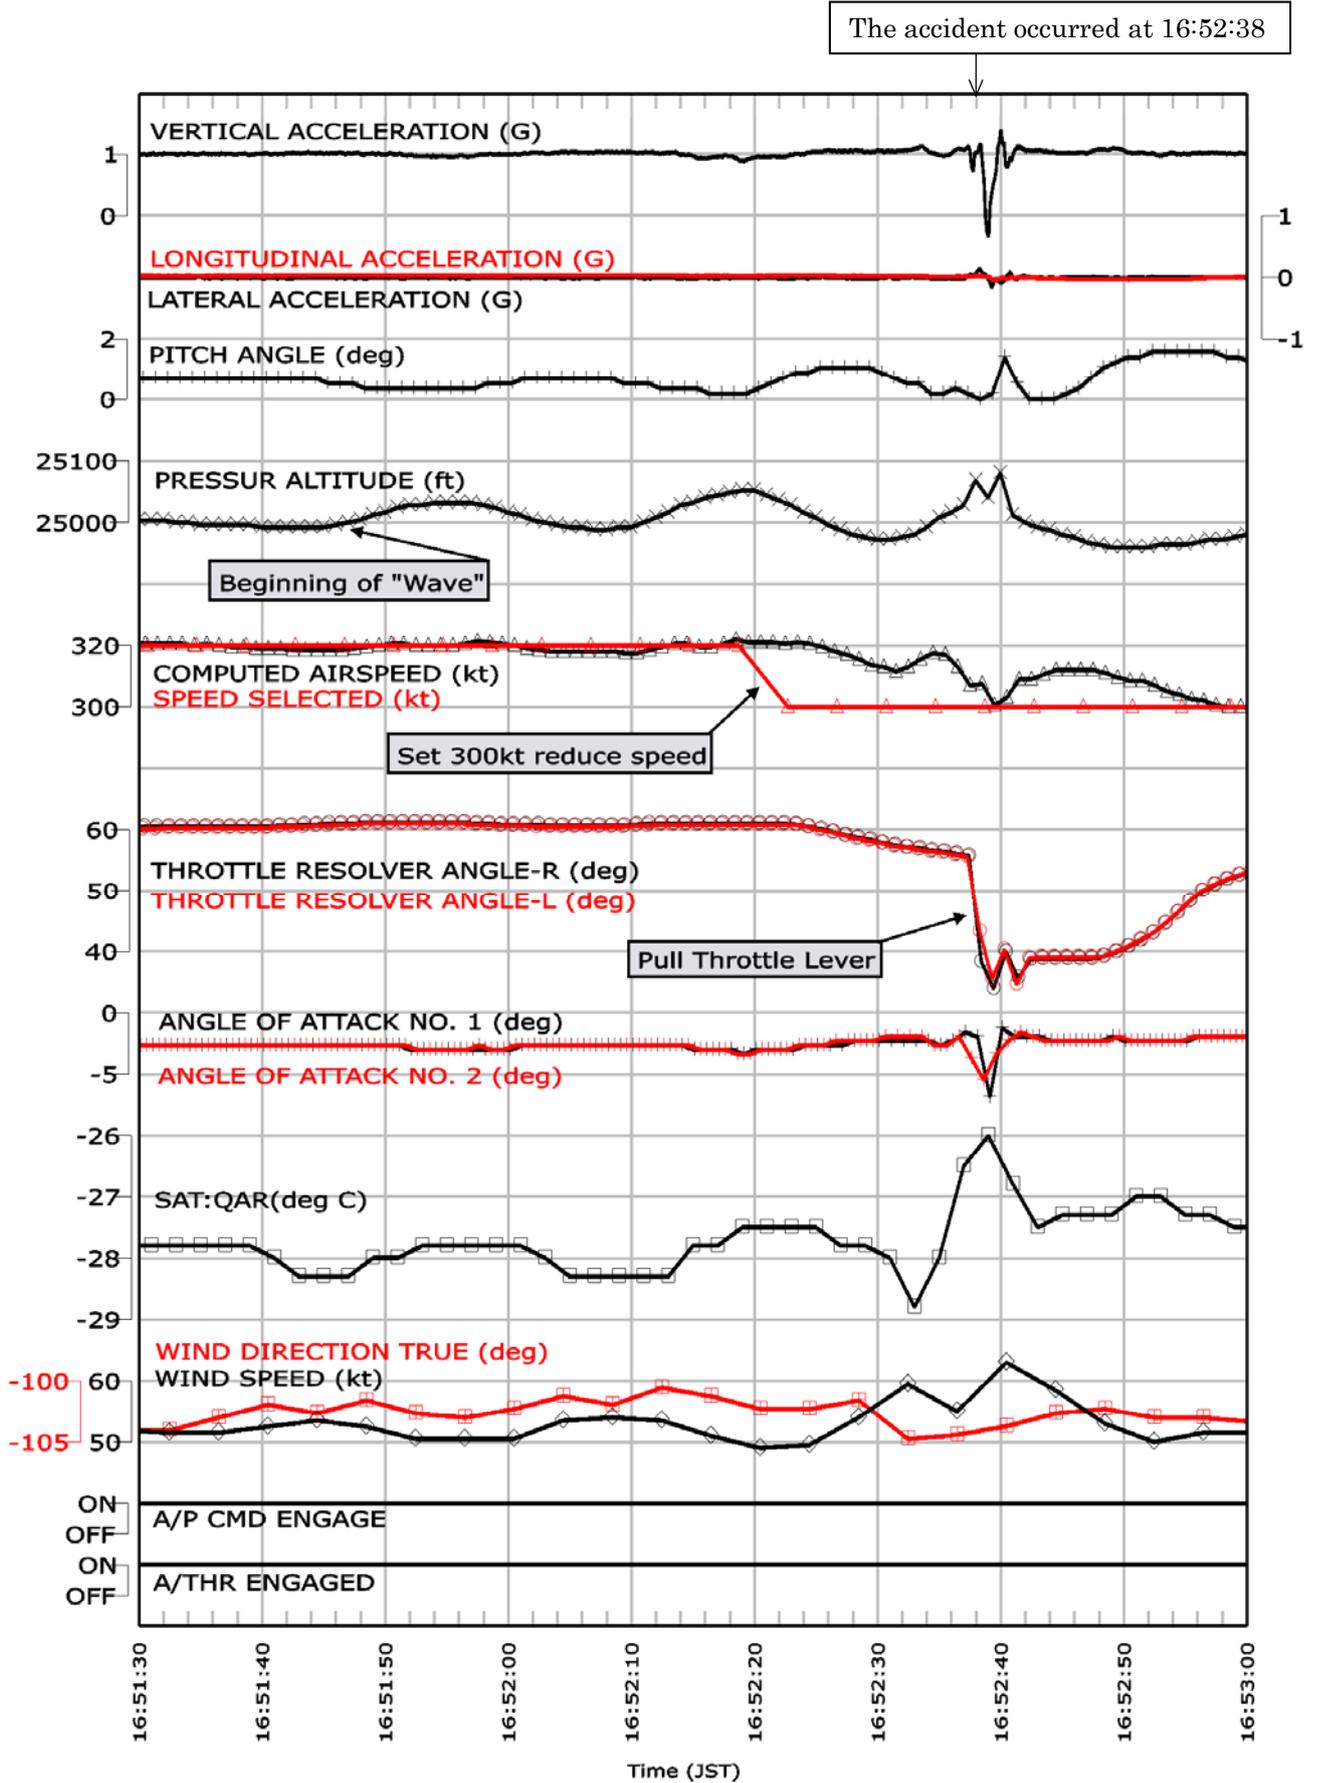
Figure 2 DFDR Records

16:52:25 The wind velocity increased by 10 kt in 7 sec to reach 60 kt, and decreased by 4 kt in the next 4 sec, and then increased by 7 kt in the next 4 sec. During this period, the wind direction changed only about 5°.

16:52:31 The static air temperature (SAT) started to fluctuate with the gauge moving down, up and down again in about 12 sec, and resulted in an increase of 0.7°C compared with the temperature prior to fluctuation.

16:52:38 A bump sound was heard in the cockpit, and a vertical acceleration of -0.34 G was recorded.

16:52:41 The altitude of the aircraft decreased by 80 ft in 1 second. A chime sounded indicating that the belt sign had been turned on.

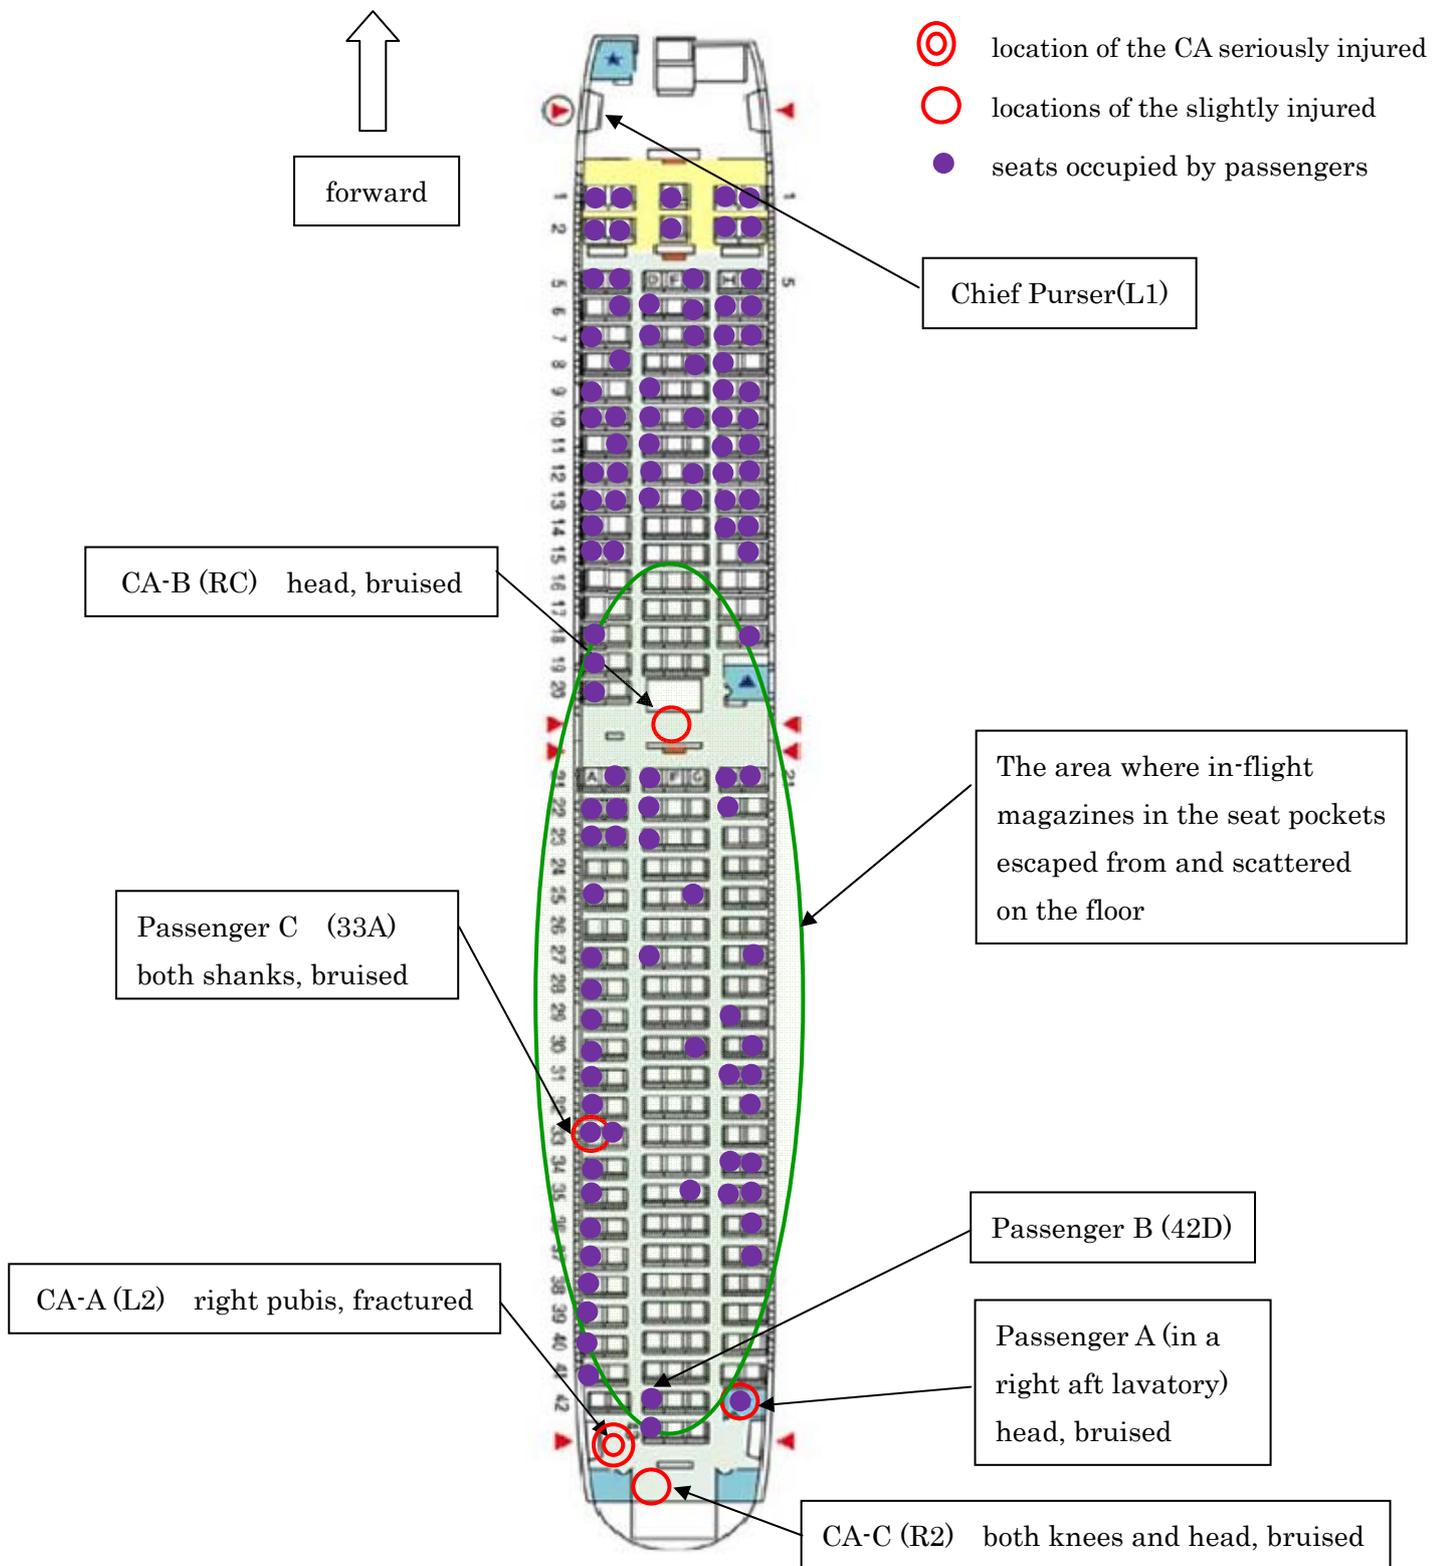
Figure 5 Locations of the Injured when the Accident Occurred

| (1) Cabin Attendant A (in charge of L2) | Right pubis, fractured | Seriously injured |

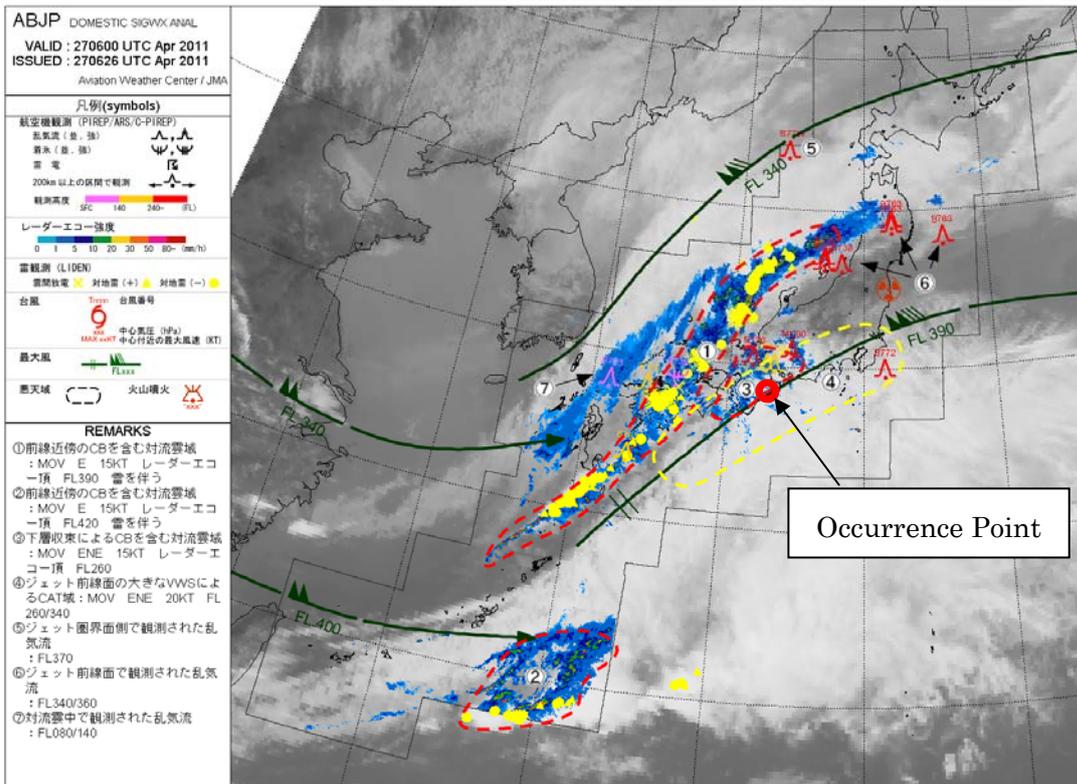
Figure 7 Domestic Significant Weather Analysis Chart

A radar echo area which developed along the forefront of the cold front extending from the low spread like a belt and was advancing to the east at 15 kt. The area of strong radar echo intensity and high top radar echo altitudes were observed along the area off the coast of Shikoku, Chugoku Region and off the coast of Hokuriku. However, there were very few echoes present with 5 mm/h or less in the airspace where the accident occurred, and their tops were as low as 2 to 4 km high.

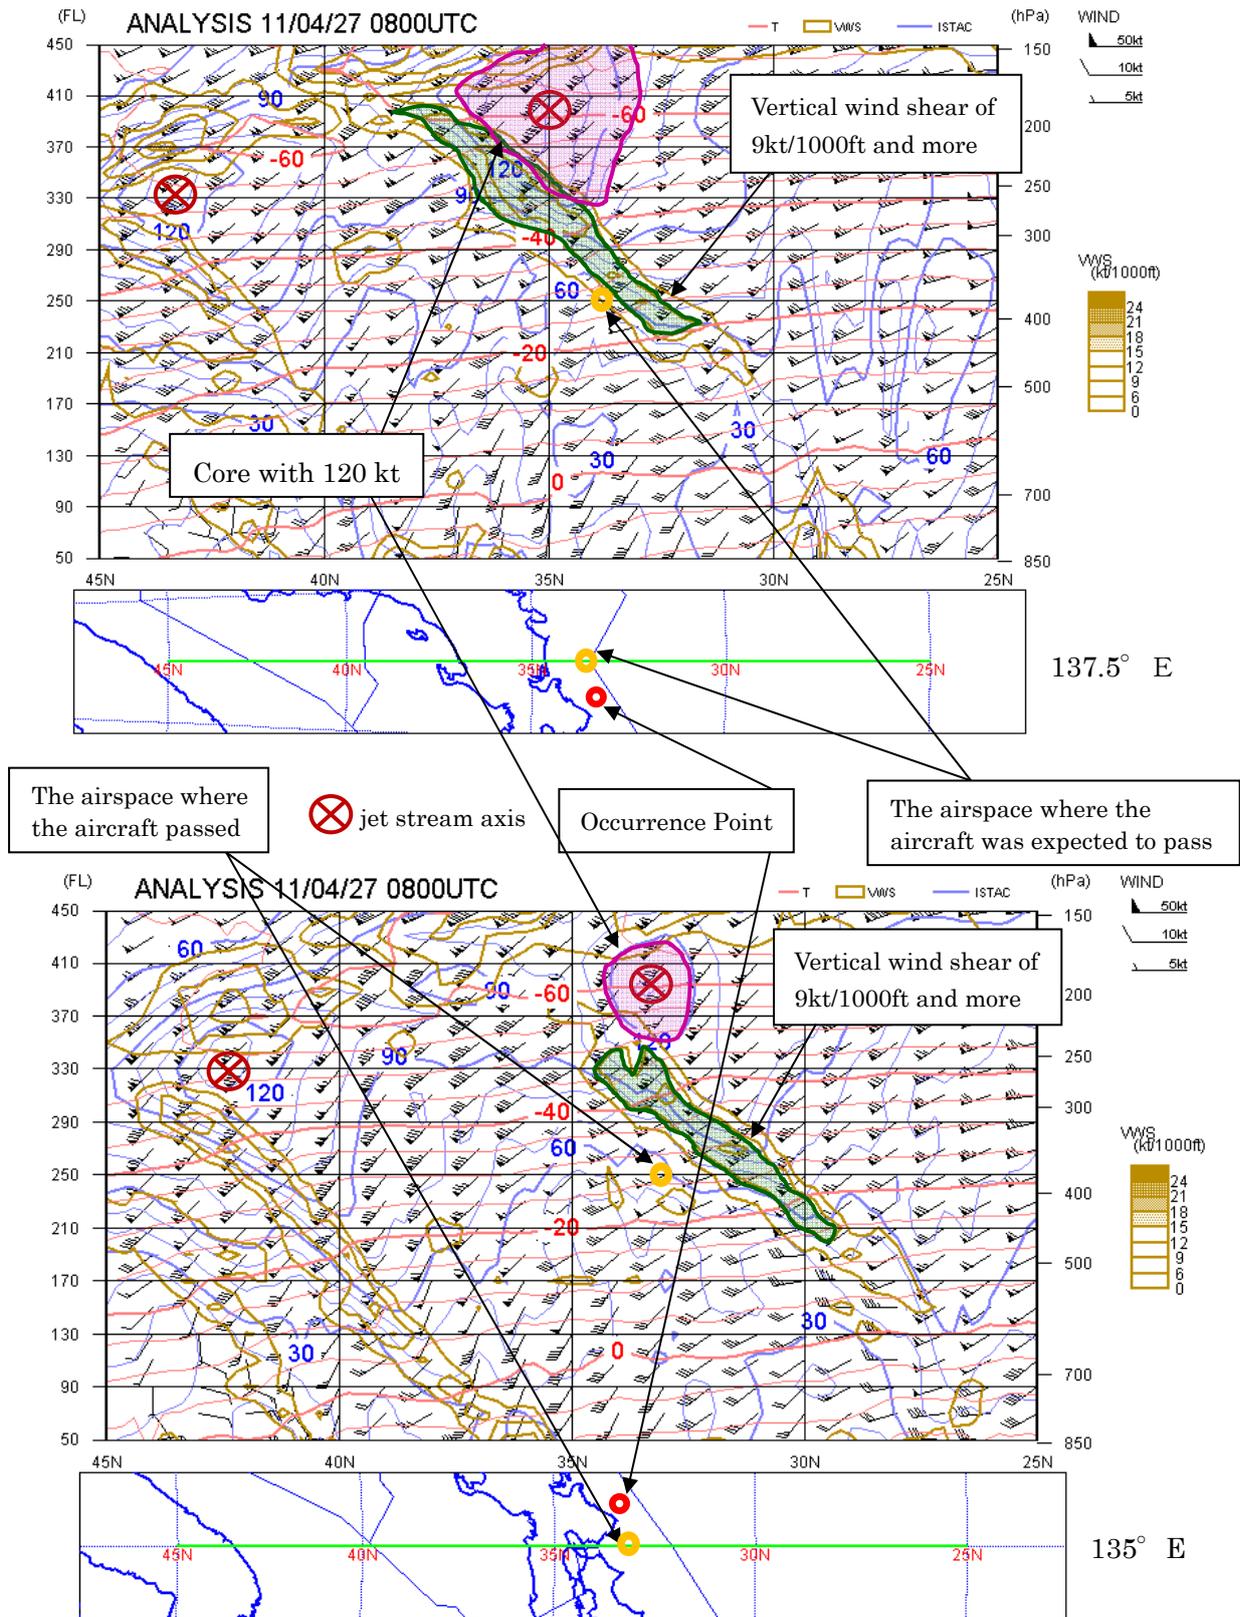
Figure 8 Hourly Analysis Chart (vertical cross section)

According to the hourly analysis chart showing the conditions at about FL 250 which was close to the time when the accident occurred, there was a vertical wind shear of 6 to 9 kt approx. 30 nm south of where the accident occurred and beyond. And further to the south, another wind shear of by far a larger scale was analyzed; however, the vertical wind shear present in the vicinity of the accident airspace was as weak as 0 to 6 kt.
