**AIRCRAFT ACCIDENT
INVESTIGATION REPORT**

**THE YOMIURI SHINBUN TOKYO HEADQUARTERS
CESSNA 560, JA8576
OVER TOKYO BAY
JUNE 30, 2006**

March 30, 2007

**Aircraft and Railway Accidents Investigation Commission
Ministry of Land, Infrastructure and Transport**

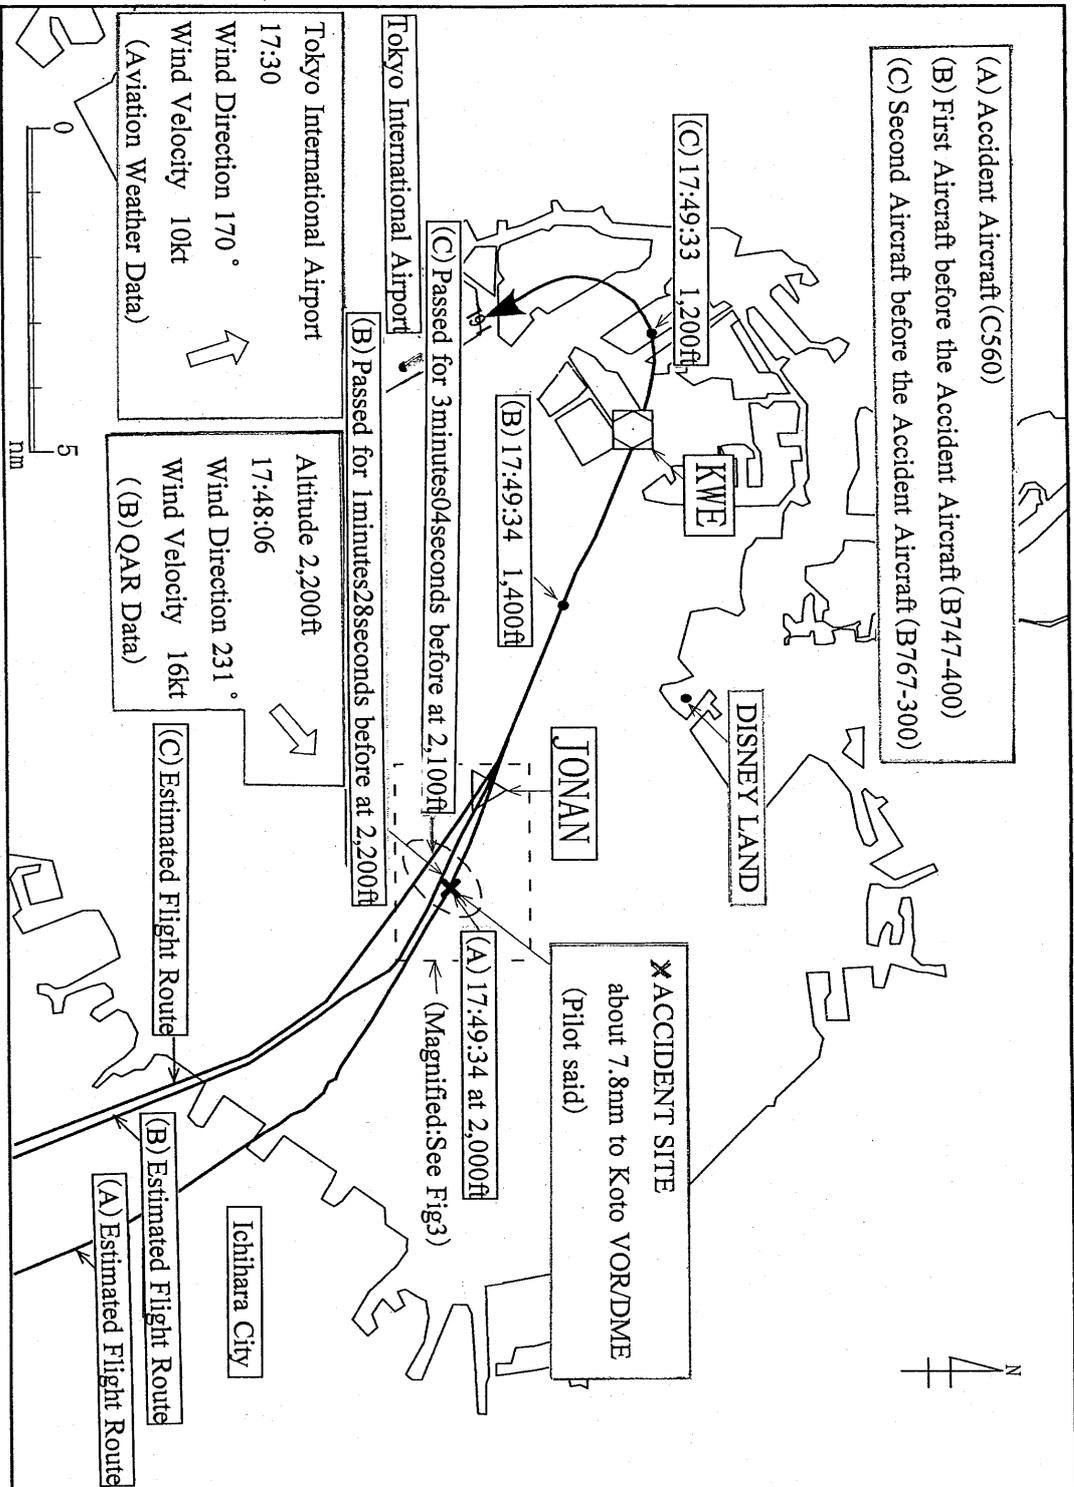
Figure 2 Estimated Flight Route near The Accident Site

- (1) Based on the PIC's statement and the radar records, it is estimated that the accident occurred at about 17:49:34 on the VOR/DME C route, approximately 1.8 nm before JONAN, as the aircraft was in level flight while decelerating, at a speed of approximately 185 kt and an altitude of 2,000 ft.
(See Figure. 2.)

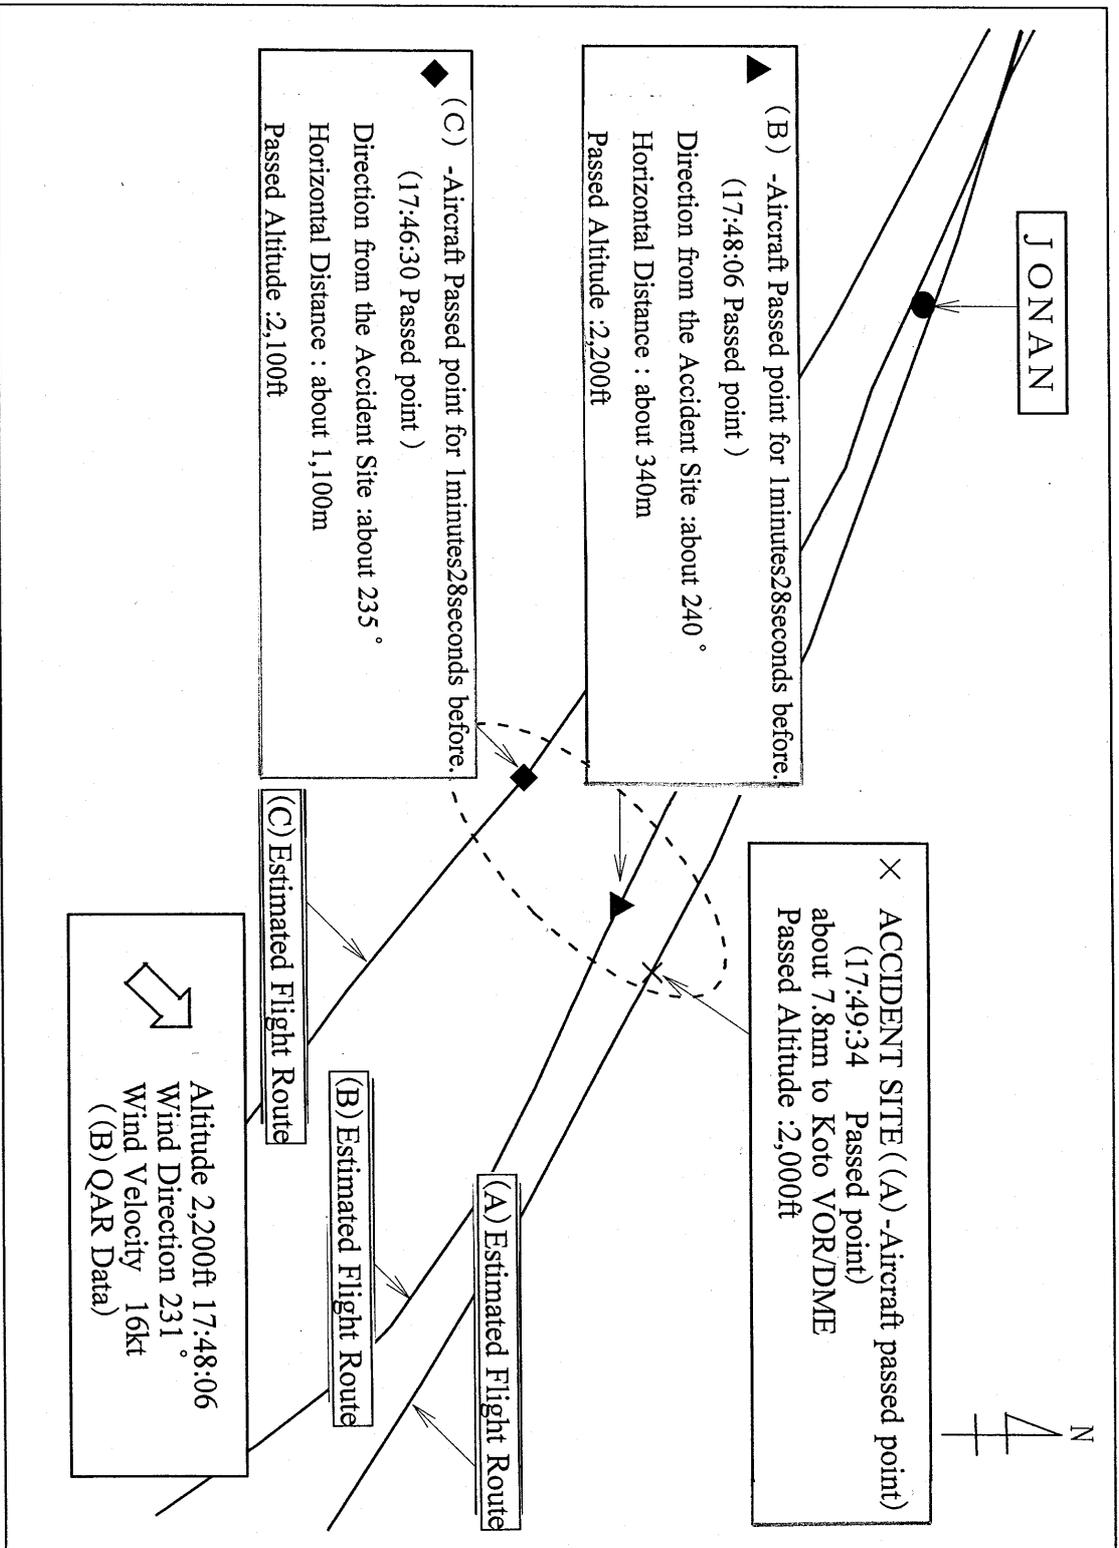
Figure 3 Around the Accident Site (Magnified)

According to the ATC radar records (hereinafter called “the radar records”), the second nearest preceding aircraft flew approximately 1.1 km southwest (approximately 235°) of the accident site at an altitude of approximately 2,100 ft, 3 min and 4 s prior to the occurrence of the accident. The preceding aircraft flew approximately 0.3 km southwest (approximately 240°) of the accident site at an altitude of approximately 2,200 ft, 1min and 28 s prior to the occurrence of the accident. Furthermore, at 17:47:04 when the ATC issued speed instruction immediately before the transfer from radar approach control (hereinafter called “the radar”) to the airport control tower (hereinafter called “the tower”), there was a separation of approximately 5.3 nm between the aircraft and the preceding aircraft.

- (2) The radar records show that the second nearest preceding aircraft passed the area around the accident site at an altitude of approximately 2,100 ft, 3 minutes and 4 seconds before the occurrence of the accident, while the preceding aircraft passed the area at an altitude of approximately 2,200 ft, 1 minute and 28 seconds before the occurrence of the accident. Based on this, it is estimated that, at the time of the accident, the aircraft was flying approximately 100 ft below the altitude at which the second nearest preceding aircraft had passed near the accident site and approximately 200 ft below the altitude at which the preceding aircraft had passed there.

- (3) Based on the position of the aircraft relative to the preceding aircraft and the wind direction/velocity at an altitude of approximately 2,200 ft about 1 min and 30 s before the accident, it is estimated that the shaking of the aircraft was due to wake turbulence left behind large aircraft such as the preceding aircraft (or the second nearest preceding aircraft, or both) on the approach route crowded with landing aircraft.

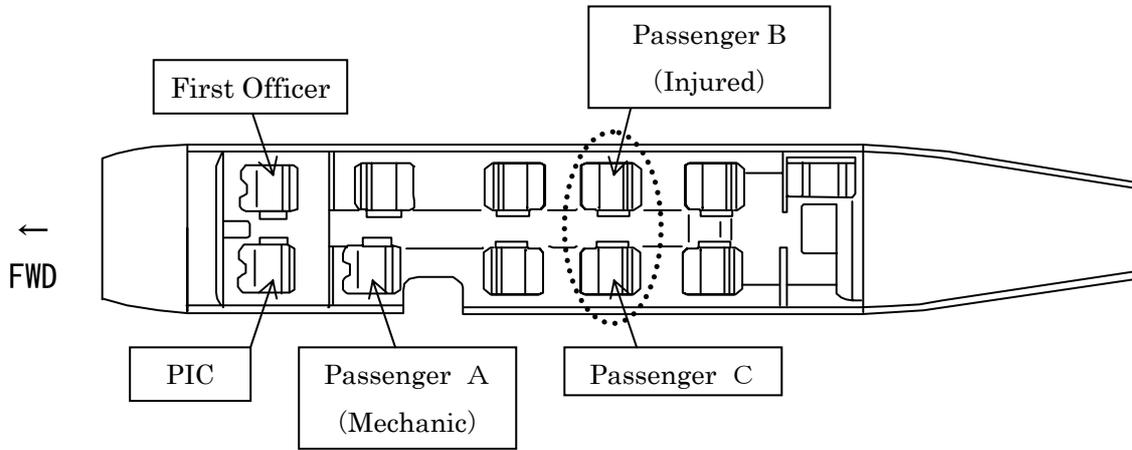
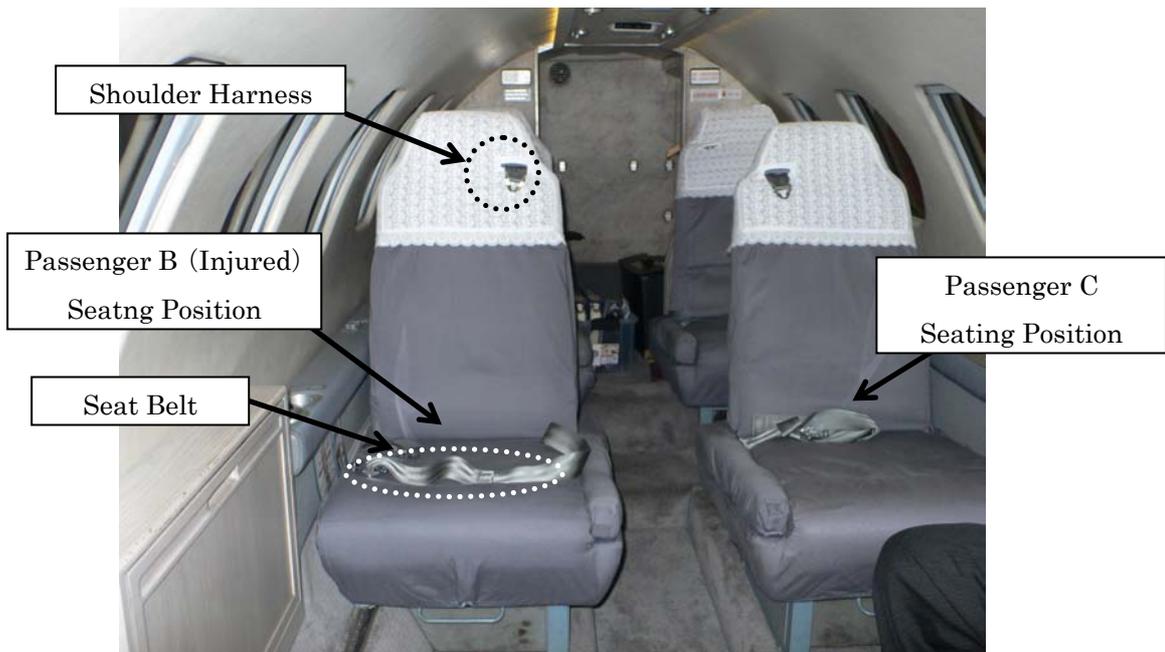
Figure 5 Seat Arrangement

The passenger who was injured (Passenger B) was sitting on the seat shown in Fig. 5, in an apparently normal posture. After the shaking, Passenger A, who was looking after Passenger B, told me that Passenger B seemed to have suffered injury to his lower back. When I asked “ (Passenger B) did not fasten seatbelt ? ”, the answer was “Yes, he did properly.”

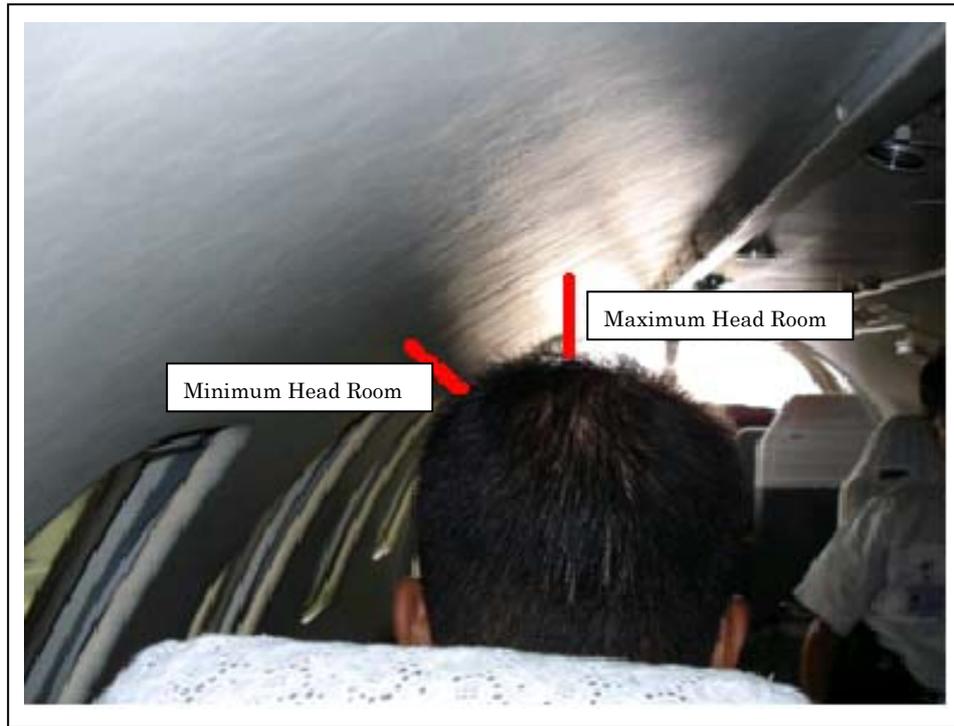
Figure6 Position Relation of Ceiling and Head

The ceiling of the aircraft’s cabin was formed in a semi-cylindrical shape. The headroom was rather small even for someone sitting normally on the seat and a tall person could easily hit his/her head against the ceiling from even small vertical movements of the aircraft.

- (7) Passenger A stated that Passenger B did not fasten shoulder harness. Even if Passenger B had fastened shoulder harness, it is considered that the accident would still have been unavoidable because the shaking of aircraft of this time, which is estimated to be caused by the wake turbulence, was in vertical direction, and the shoulder harness equipped in the aircraft's cabin was less capable of restraining the body against vertical movement.
- (8) During the shaking of the aircraft, the corporate passengers hit their heads against the aircraft's ceiling but did not sustain head injury. It is estimated that such factors as the semi-cylindrical shape of the ceiling and the lining working as a cushion helped prevent injuries to the passengers' heads.

PIC	1 0 cm	Same as Left
First Officer	7 cm	Same as Left
Passenger A	7 cm	5 cm
Passenger B	1 0 cm	6 cm
Passenger C	8 cm	6 cm

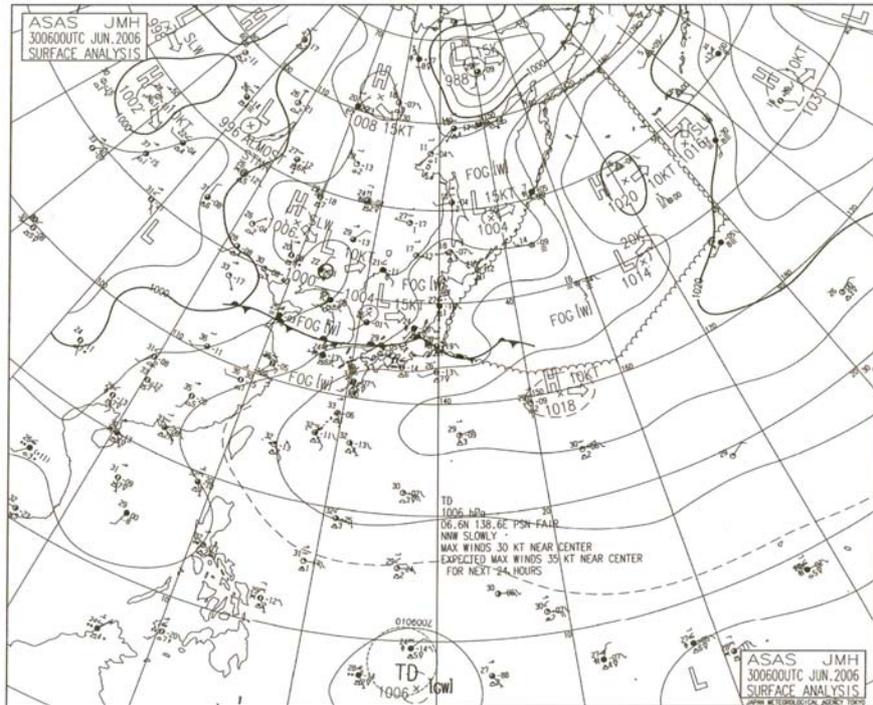
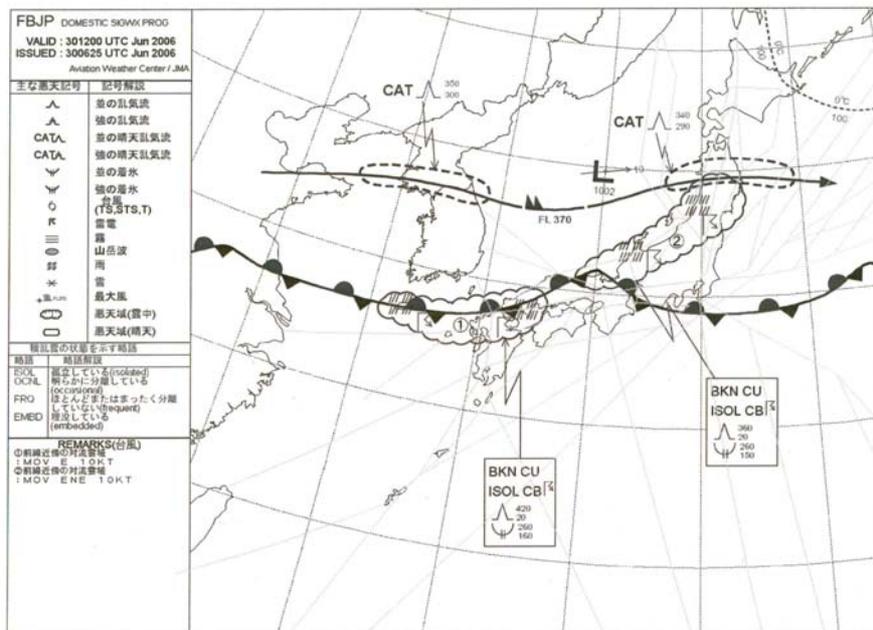
3.3 Because the weather charts for the day of the accident (the surface weather chart for Asia and the significant weather forecast chart for Japan) showed a stationary front across Kanto region, and as mentioned in 2.7.4, wind was variable along the approach course (at 700 ~ 1,000 ft), the existence of atmospheric discontinuity was forecast analytically. However, because the area of atmospheric discontinuity did not coincide with the accident site and because there were no reports of turbulence from other aircraft, it is estimated that the weather at the time of the accident did not contribute to this accident.
