AA2004-4

# AIRCRAFT ACCIDENT INVESTIGATION REPORT

ASIA AIR SURVEY COMPANY LIMITED  
GULFSTREAM COMMANDER 695,JA8604  
CRASH DUE TO SPIN  
OGAWA,NAKA COUNTY,IBARAKI PREFECTURE,JAPAN  
AT ABOUT 10:52 JST,MARCH 24,2003

September 24,2004

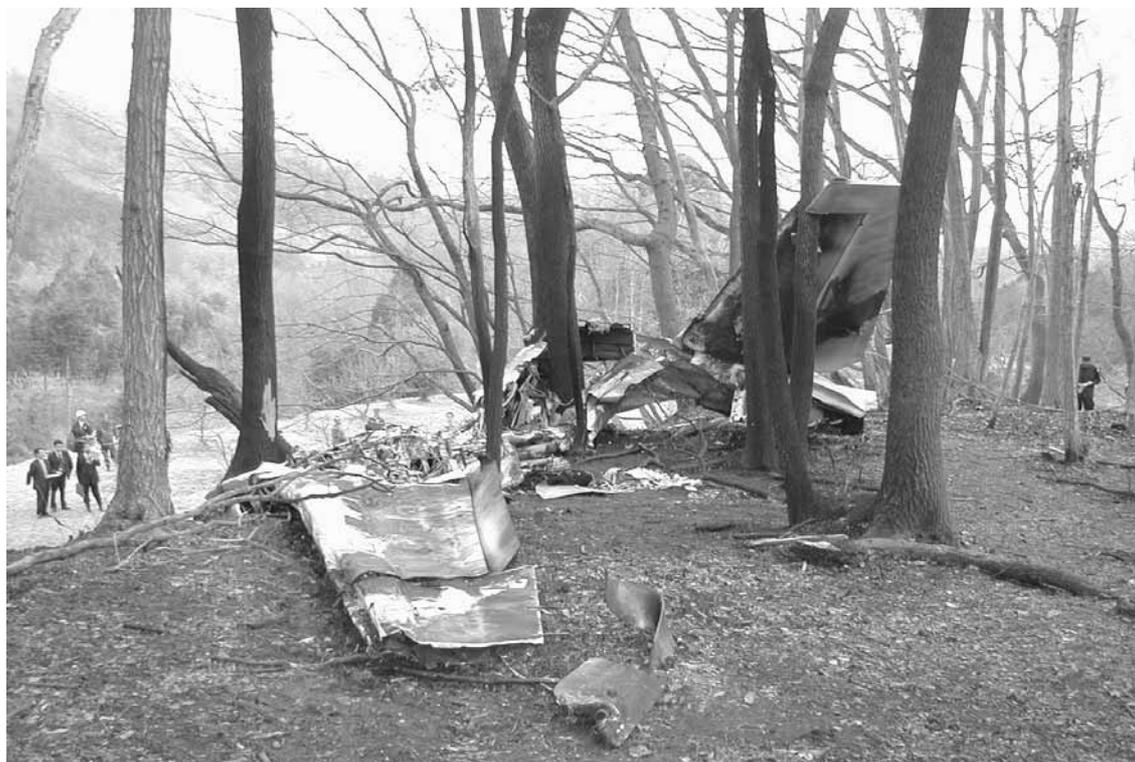
Photograph 2 Accident Site ( Left Wing )

The right propeller had separated from the front of the right engine. One blade of the left propeller had separated and was found in the aft vicinity of the left wing tip.

- (2) The inboard sections of both wings between the fuselage and engine nacelles were destroyed by fire. The sections of wing outboard of the engine nacelles were burned and deformed. The tip of the left wing was separated from its attachment. There was no fire damage to the aft portion of right engine nacelle.

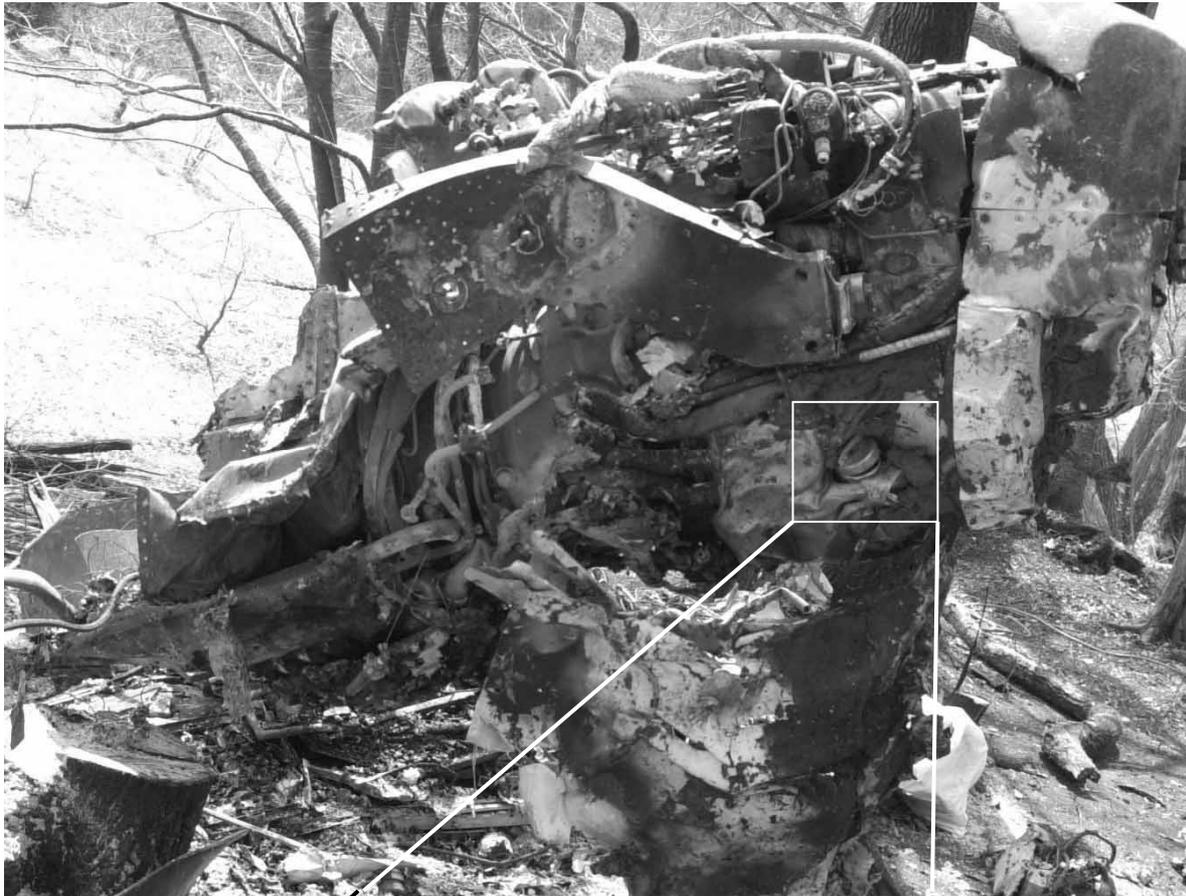
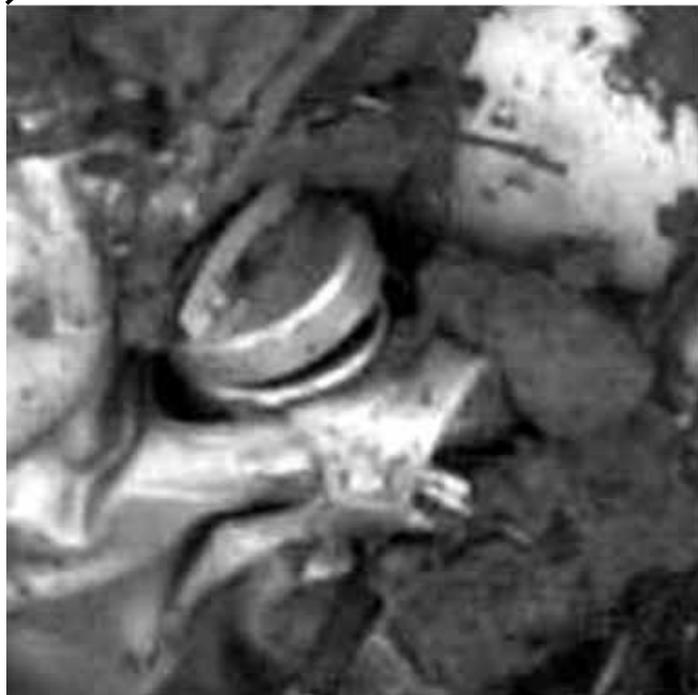
Photograph 3 Left Engine ( At Accident Site )

The left engine propeller shaft had been severed aft of the propeller attachment flange. The forward flange the compressor section case was damaged. The oil tank had been crushed, but was not cracked. The cap of the oil tank had not been locked to the filling port, but there was no damage to either the cap or to the flange of the filling port to which the cap is locked.

Lubricating oil was found sprayed on the engine outer case.

(3) It is considered that if a cap in the locked position were separated from the oil tank by the crash impact, the flanges of the cap and the oil filling port would be damaged and deformed. However, no there was no damage to these areas. Further, if the cap had been in the locked position, it is considered that the possibility that the cap might be rotate 90° from the locked position and removed by the flight loads is remote. Therefore, it is estimated that the cap of the left engine oil tank had not been normally locked at the start of the accident flight.

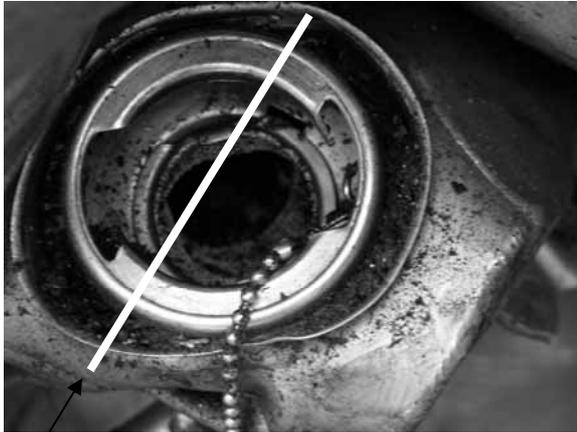
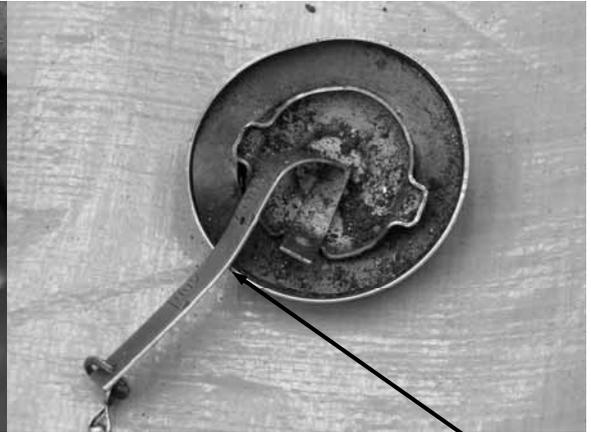
Photograph 4 Left Engine Oil Filler Port & Filler Cap

The Dipstick was bent after it was removed

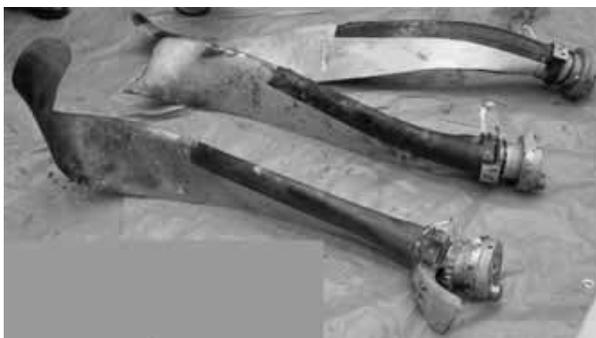
Left Propeller

Of the three left propeller blades, one had broken off near the hub and its tip was bent forward, another had been destroyed by fire from the middle to the tip, and the other was bent backwards with the tip bent slightly forwards.

On both propellers, the propeller pitch change piston in the hub was locked by the starting latch, and blades were found to be at ground idle pitch.

In both the left and right propellers, the pin attached to each blade to change the blade pitch had broken off in one blade, and was damaged in another blade.

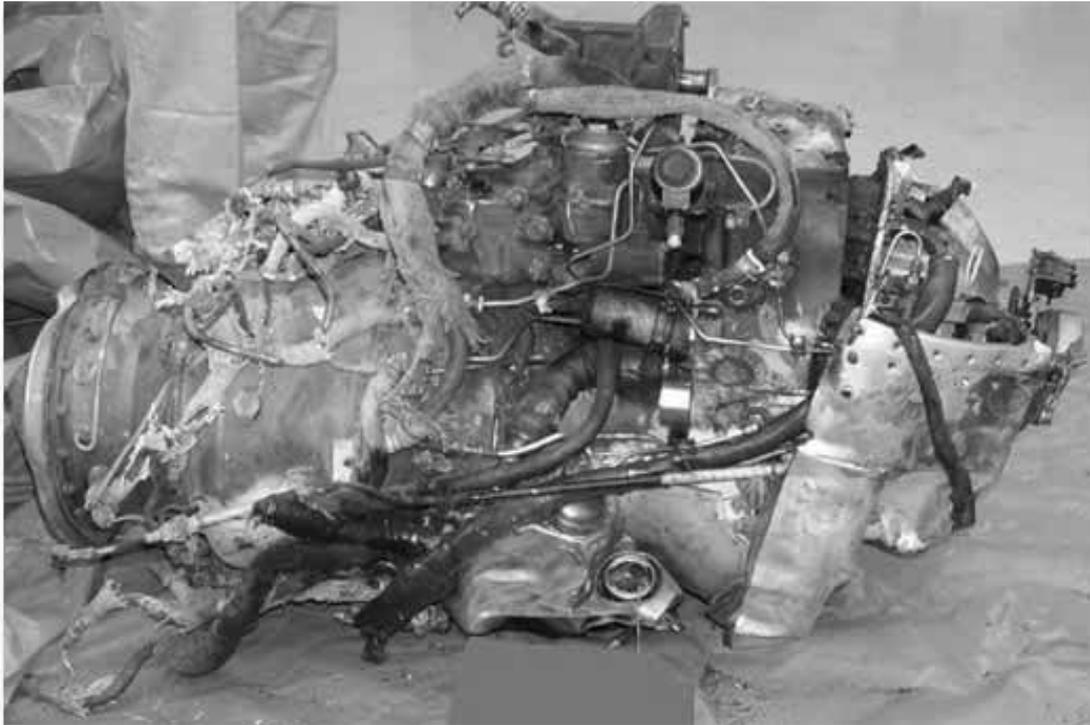
Photograph 6 Left Engine

The starter/generator had broken off at its attachment.

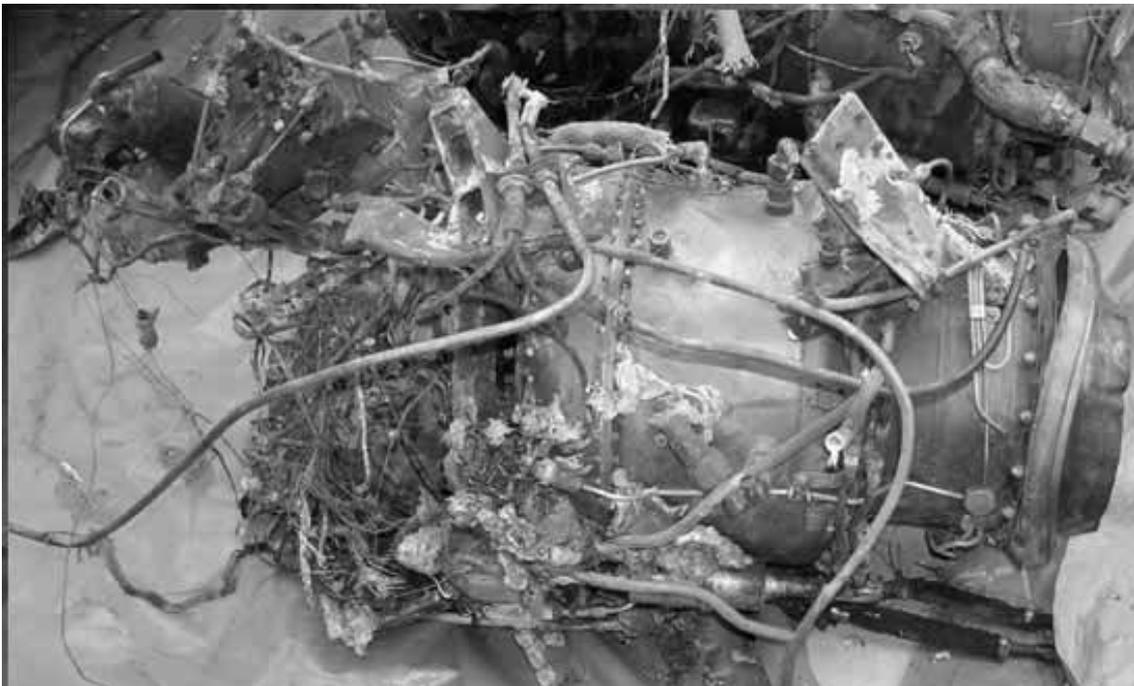
Photograph 7 Right Engine

The right engine's reduction gear case had separated. The front flange of the compressor section case was damaged and the first stage impeller was deformed. The fuel control unit had broken away.

The oil tank was damaged and was empty of lubricating oil. The oil tank cap was locked to the filling port.
