AIRCRAFT ACCIDENT INVESTIGATION REPORT

ALL NIPPON AIRWAYS FLIGHT 589
BOEING 767-300,JA8669
APPROXIMATELY 18 KILOMETERS NORTH OF MATSUYAMA AIRPORT,
AT AN ALTITUDE OF APPROXIMATELY 800 METERS
JANUARY 22, 2006

November 24, 2006

Aircraft and Railway Accidents Investigation Commission
Ministry of Land, Infrastructure and Transport

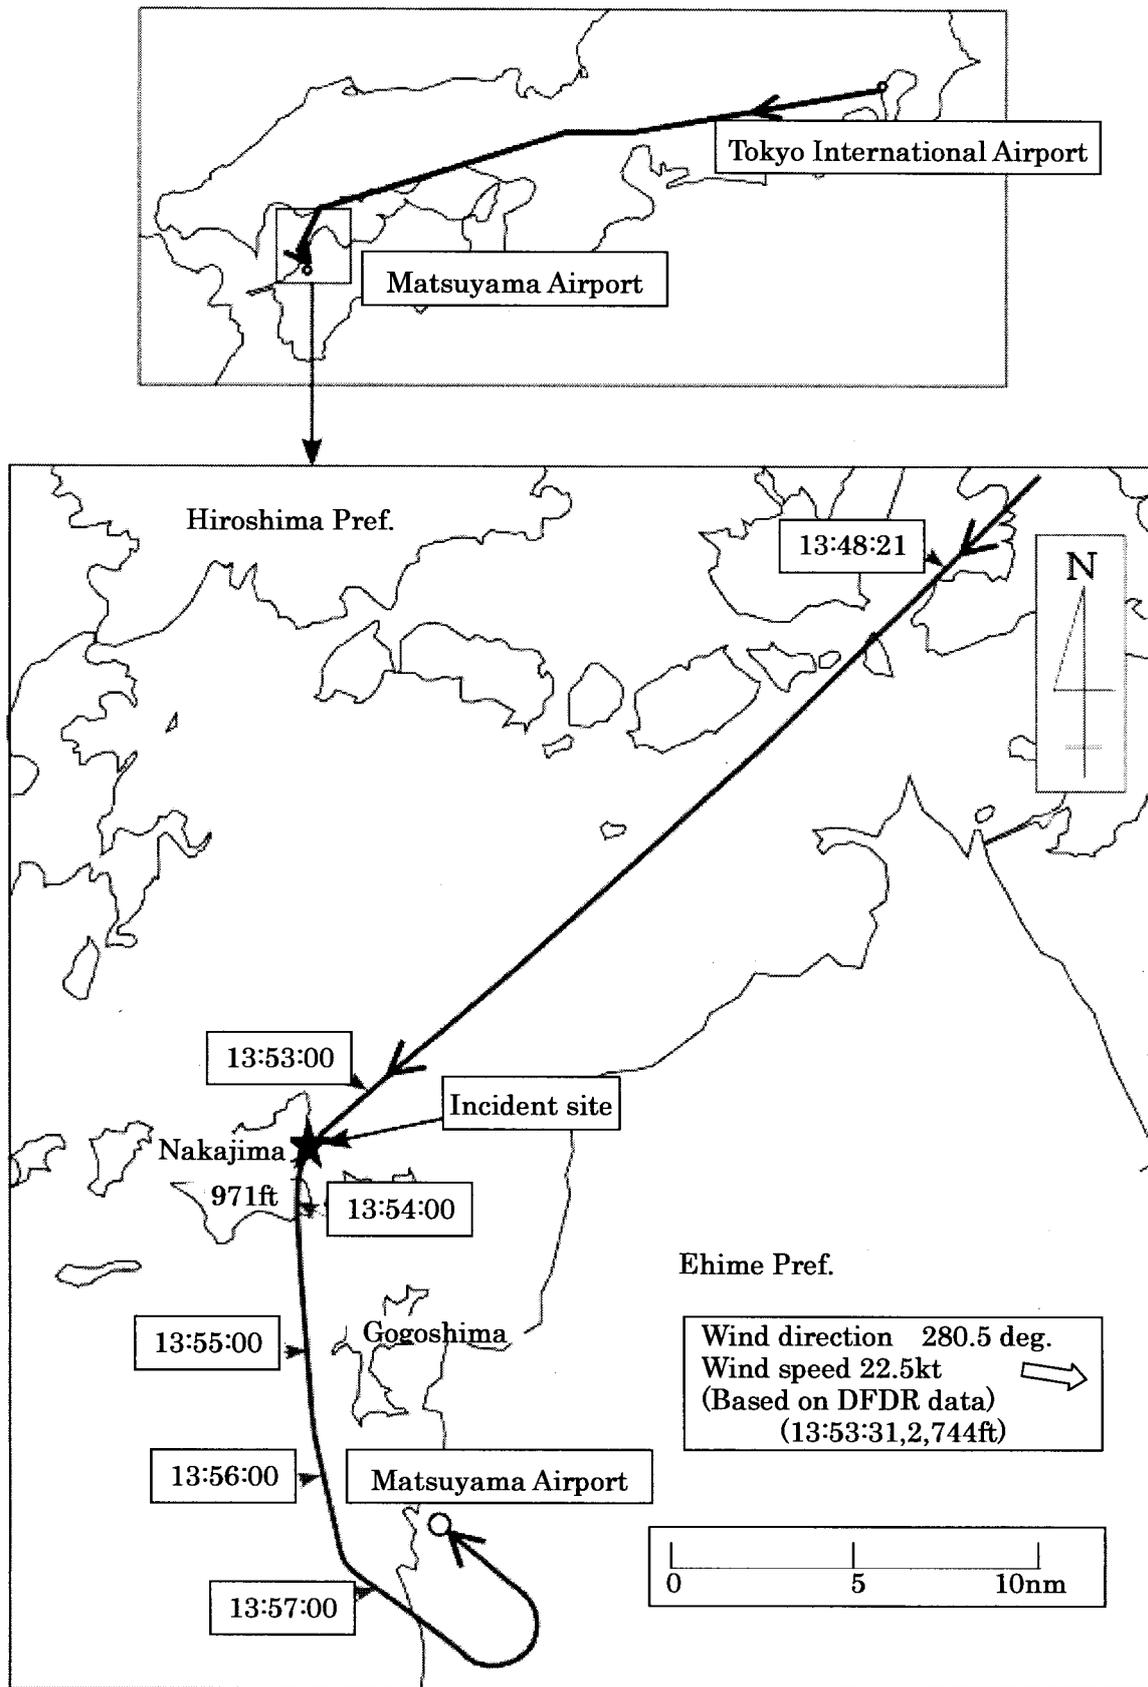
Figure 1 Estimated Flight Route

This accident occurred at about 13:54, at a point approximately 18 kilometers north of Matsuyama Airport at an altitude of approximately 800 meters (approximately 2,700 feet).

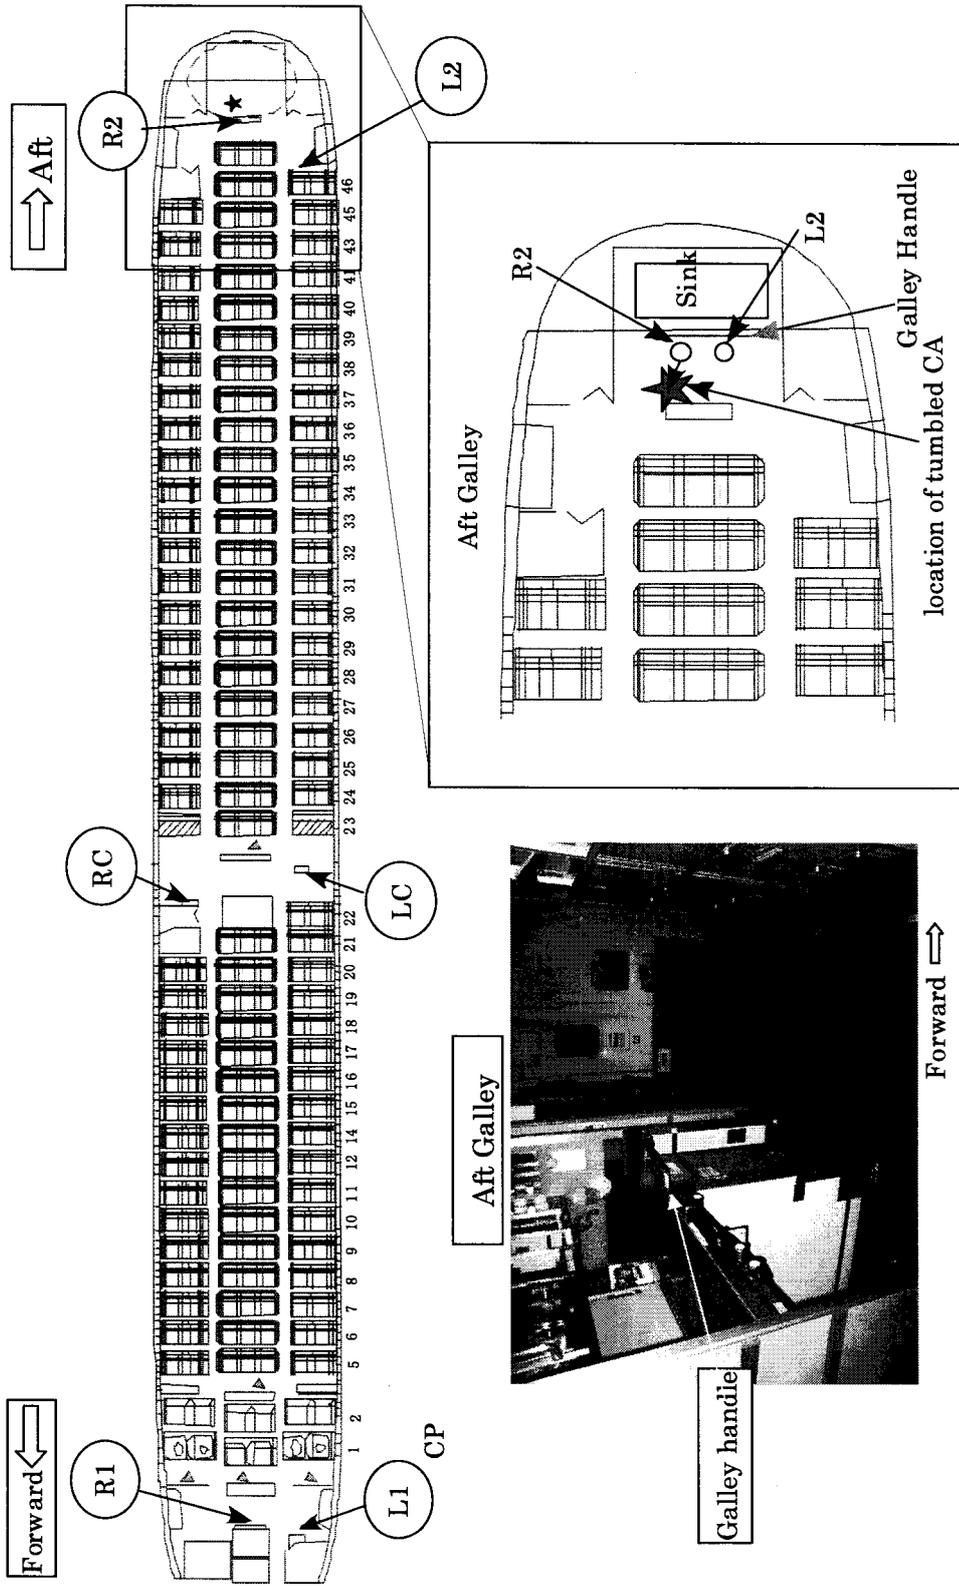
Figure 3 CA seating locations

The one CA responsible for the R2 area was seriously injured, and the one CA responsible for the L2 area was slightly injured.

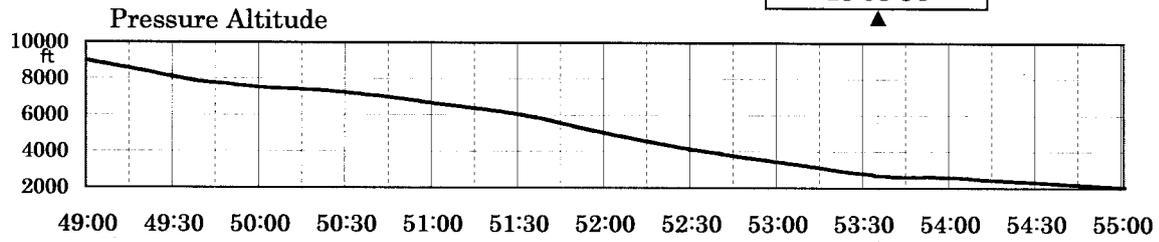
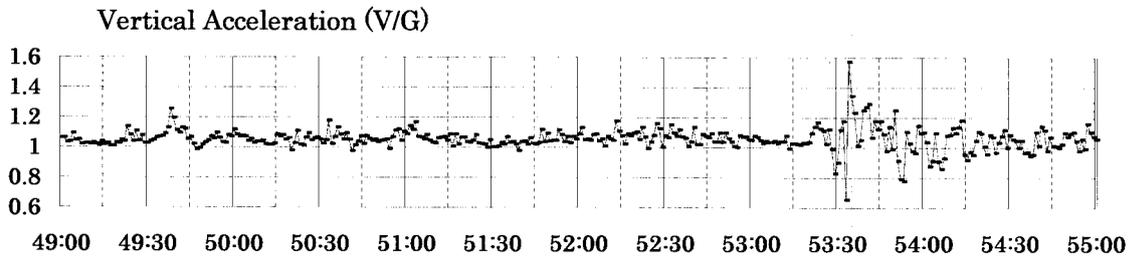
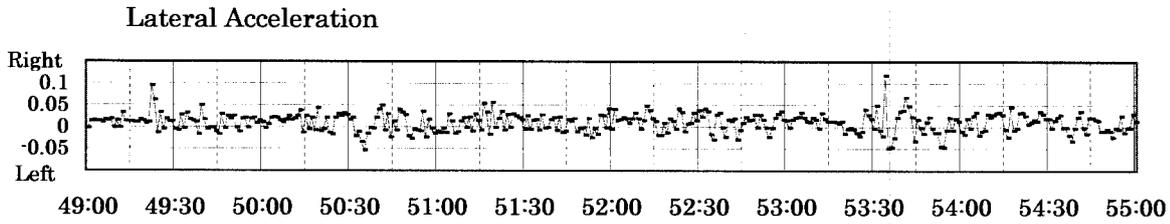
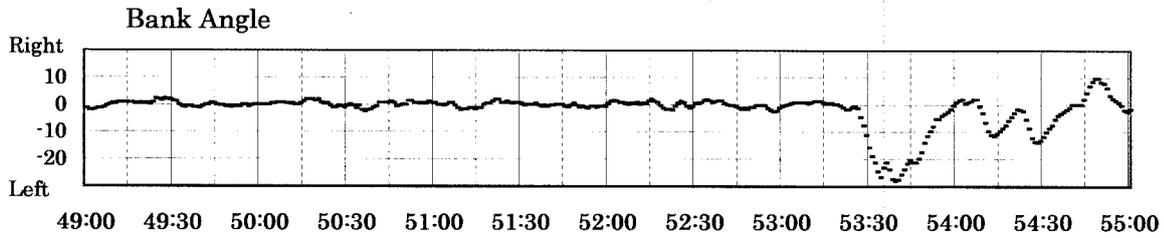
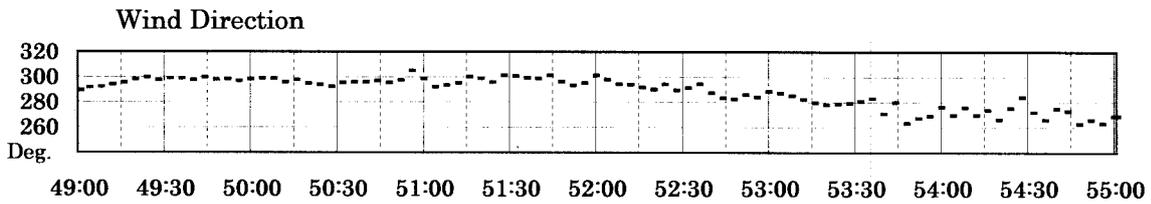
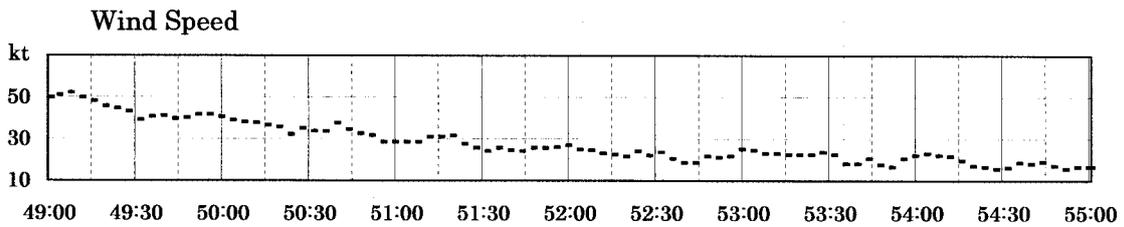
Figure 4 DFDR Recording

According to the DFDR records, the aircraft was descending when it reached an altitude of 10,012 feet at 13:48:21 .

The aircraft started shaking when it passed an altitude of 7,848 feet at 13:49:38. Shaking of the same magnitude continued until 13:52:55 and then weakened slightly. At 13:53:23 , the magnitude of the shaking started increasing again, with the minimum vertical acceleration recorded at 13:53:33 being 0.654G and the maximum vertical acceleration

recorded at 13:53:34 being 1.57G. The shaking then continued, without showing any salient peaks.

The aircraft made a left turn at about 13:53:25 to change its heading southward; the bank angle was 26.7° at 13:53:34 and reached a maximum of 28.1° at 13:53:39.

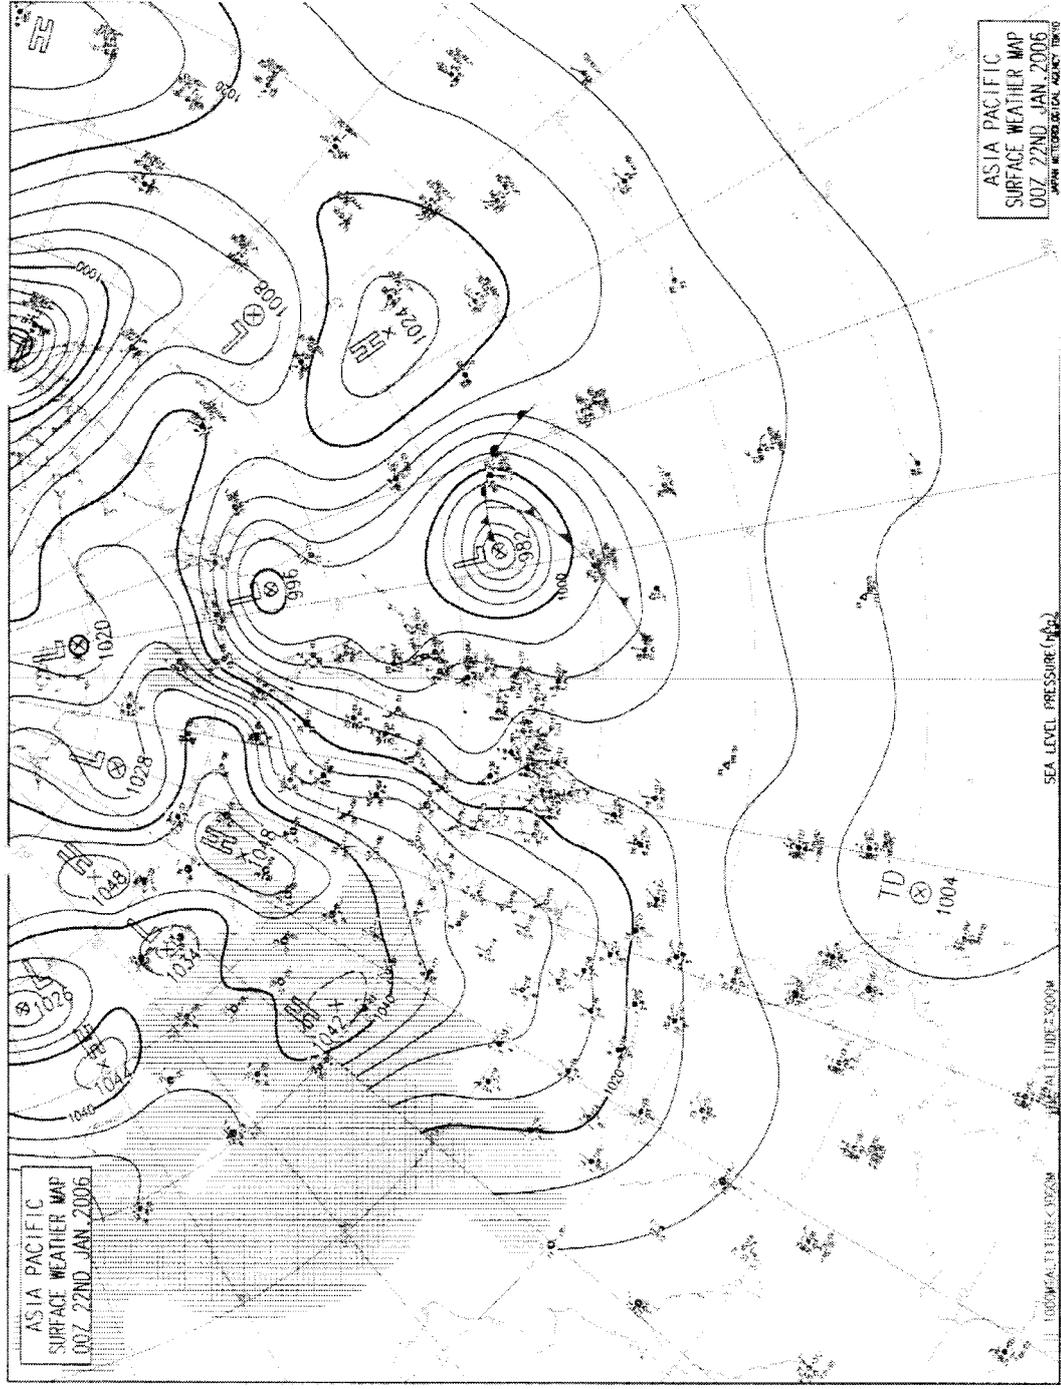
Figure 5 Asia surface weather map (09:00 January 22, 2006)

The surface weather map for 09:00 on January 22, 2006 shows a typical winter

pressure pattern including high pressure centered around the upper reaches of the River Amur and low pressure that caused snow on the previous day in the Kanto region and was now present over the sea to the east of Japan. The low pressure was traveling fast, resulting in widely spaced isobars near the Shikoku area and consequent surface winds not higher than 10 knots in velocity.
