**AIRCRAFT SERIOUS INCIDENT  
INVESTIGATION REPORT**

**JAPAN AIRLINES INTERNATIONAL CO., LTD.  
J A 8 9 0 4**

**JAPAN AIRLINES INTERNATIONAL CO., LTD.  
J A 8 0 2 0**

AT ABOUT 10:33 JST FEBRUARY 16, 2008

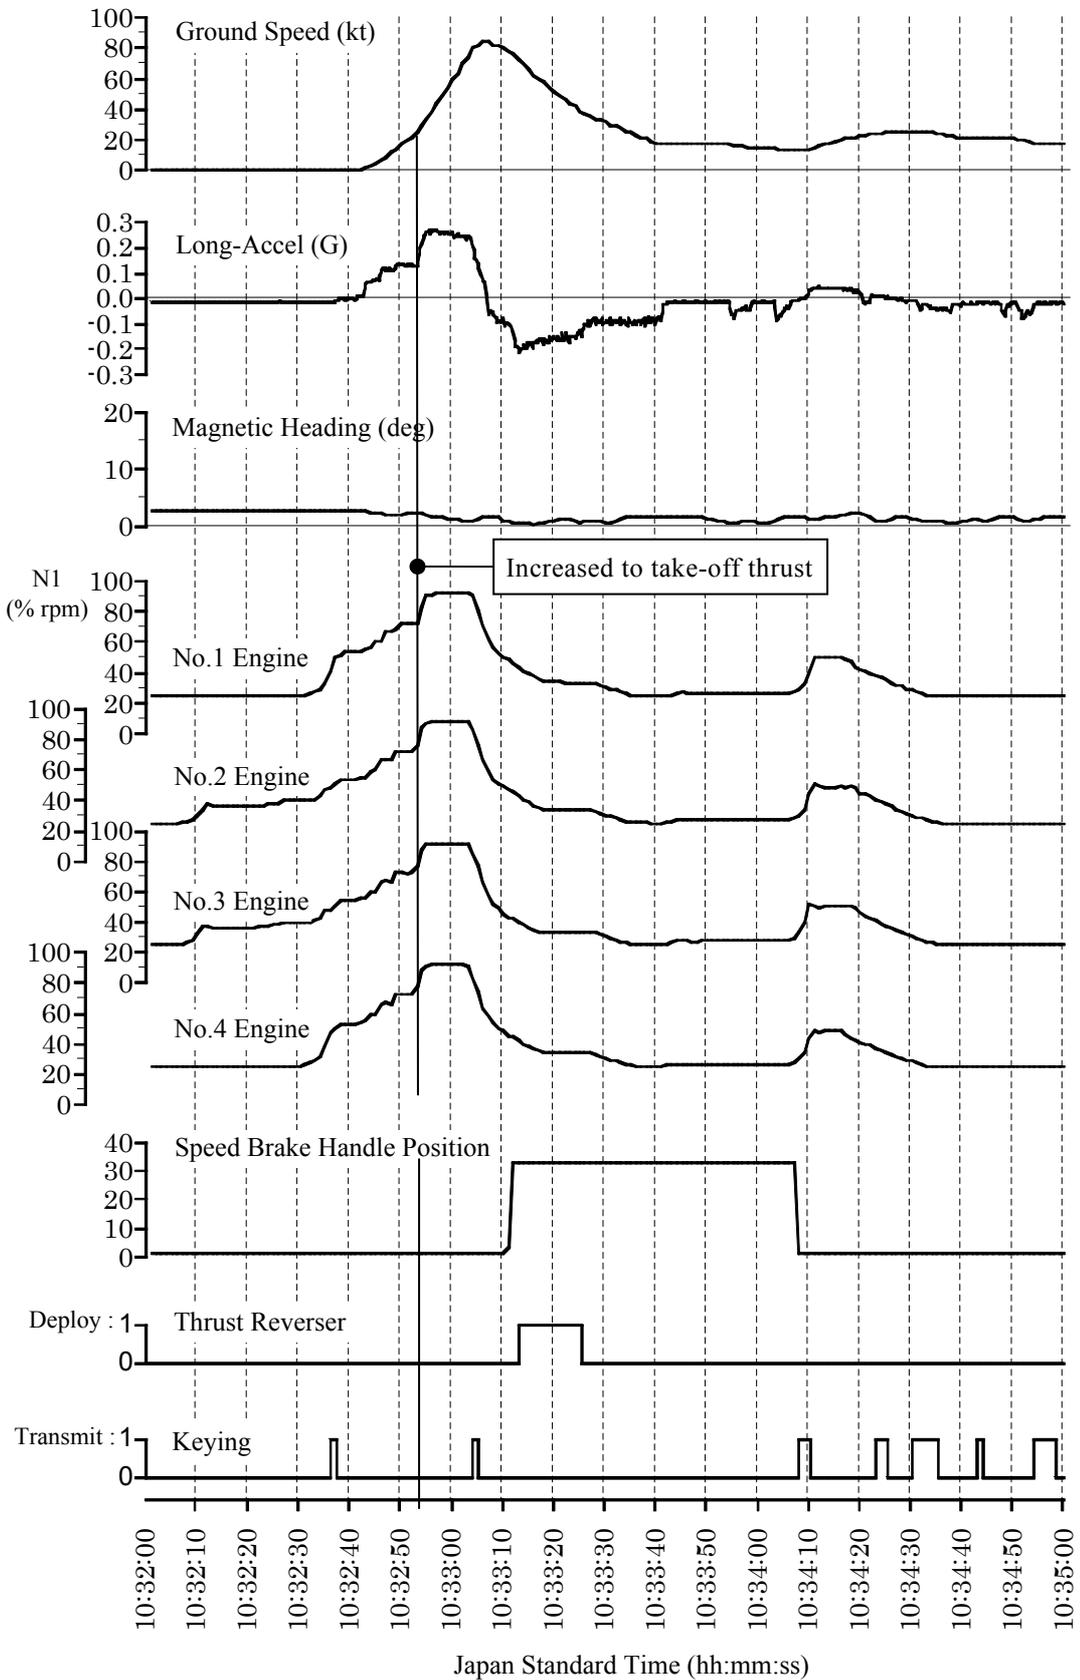
Figure 2 DFDR data of the Aircraft A

- 10:33:05 The aircraft A replied to the tower, “JAPAN AIR 502”. And the engine thrust of the aircraft A began to decrease.
- 10:33:07 The ground speed of the aircraft A reached about 84kt at the maximum, and thereafter decreased.
- 10:33:12 The tower instructed aircraft C at about 5nm south of the B runway threshold, which was making final approach for landing, to make go around.
- 10:33:13 The speed brake handle stood and engines of the aircraft A applied reverse.
- 10:33:24 The aircraft C replied to the tower, “GO AROUND, FOLLOW MISSED APPROACH PROCEDURE”
- 10:33:25 The Aircraft B began to face in the direction of taxiway B2 from the runway. (The aircraft A and B were at the nearest distance at about 1,800m)
- 10:33:42 The tower instructed the aircraft B to contact ground.
- 10:33:46 The aircraft B replied to the tower, “ROGER, CONTACT GROUND”.
- (See figure 1, 2 and attachment 1)
