# AIRCRAFT SERIOUS INCIDENT INVESTIGATION REPORT

ALL NIPPON AIRWAYS  
AIRBUS A320-200, JA8947  
(DECOMPRESSION IN AN AIRCRAFT CABIN)

September 27, 2002

Aircraft and Railway Accidents Investigation Commission  
Ministry of Land, Infrastructure and Transport

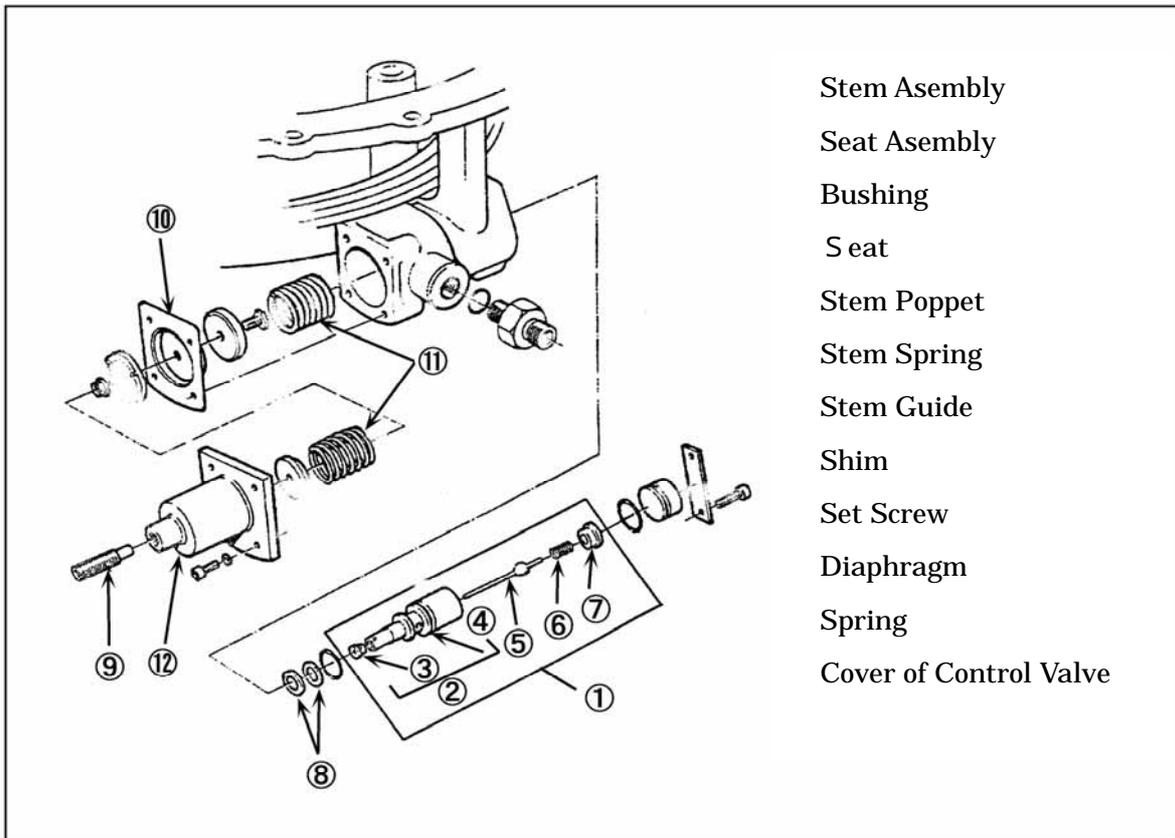
Figure 5 Internal Structure of Safety Valve

The adjusting screw, which sets the valve's positive differential pressure cracking point (indicated as "set screw" in Figures 4 and 5), was driven in to an abnormal depth on S/N129. The length from the control cover to the tip of adjusting screw head was measured as 1.63mm, but is nominally around 5.6mm.

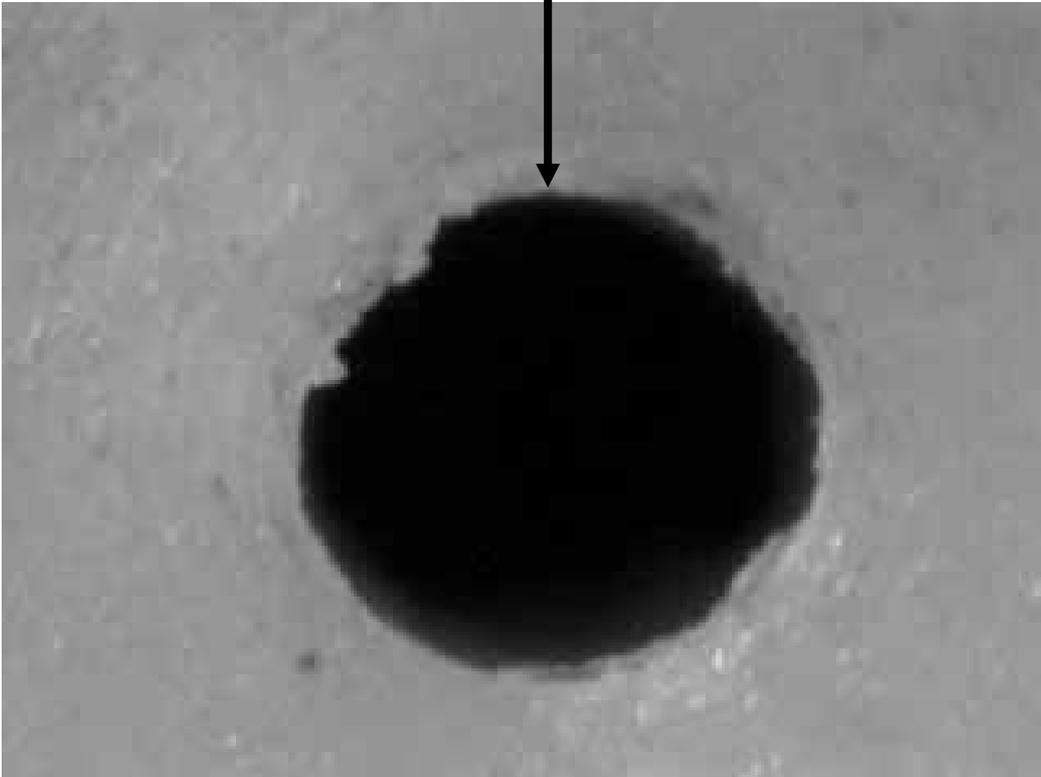
### Photograph 3 Inside Stem, Poppet

hole in which the stem poppet slides was found to be partially worn. Also, several burrs were found on the edge of a drill hole in the seat assembly.

The bush hole in which the stem poppet slides was found to be worn

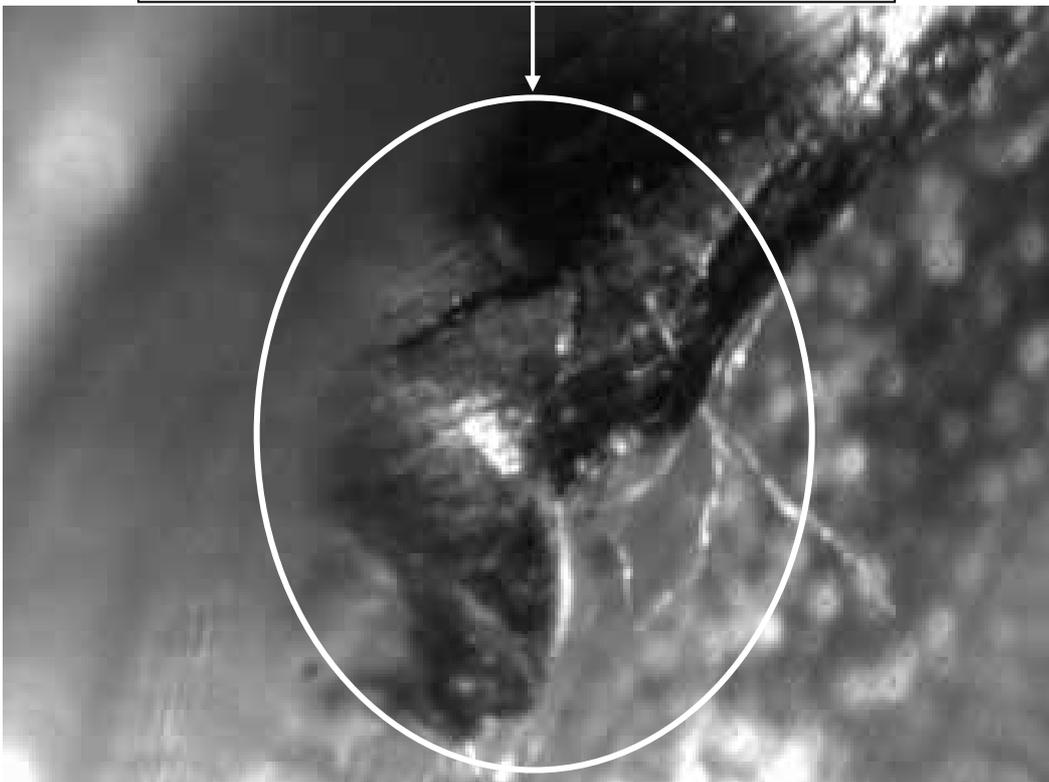
### Photograph 4 Inside Stem, Poppet

On S/N127, a few burrs were found on the edge of a drill hole in the seat assembly, but no other abnormality was found.

Several burrs were found on the edge of a drill hole

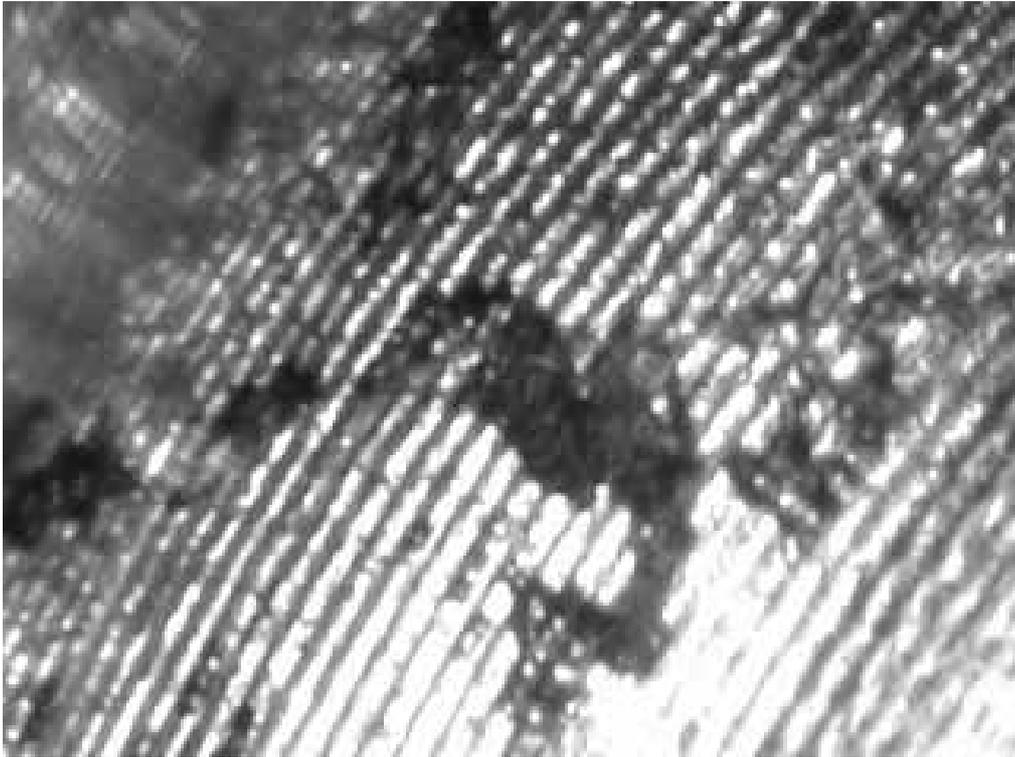
Photograph 5 Inside Stem, Poppet

Contamination

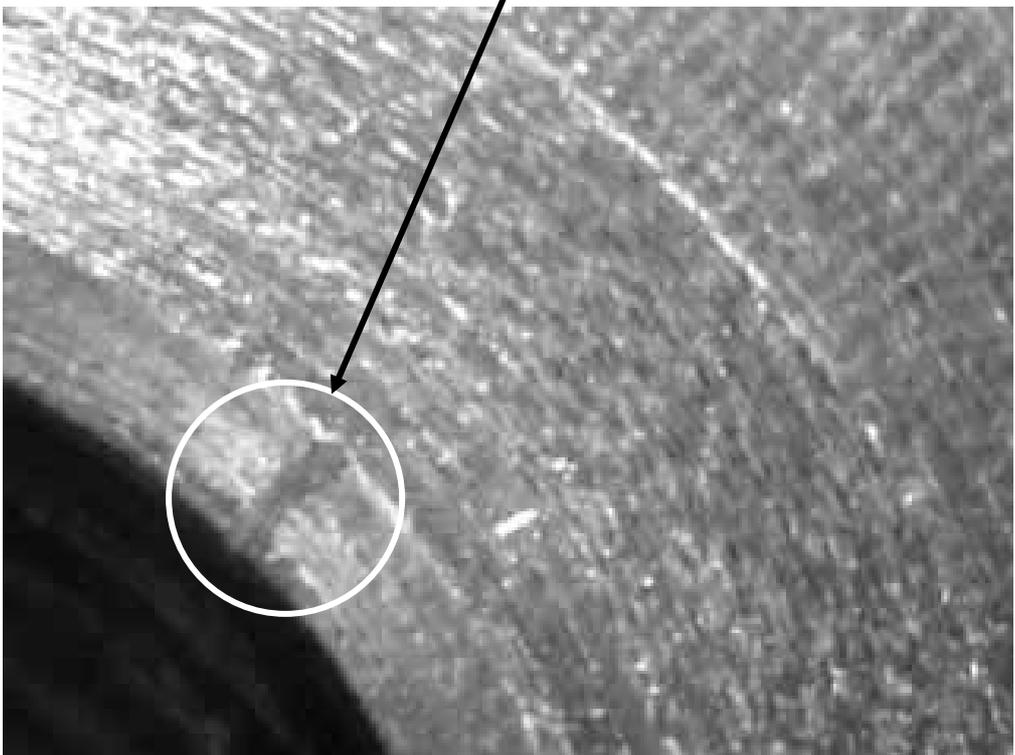
Photograph 6 Inside Stem, Poppet

Scratch
