AI2020-3

**AIRCRAFT SERIOUS INCIDENT
INVESTIGATION REPORT**

**JAPAN AIRLINES CO., LTD.
J A 8 9 8 0**

BOEING 767-300, JA8980

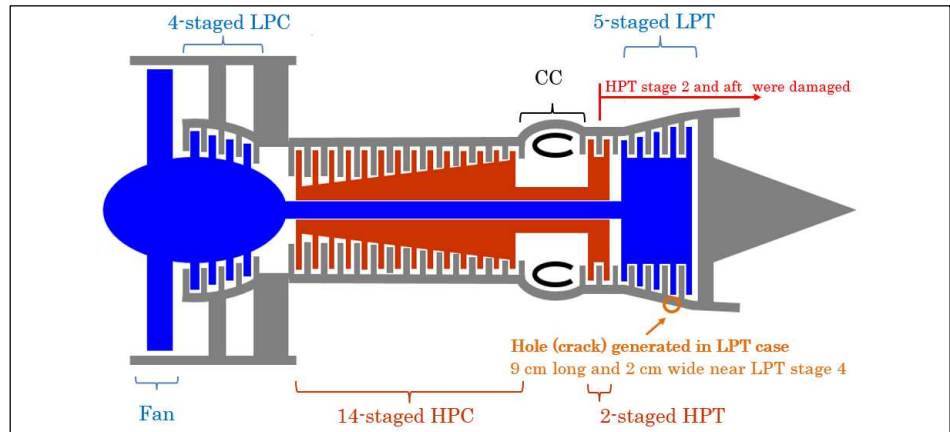
Figure 2: Structure and fractured sections of Engine

The Aircraft was equipped with a two-spool turbofan engine that consists of a fan, 4-staged low-pressure compressor (LPC), 14-staged high-pressure compressor (HPC), combustion chamber (CC), 2-staged high-pressure turbine (HPT) and 5-staged low-pressure turbine (LPT). HPT stage 2 and aft of No. 1 engine were fractured, condition of which is as shown in Figure 2.

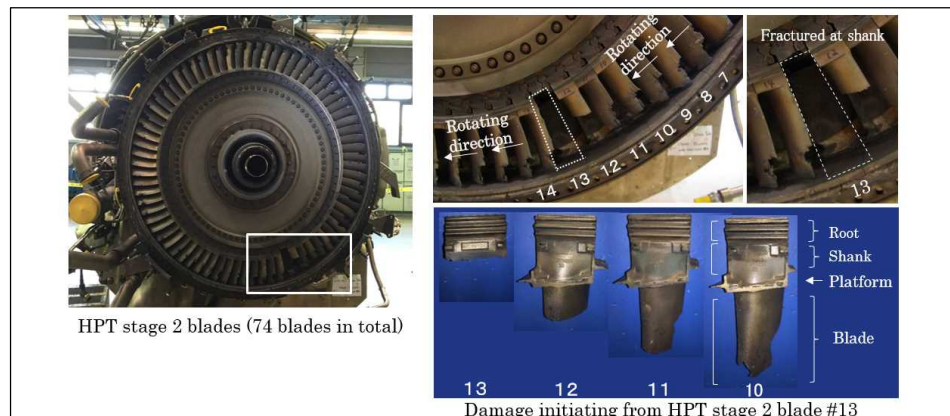
Figure 3: Condition of damaged blades of HPT stage 2

Among total 74 blades on HPT stage 2, blade #13 was fractured at the shank. Besides, blade #12 was fractured at the position of about half of the airfoil. Furthermore, the blade #11 and #10 were fractured near the tip of the blades. Other blades had tips chipped along the entire circle (see Figure 3).
