**AIRCRAFT SERIOUS INCIDENT
INVESTIGATION REPORT**

**JAPAN AIRLINES CO., LTD.
J A 8 9 8 0**

BOEING 767-300, JA8980

AT AROUND 15:55 JST, MAY 24, 2018

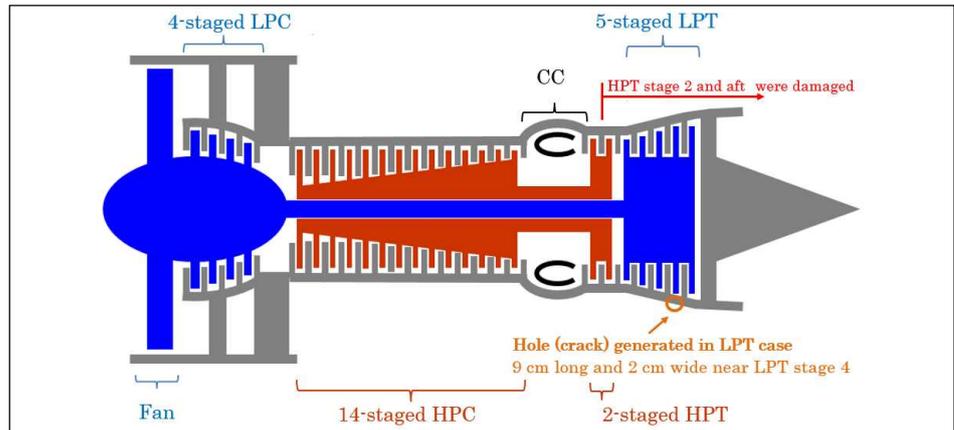
Figure 2: Structure and fractured sections of Engine

The Aircraft was equipped with a two-spool turbofan engine that consists of a fan, 4-staged low-pressure compressor (LPC), 14-staged high-pressure compressor (HPC), combustion chamber (CC), 2-staged high-pressure turbine (HPT) and 5-staged low-pressure turbine (LPT). HPT stage 2 and aft of No. 1 engine were fractured, condition of which is as shown in Figure 2.

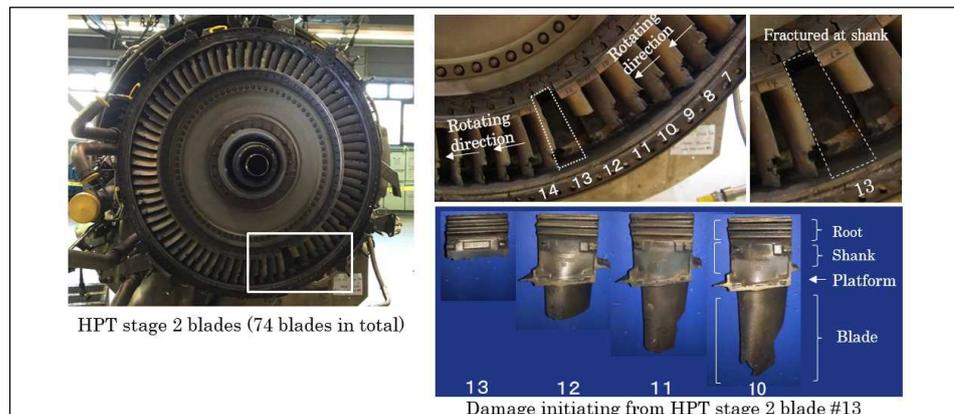
Figure 3: Condition of damaged blades of HPT stage 2

Among total 74 blades on HPT stage 2, blade #13 was fractured at the shank. Besides, blade #12 was fractured at the position of about half of the airfoil. Furthermore, the blade #11 and #10 were fractured near the tip of the blades. Other blades had tips chipped along the entire circle (see Figure 3).

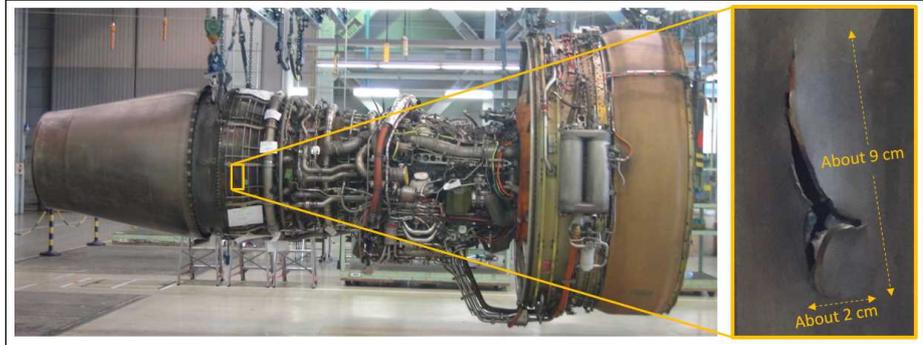
Figure 4: Hole (crack) generated on LPT casing

There was a hole (crack), which was about 9 cm long and about 2 cm wide, generated near LPT stage 4 (in the direction of around three o'clock if seen from the engine aft).

Besides, the core cowl*1 outside the hole generated on LPT casing was free from damage.

It is probable that damage to HPT stage 2, LPT and LPT casing was initiated by the fractured blade #13 of HPT stage 2, followed by a chain of fractures of blades and stator vanes of aft stages, fragments of which collided with LPT casing near LPT stage 4 and generated a hole.

Although the hole was generated on LPT casing, it is probable that fragments of the engine did not penetrate LPT casing because the inner surface of core cowl covering LPT casing was free from marks of collision with the fragments.

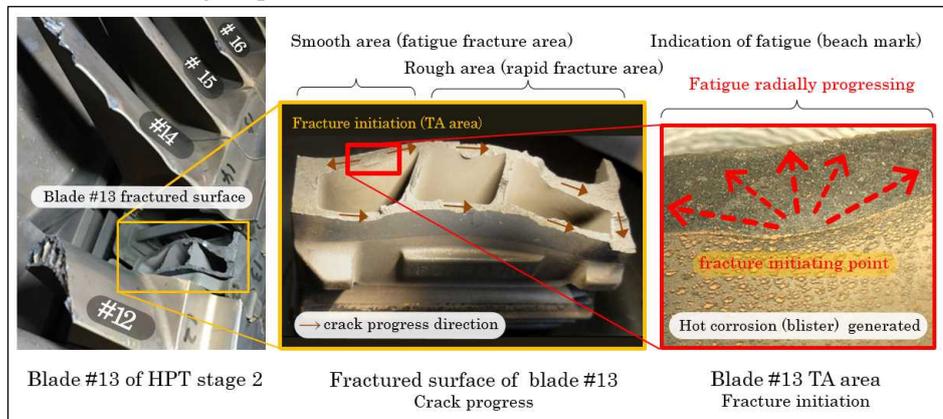
Figure 6: Fractured surface of the blade #13

There existed two different areas on the fractured surface of blade #13, a smooth area (fatigue fracture area) and a rough area (rapid fracture area). The fracture progressed from TA (Turning Around: branching and turning around of cooling air flowing inside blades) area as an initiating point in the air passage 1 in the smooth area, and the mark (beach mark) of indication of fatigue was observed.

It is highly probable that the fractured blade #13 was caused by cracks that were generated on TA (Turning Around (branching and turning around of cooling air flowing inside blades)) area and progressed thereafter.

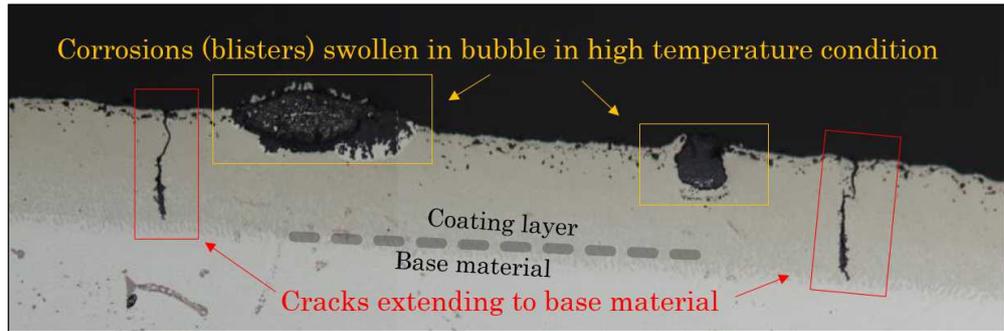
Figure 7: Coating layer near the fracture initiating point of blade #13
(cross sectional view)
(condition of cracks and corrosions of coating layer)

Besides, cracks were generated on aluminide coating layer*⁷ near the initiating point (see Figure 7), and corrosion (blister)*⁸ swollen in hot bubble was generated near the cracks. Detailed investigation into the fractured surface of the blade with Scanning Electron Microscope revealed the marks of low-cycle fatigue*⁹ that progressed from TA area. (See Figure 6 and 7) Blade shape and coating layer thickness met the design and manufacturing requirements.

It is somewhat likely that cracks generated on TA area were caused by hot corrosion swelling (blister) generated on the coating layer of the blades and low-cycle fatigue initiating from the cracks.

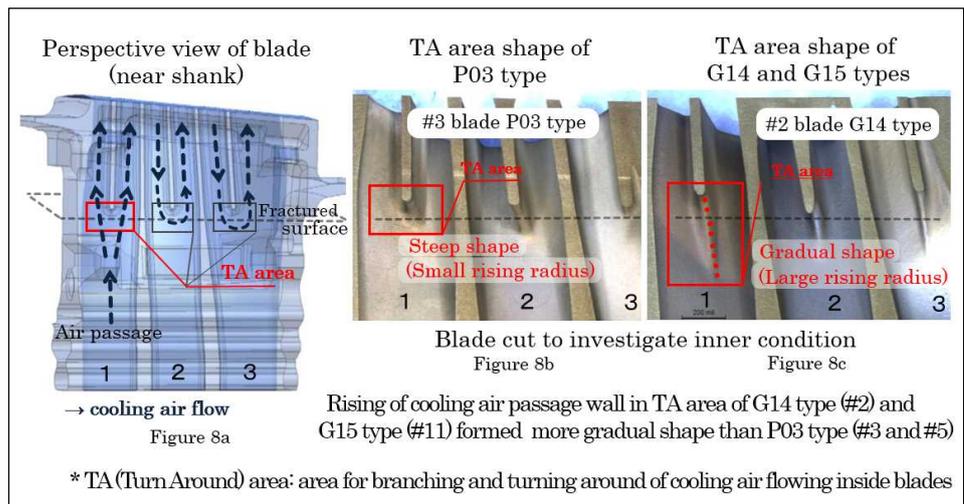
Figure 8: TA area condition of P03, G14 and G15 types

Measuring the coating layer thickness verified that these blades met the design and manufacturing requirements; however, blade #3, 5 and 13 were relatively thicker with cracks generated in the coating layers.

Besides, the coating layer of the blades was aluminide coating, which has a low thermal ductility, and therefore, is prone to generate cracks easily at lower temperatures when the coating layer is thick. TA areas of G14 Type and G15 Type had a thinner coating layer than P03 Type forming a gradual shape, which is prone to resist stress concentration. G14 Type and G15 Type were free from hot corrosions and cracks, which were generated in P03 Type.

had a relatively thicker coating layer (see Table 1 and Figure 8). It is somewhat likely that the thicker coating layer affected generation of cracks on the base materials because aluminide coating of blades has a low ductility with tendency to be prone to generate cracks when coating layer is thick.
