**AIRCRAFT SERIOUS INCIDENT
INVESTIGATION REPORT**

**JAPAN AIRLINES INTERNATIONAL CO., LTD.
J A 8 9 8 6**

BOEING 767-300, JA8986

ON RUNWAY 34L OF TOKYO INTERNATIONAL AIRPORT

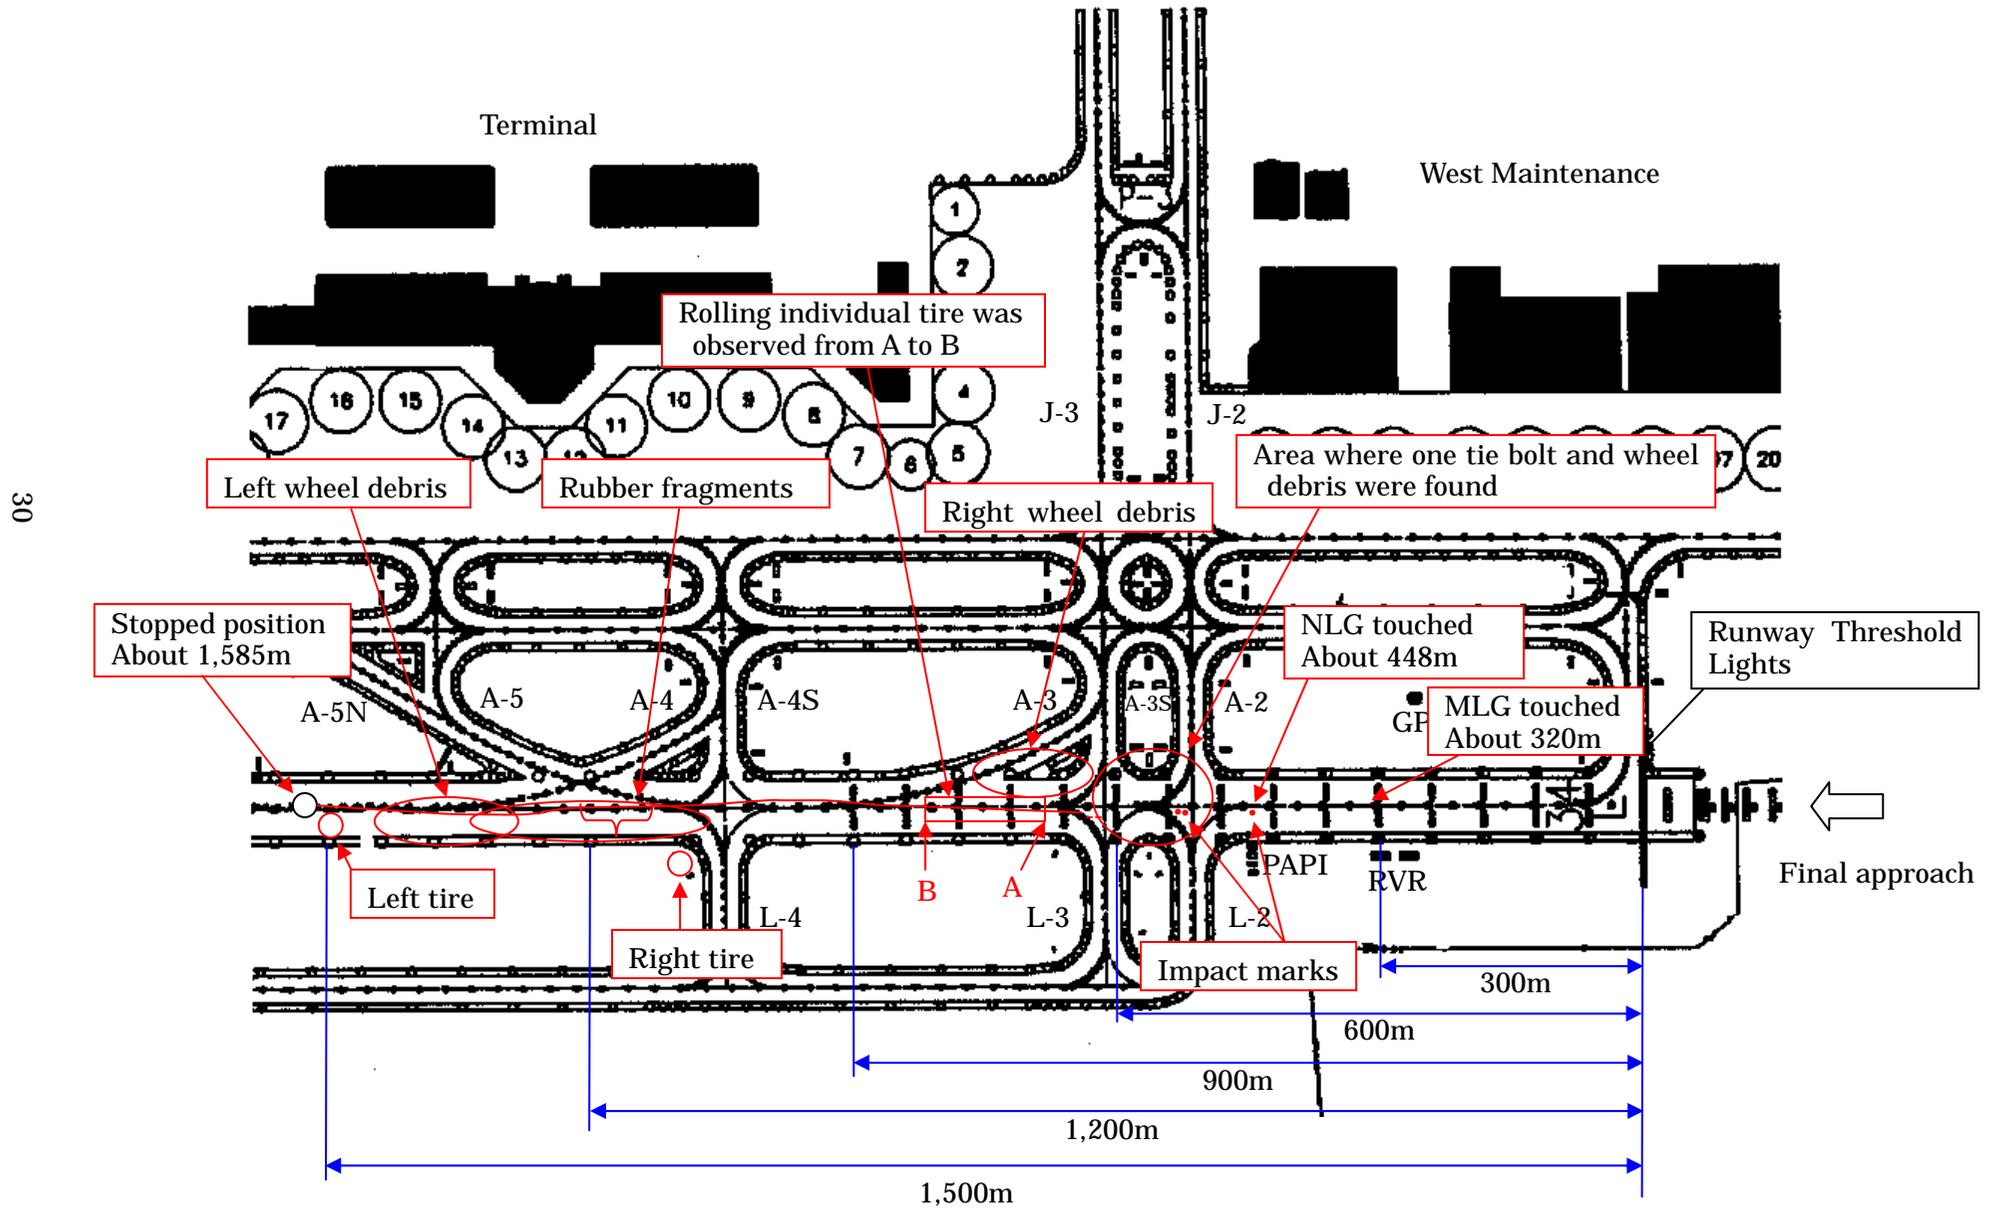
Figure 2 Scattered Debris

From around the area where the nose gear of the Aircraft is considered to have touched down to the point at which the Aircraft came to a stop, multiple wheel debris and tire fragments, as well as some parts of the nose gear were scattered on Runway 34L and on both sides of it. In addition, the right and left tires that were separated from the nose gear were separately found on the runway behind the Aircraft stopping position and on the side of the runway.

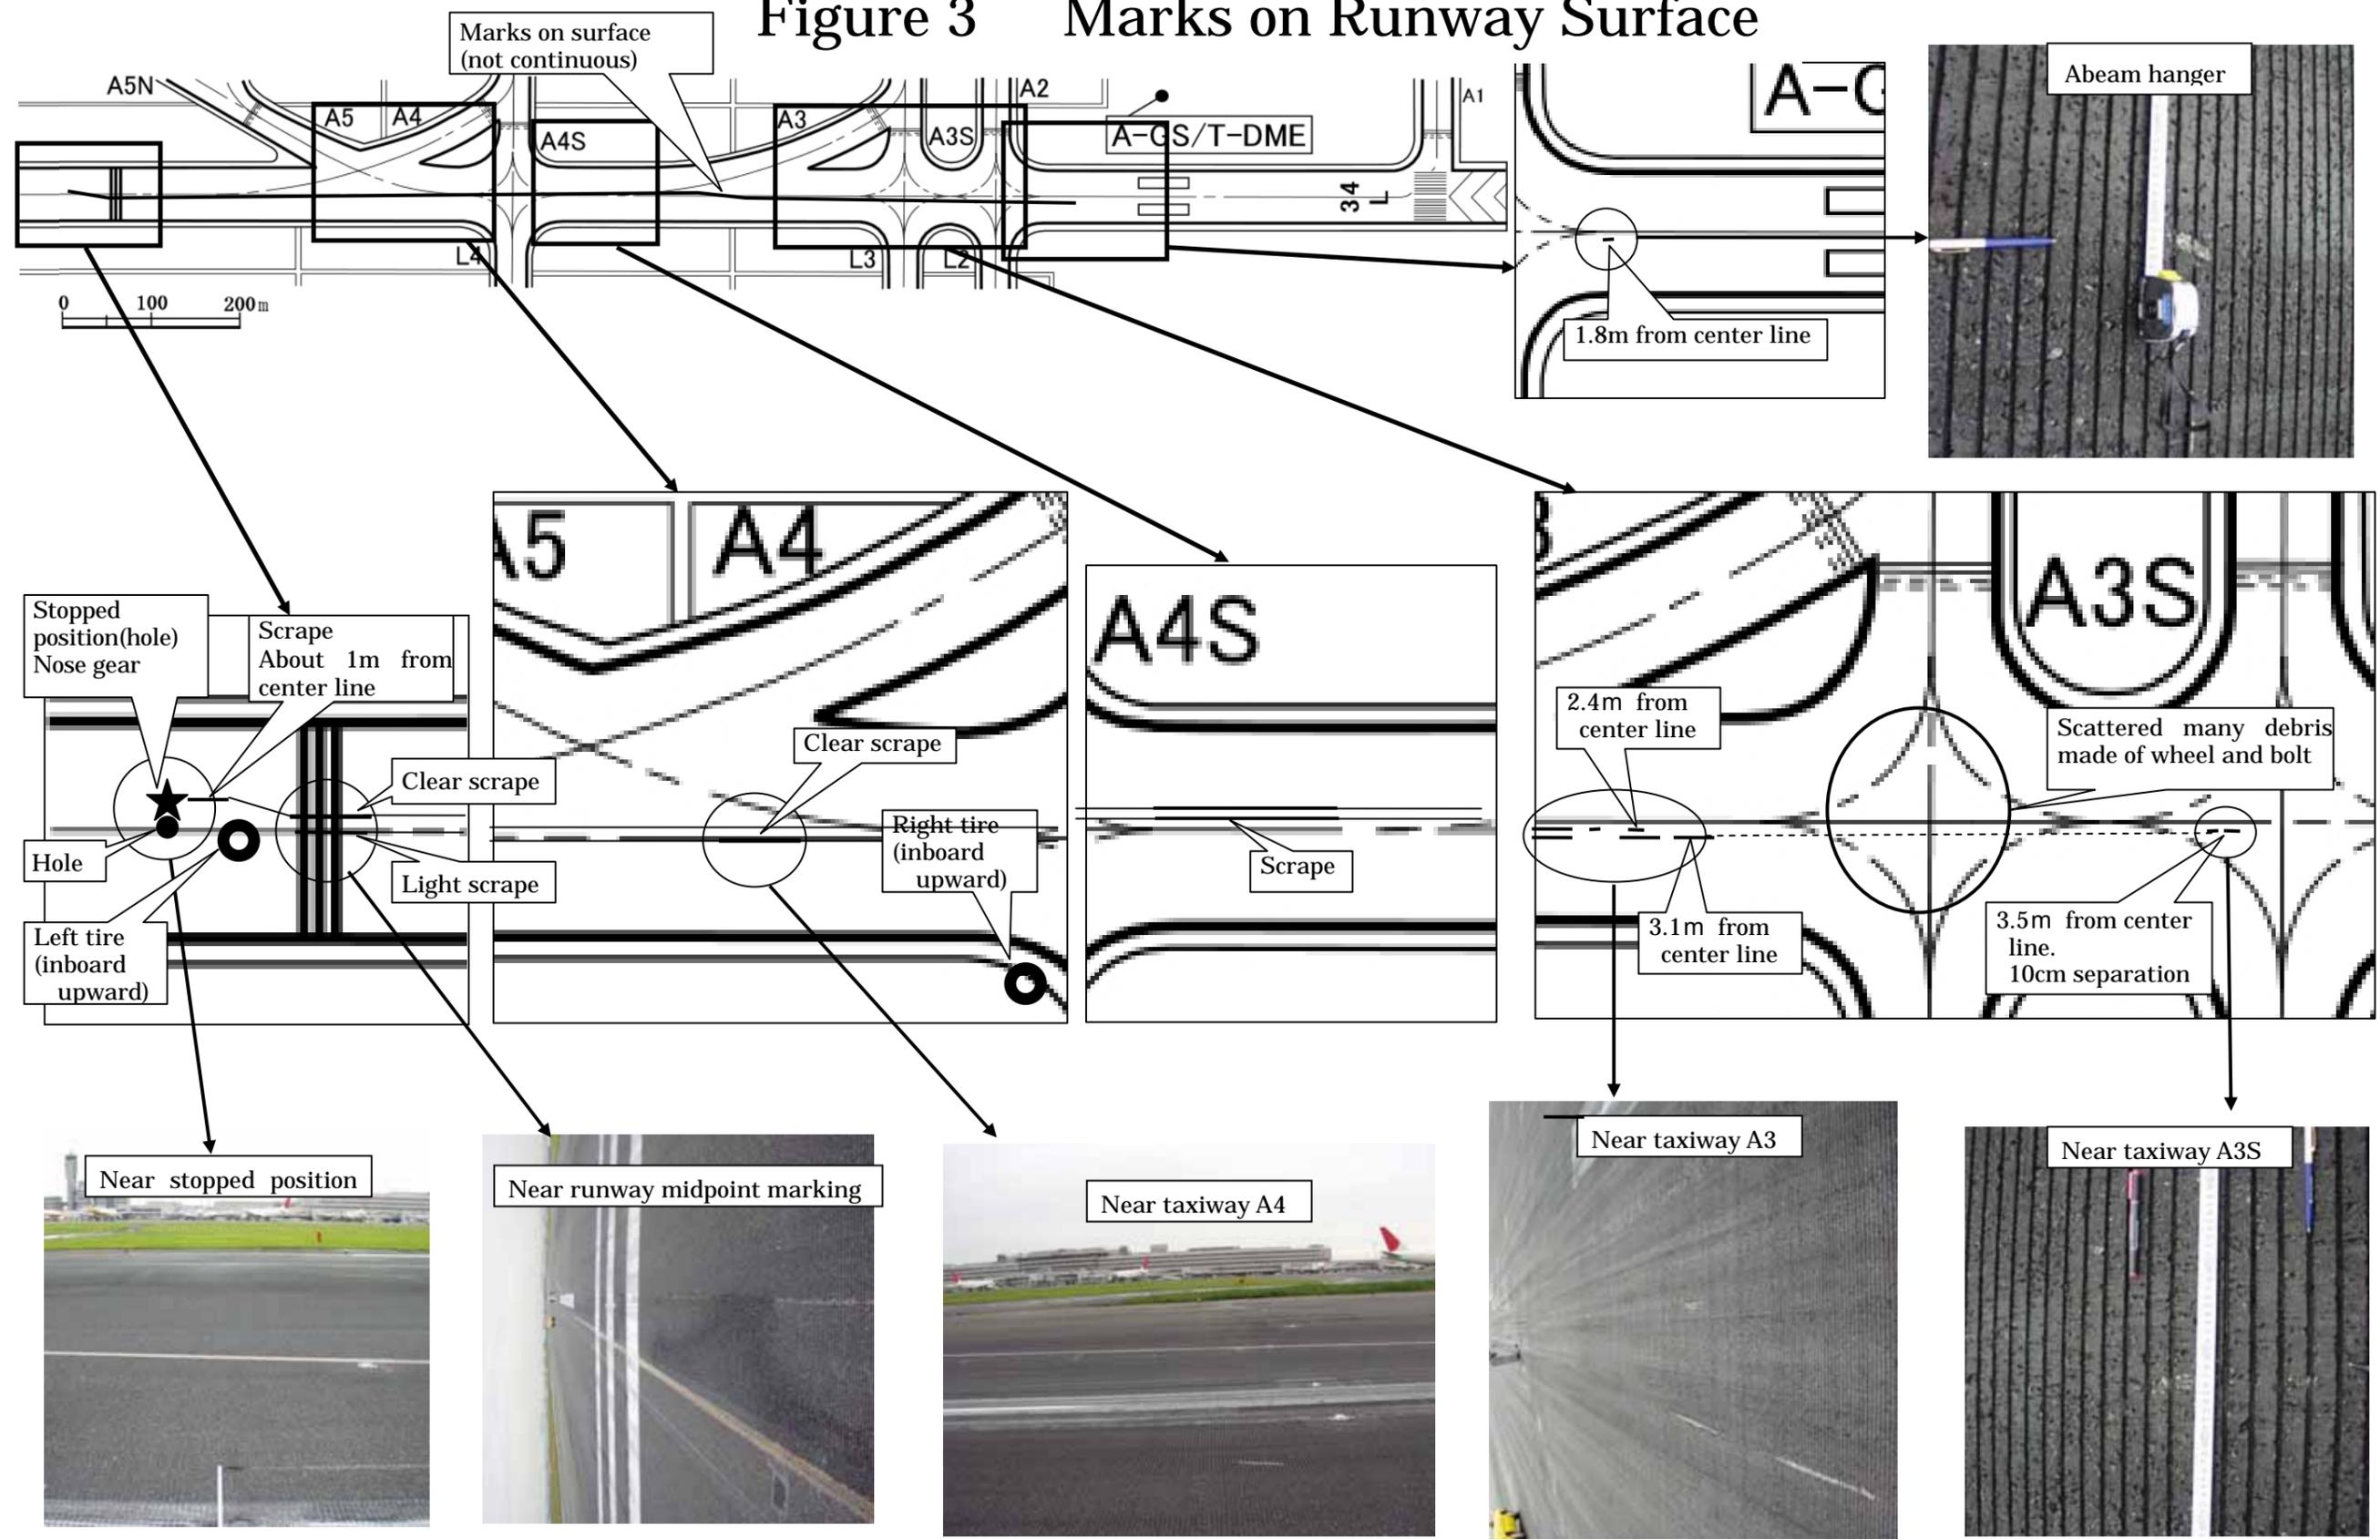
Figure 3 Marks on Runway Surface

As a consequence of landing roll of the Aircraft only by the wheels after the tires of the nose gear had been disengaged, scratch marks were left on the surface of Runway 34L, and eight runway centerline lights and nine taxiway centerline lights were broken.

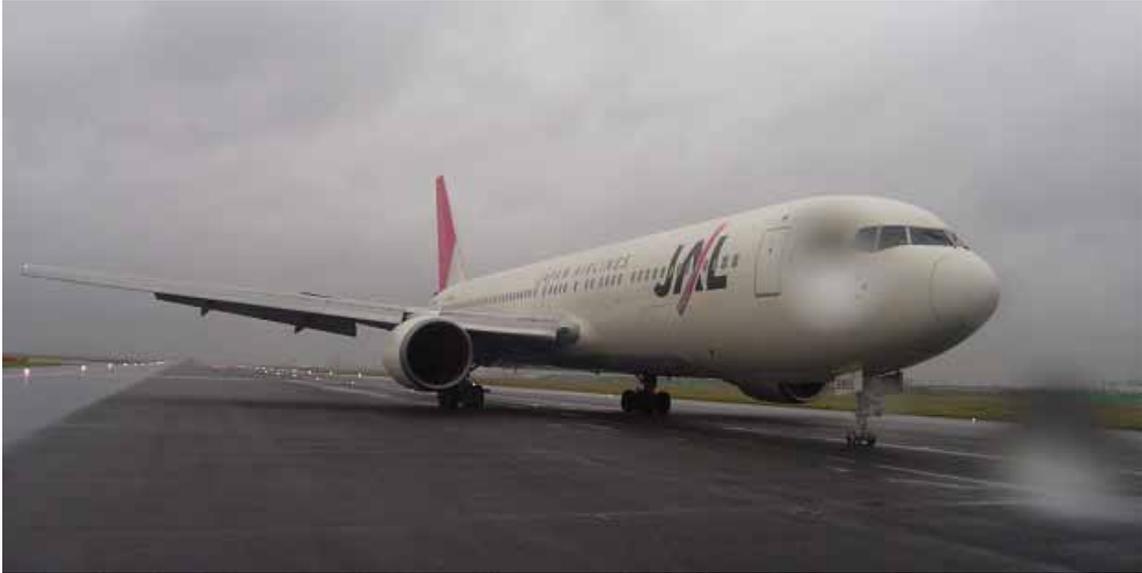
Photograph 1 Serious Incident Aircraft

The body and wings: The front skin, the right main wing leading-edge slat, and trailing-edge flaps of both the right and left wings, etc., were damaged.

There were scratch marks, impact marks, and other damages on the left and right sides of the forward fuselage.

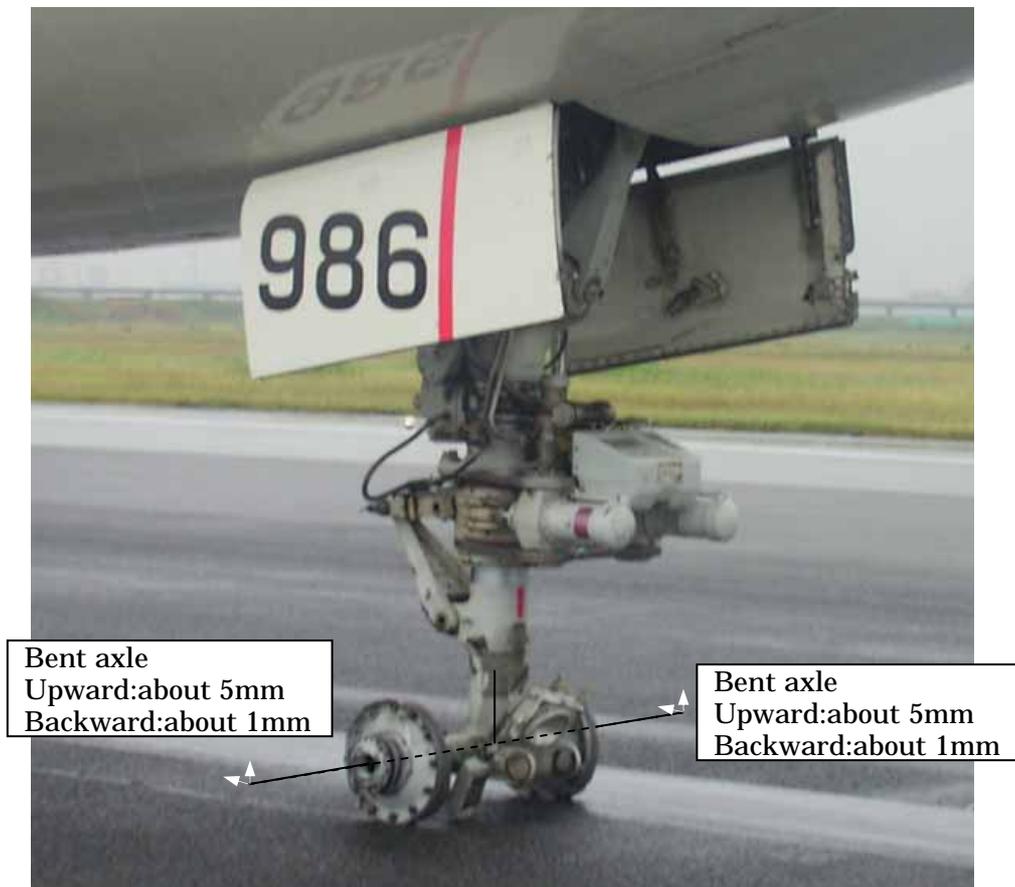
Photograph 2 Damaged Nose Gear

Nose gear: Damage to wheels, disengagement of tires, separation of and damage to peripheral accessories

Scratch marks of tire rubber were left inside the wheel mounts of both the left and right axles, and scratch marks were found on both sides of the left axle strut.

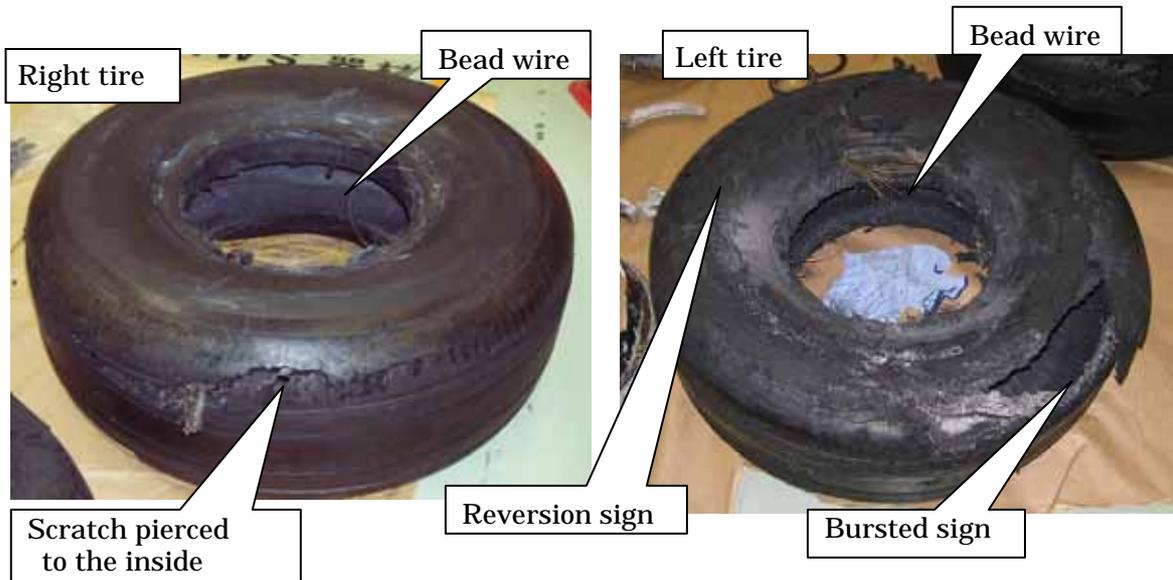
Photograph 3 Removed Both Nose Tires

The left tire was separated from the wheel, and found at approximately five meters behind where the Aircraft stopped. There were marks on the tire indicating it had burst.

The right tire was separated from the wheel, and found at approximately 420 meters behind where the Aircraft stopped. On the inside of the tire, marks which seemed to have been made by bottoming³ were found.

Moreover, the extent of the damage was investigated for each layer of the textile cord when samples were removed. The results showed that the right tire received extensive damage to the outboard and the left tire received damages on both the outboard and inboard.

Judging from the damages on the left and right tires and wheels, the order on disengagement of the tires is considered as follows:

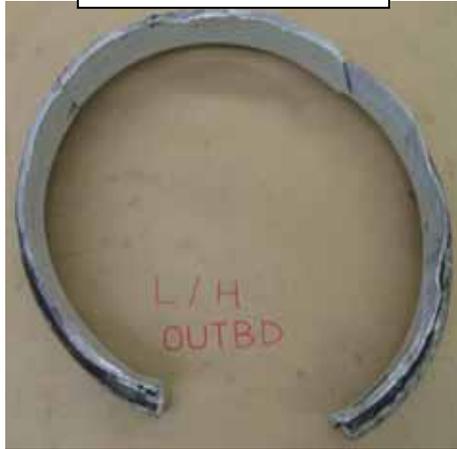
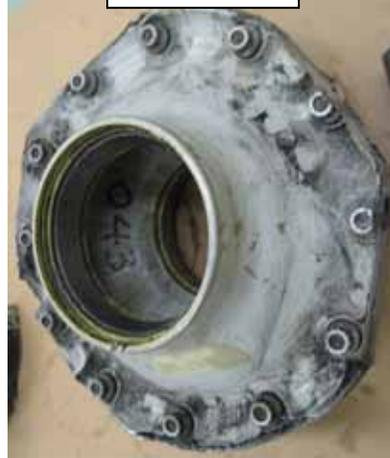
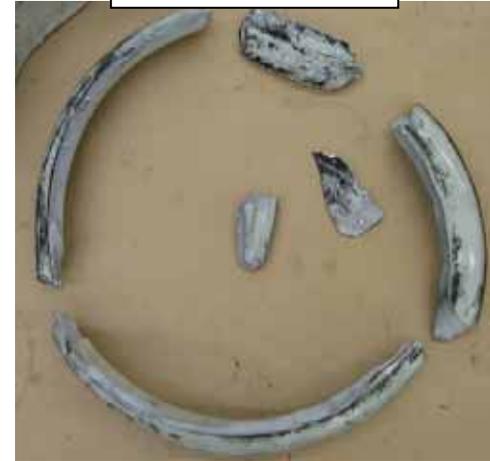
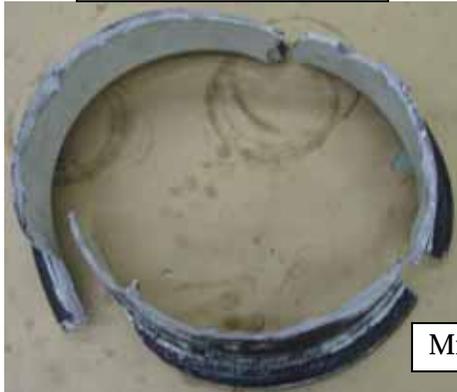
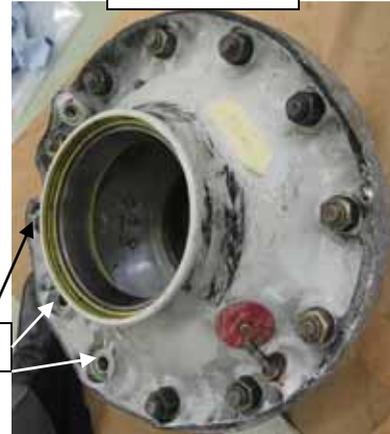
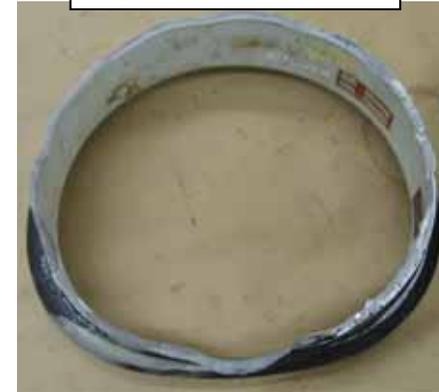
Photograph 5 Destroyed Nose Wheels

The peripheries of both the left and right wheels, both inside and outside, on all circumferences, were broken from their bases, and marks made by the Aircraft's rolling on the ground on the remaining wheels were left, however, the bolts were tightened normally and were not loose.

No defects were observed throughout all portions of the materials, and wave patterns that typically appear on a fracture surface in case of fatigue breaking were not confirmed. Furthermore, no appearance indicating the origin of breaking was confirmed, and dimple patterns⁴ were

confirmed extensively on all fracture surfaces, therefore it is judged that a ductile fracture⁵ occurred.

It is estimated that the bottoming of the tires occurred first and then the wheels were destroyed, because marks of bottoming were found inside the right tire by the appearance inspection on tires, and also because, based on the result of the actual load strength test described in 2.12.4, it is considered likely that the wheels would not be destroyed unless the bottoming of tires occurs.

It is estimated that both of inboard and outboard rims of the right wheel and the inboard rim of the left wheel were destroyed almost simultaneously the instant the nose gear touched down on the ground, and rolled for a while in a condition in which the outboard rim of the left wheel remained, and then the outboard rim of the left wheel was eventually destroyed, because there was a mark of damage only on the outboard rim of the left wheel, which indicates that the left wheel rolled on the runway surface.
