**AIRCRAFT ACCIDENT  
INVESTIGATION REPORT**

**S·G·C SAGA AVIATION CO., LTD.  
J A 9 2 5 2**

CRASH AFTER CONTACT WITH A POWER LINE  
S·G·C SAGA AVIATION CO., LTD.  
AEROSPATIALE AS350B, JA9252  
CHIKUSEI CITY, IBARAKI PREFECTURE, JAPAN  
AT ABOUT 08:18 JST, JULY 29, 2019

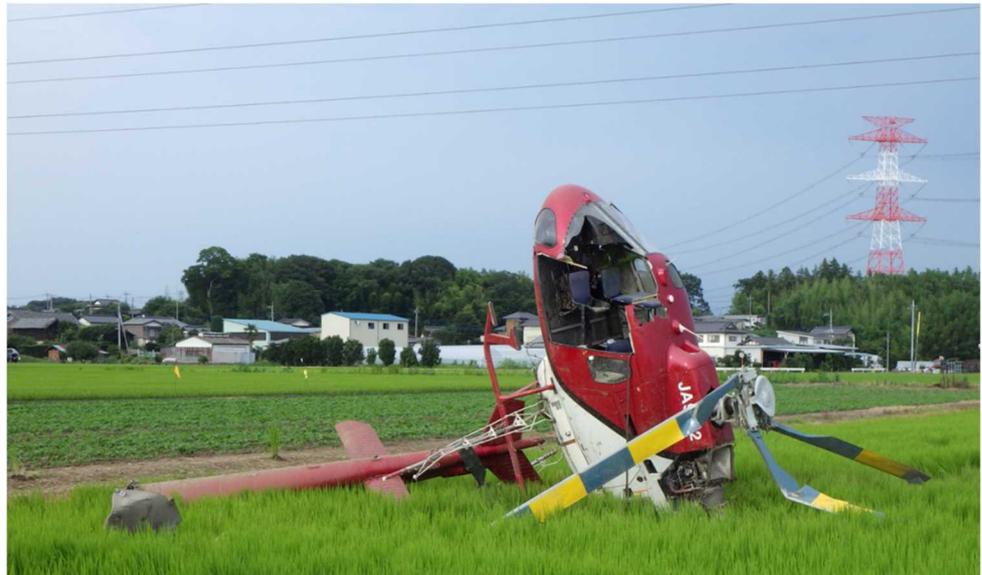
Figure 2: Damage situation of the crashed rotorcraft

(1) Extent of damage: Destroyed

(2) Damage to the Rotorcraft Components

- Forward fuselage, frame: Damaged, deformed
- Main rotor blades: All three damaged
- Tail boom: Separated at the connecting part to the fuselage and damaged
- Tail rotor blades: Damaged
- Landing gear: Damaged
- Pesticide spray apparatus: Damaged

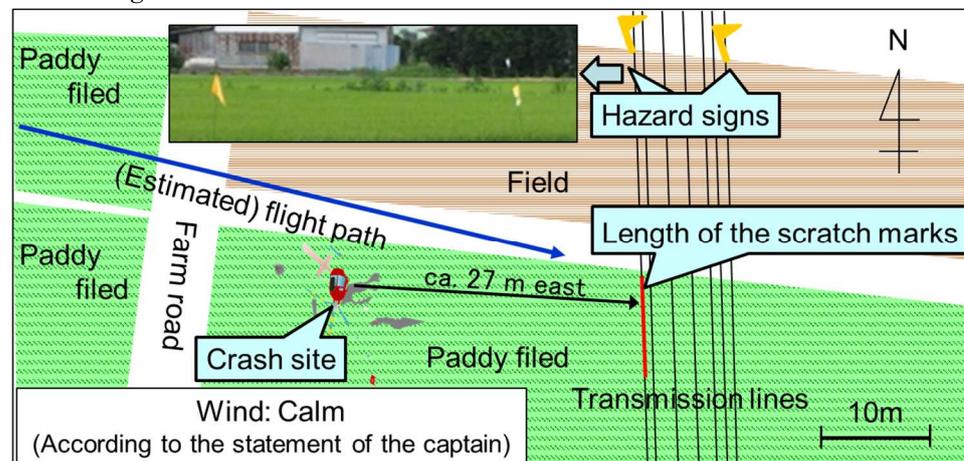
Figure 3: Condition diagram of hazard signs and accident site

On the other hand, the hazard signs at the accident site were installed almost immediately under the outermost power line at intervals of more than 100 m. On the day of the accident, the captain did not request the Official to add the hazard signs or change its location, thinking he should use the hazard signs as a reference for the location of power lines.

The crash site of the rotorcraft was a paddy field where the fuselage of the rotorcraft was lying with its nose facing up, and its tail boom was separated from it. And debris of the rotorcraft were found scattered around the fuselage.

On the east side of the crash site, there are six power lines and an overhead ground wire running in a north-south direction. Among those lines, on the closest to the crash site, scratch marks were recognized. This power line with the scratch marks was located about 27 m east side of the crash site and the length of the scratch marks was about 10 m and its height from the ground was about 14 m.

In the vicinity of the accident site, the hazard signs were installed almost just under the outermost power line.

It is somewhat likely that if the hazard signs had been located 50 m away from the power lines and installed at intervals of 30 to 50 m in parallel with the power lines as shown for one in the Guideline, the captain might have been able to correctly identify the position of the rotorcraft before getting closer to the power lines.

② Installation of the hazard signs

The persons representing their respective area who is in charge of installing the hazard signs shall be instructed to install the signs in accordance with the examples shown in the

Guideline. In addition, it shall be ensured that each official thoroughly confirm with the captain about the addition or location change of hazard signs at the site investigation to be conducted with the captain.

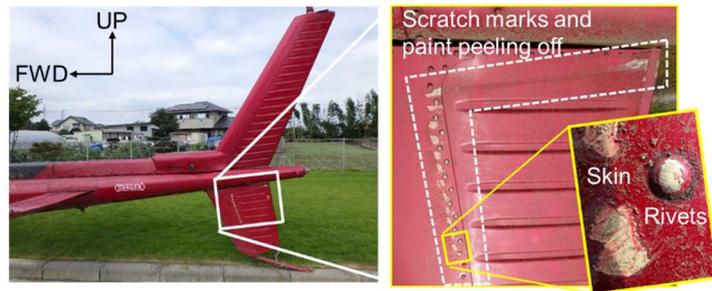
Figure 4: Condition of damage to the rotorcraft and the power line

Several scratch marks and airframe paint peeling off were found on the left outer skin of the lower fin of the vertical stabilizer (hereinafter referred to as “the Fin”) and a part of the rivets.

Several scratch marks and paints, and some frayed were observed on the power line.

The rotorcraft (Fin)

Transmission line

The captain applied cyclic stick to the right aft in order to avoid contact with the power lines because while flying for a pesticide spray at an airspeed of about 30 kt, about 12 m AGL, he visually recognized the power lines ahead on the left side in a position slightly higher and a short range. It is highly probable, however, that as the rotorcraft had been already coming too close to the power lines at that time, the left side of the Fin contacted with the power line during the evasion, and the rotorcraft lost its balance and crashed.

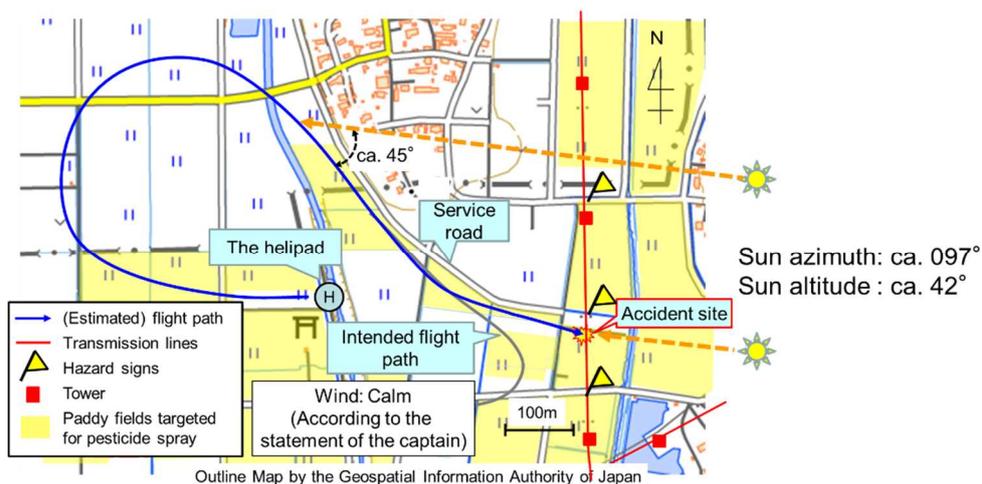
Figure 5: (Estimated) flight route

When the captain started the 15th pesticide spray operation, the sun's position was about 45° to the left from the heading (southeast) of the rotorcraft. It is somewhat likely, however, that the heading of the rotorcraft had been gradually changing to the east as the rotorcraft was spraying along the service road, it came to face the sun almost straight in the vicinity of the power lines, and therefore, it became difficult for the captain to visually recognize the power lines due to the backlighting. (See Figure 5)

b Full dissemination to all flight crew about ban on flying sunward

Make thorough complete ban on flying sunward. Even with some changes in the spraying order in the flight operation plan, it shall be ensured that every flight crew clearly understands that flying sunward means flying in the backlit state, which may make it difficult to identify obstacles like power lines, resulting in a collision accident
