**AIRCRAFT ACCIDENT
INVESTIGATION REPORT**

**YUUHI AVIATION COMPANY LIMITED
AEROSPATIALE AS350B, JA9445
YAMAGATA AIRPORT, JAPAN
JUNE 2, 2004**

**YUUHI AVIATION COMPANY LIMITED
AEROSPATIALE AS350B, JA9445
CRASH DURING AN AUTOROTATION LANDING
DUE TO FUEL STARVATION
YAMAGATA AIRPORT, YAMAGATA PREFECTURE, JAPAN
AT ABOUT 11:34 JST, JUNE 2, 2004**

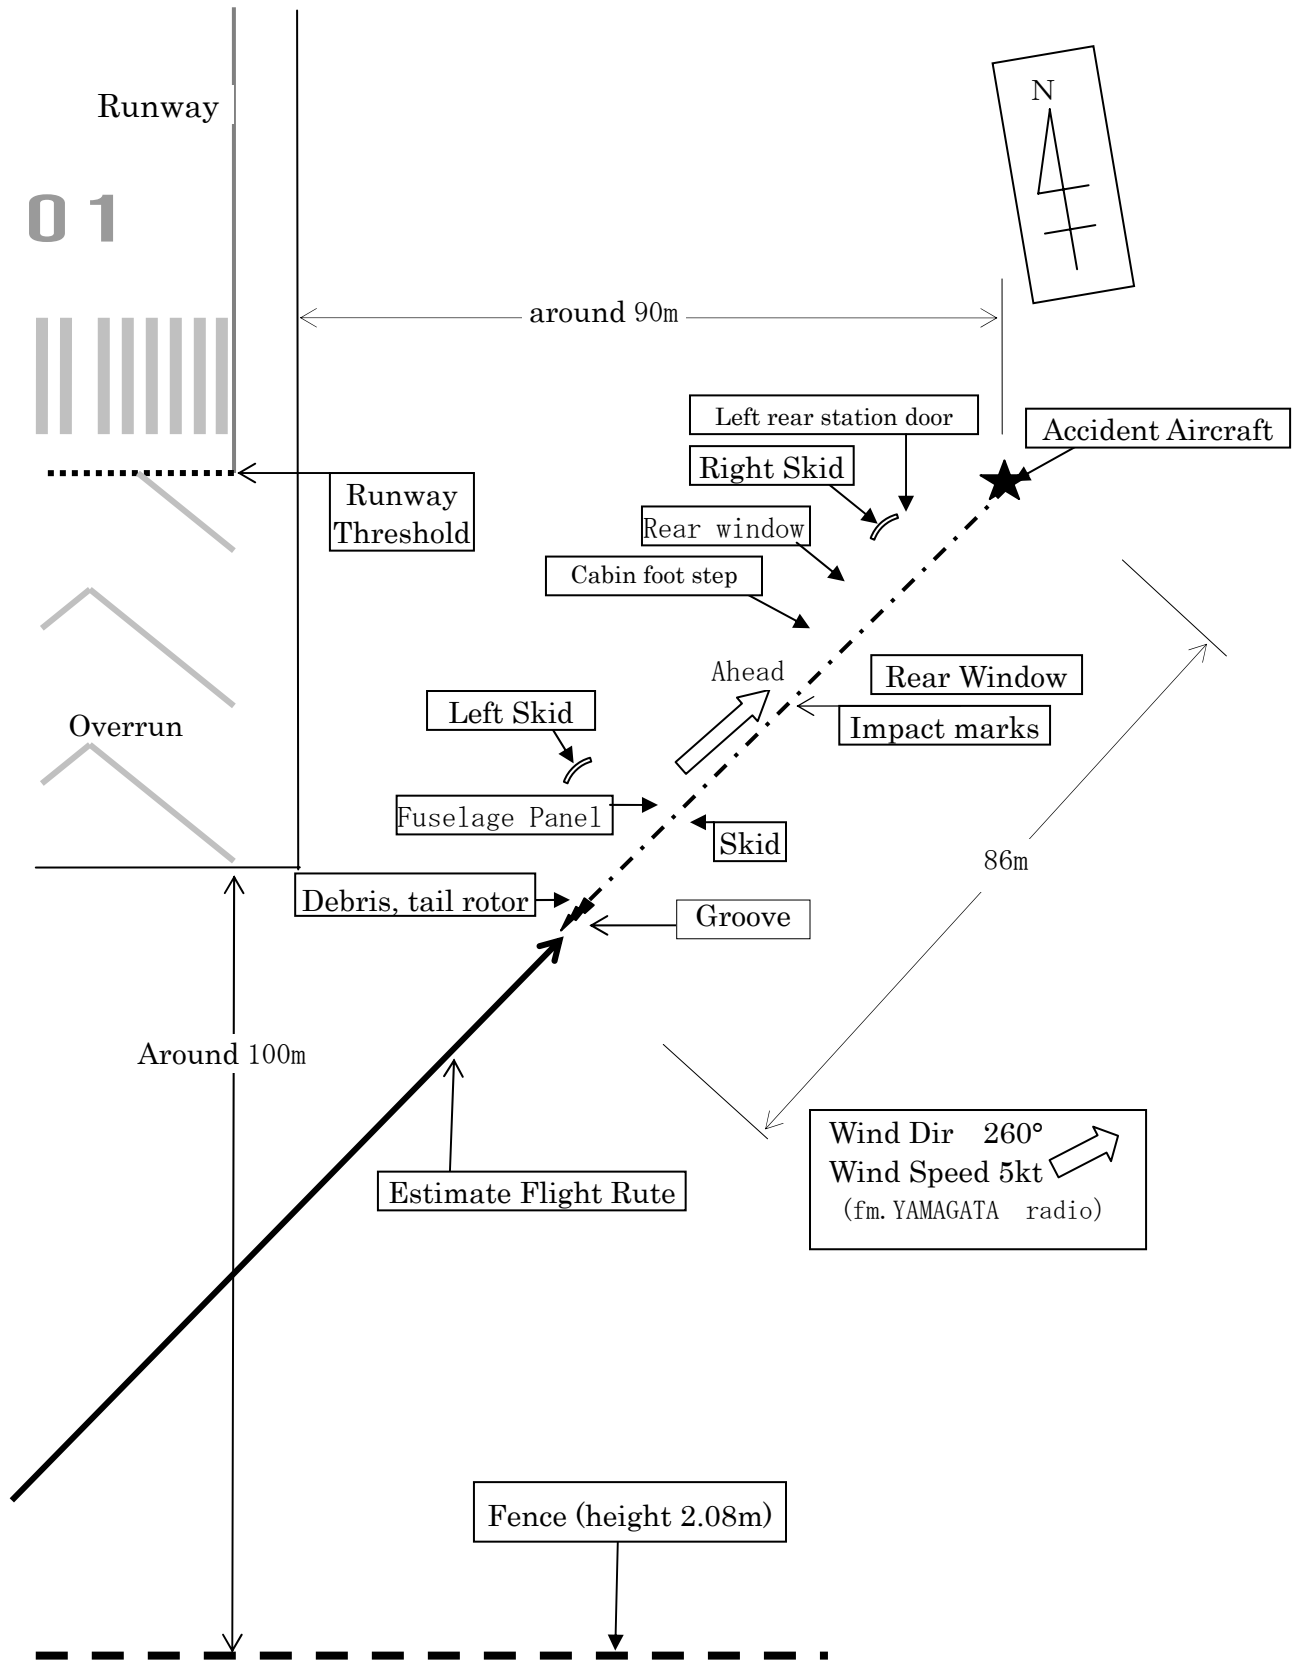
Figure 2 Accident Site Layout

The site of the accident was at Yamagata Airport around 90m east of the threshold of runway 01. There was a sharply excavated groove around 80cm long and around 20cm deep in the grass field 86m southwest of the point the aircraft came to rest. Tail rotor blades fragments were found around 3m left of this groove. Tracks continued 86m from around the groove to the position of the aircraft, and fragments of the fuselage were scattered to the left and right side of the tracks.

The aircraft came to rest rolled onto its left side pointing opposite to the direction of travel, and traces of a small amount of fuel leakage were found.

The tail boom had separated at its fuselage attachment, and traces of hydraulic fluid leakage were found.

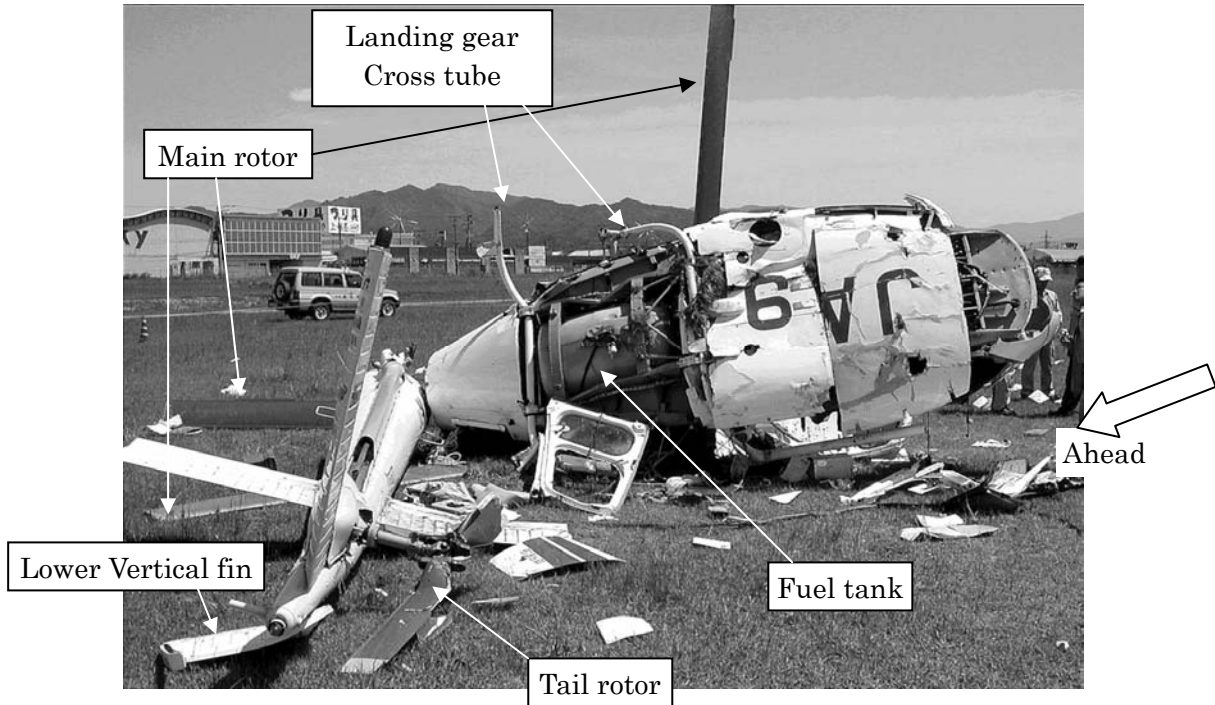
(1)

The nose section was deformed, the windshields had been broken and lost, and both cockpit doors had come off. The right side of the fuselage-strengthening X-frame had been destroyed.

The lower part of the fuel filler port was damaged, and the fuel tank was empty. The star-flex sections of the main rotor hub assembly were broken at three locations, but there was no substantial damage to the main rotor blades.

Both the left and right landing gear skids were damaged, and the cross tubes installed with the left and right skids were greatly deformed.

The tail boom had separated at its attachment to the fuselage, and the tail hydraulic pipe was broken. The lower vertical tail fin had been bent left through around 90°, but otherwise

there was no substantial damage. One of the tail rotor blades was fractured at the mid section.
(See Photographs.)
