**AIRCRAFT SERIOUS INCIDENT  
INVESTIGATION REPORT**

**NAKANIHON AIR SERVICE CO., LTD.  
J A 9 6 6 0**

**May 30, 2019**

<b>Company Name</b>	Nakanihon Air Service Co., LTD.
<b>Type, Registration Mark</b>	Aérospatiale AS332L (Rotorcraft) JA9660
<b>Incident Class</b>	Dropping of Object during External Cargo Sling Operation Item 15, Article 166-4 of the Ordinance for Enforcement of Civil Aeronautics Act of Japan
<b>Date and Time of the Occurrence</b>	At about 12:12 (JST: UTC + 9hrs, unless otherwise stated all times are indicated in JST on a 24-hour clock), August 21, 2018
<b>Site of the Incident</b>	Fukushima-town, Matsumae-gun, Hokkaido Prefecture (41°26'39" N, 140°13'03" E)

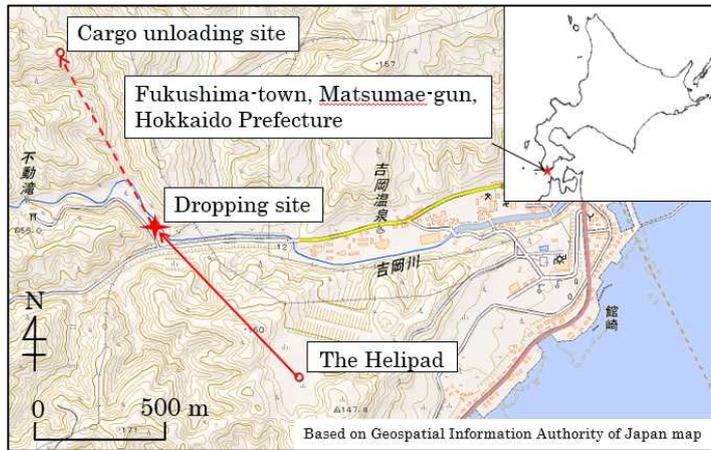
Figure 1: Estimated Flight Route

(1) History of the Flight (See Figure 1: Estimated Flight Route.)

In order to transport materials for tower construction, the aircraft lifted three cargos at the cargo loading site of the Helipad, and commenced to fly toward the cargo unloading site located about 1.5 km northwest of the Helipad.

When the aircraft crossed over a tower and started descending at a speed less than 50 kt, the on-board mechanic noticed that the blue sheet wrapping the cable was protruding from a gap near the knot of cargo net and fluttering in the wind. As the cable was being gradually exposed from the blue sheet, the captain reduced the speed to about 40 kt or less so as not to drop the cargo. When the aircraft slowed to its speed close to hovering, the blue sheet and the cable dropped in the mountain forest from about 130 m above the ground.

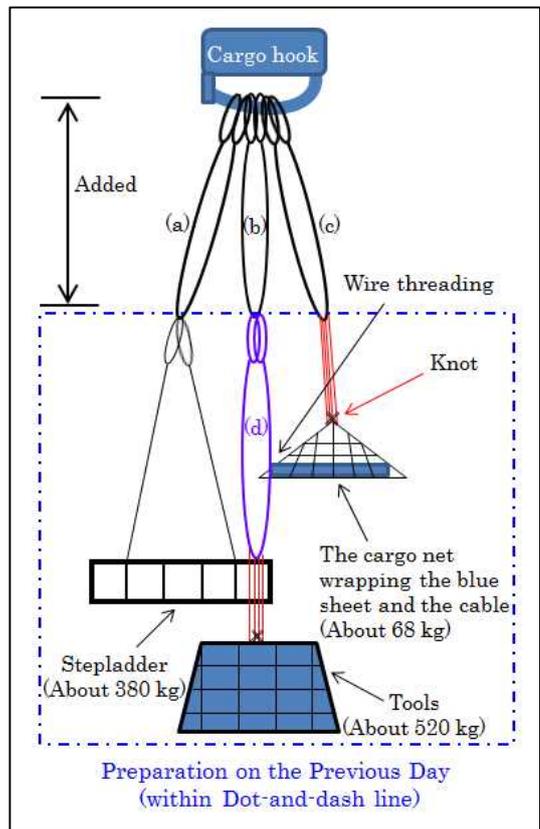
Figure 2: Planned Packing Style

(2) Planned Packing Style (See Figure 2: Planned Packing Style.)

In the preparation made on the previous day, the blue sheet and the cable were wrapped in a 4 meter square cargo net by tying to each other its diagonal handles at the four corners. In addition, in order to avoid interference between the three cargos (for cable, stepladder and tools) to be slung, one wire (d) was additionally attached to the tools’ cargo to adjust the

On the day of the incident, the captain instructed the three ground workers to attach the additional wires (a, b and c) for the cargos in order to ensure the safe clearance between the aircraft hovering over the unloading site and the trees at the site, and to thread the wire (d) through the side of the cargo net wrapping the cable (hereinafter referred to as “the Wire Threading”) in order to prevent the lightweight cable from being shaken by wind pressure during flight.

After adding the wire (c) and finishing the Wire Threading, one of the ground workers recalled another work to do, therefore, he left the site in the middle of a series of work. And after finishing the work he recalled, the ground worker returned and added two wires (a, b). Herewith, the sling wires for the three cargos were extended and only the tools’ cargo was to be slung by the two wires (b, d).

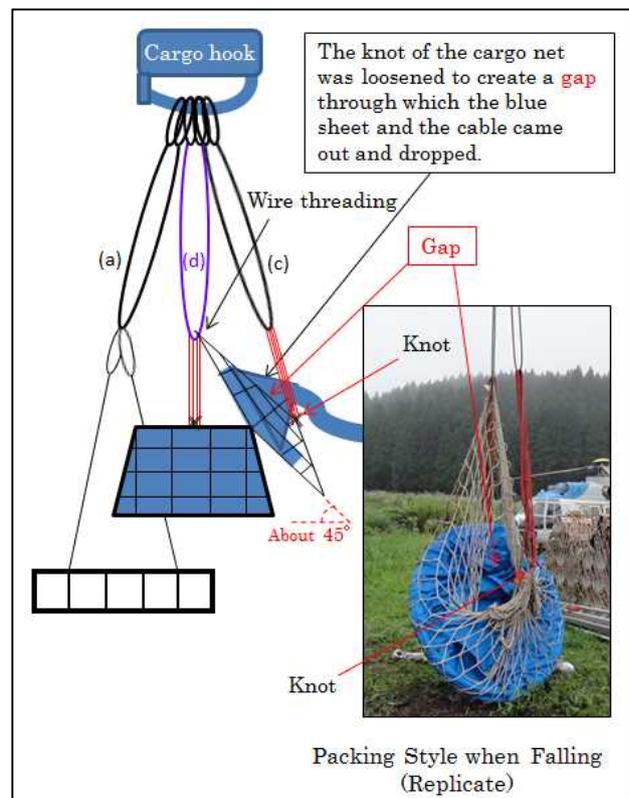
Figure 3: Actual Packing Style

### (3) Loading Operations (See Figure 3: Actual Packing Style.)

The three ground workers hooked the three cargos one by one on each hook. But when hooking the wire for the tools’ cargo, the ground worker who had added one wire (b), presumed that he might have attached one extra wire, therefore, he removed the added wire (b) and hooked the wire (d) on the cargo hook.

When the three cargos were lifted up by the aircraft, the Wire Threading part was also pulled up, and the cargo net wrapping the cable was tilted by about 45 degrees.

When confirming the packing style after the cargos were lifted up, the captain did not notice that the cargo net wrapping the cable was being tilted, despite his looking at the cargos by a rearview mirror at the bottom of the cockpit. The three ground workers and the on-board mechanic noticed that the cargo net wrapping the cable was being tilted, but having judged “there would be no problem with this kind of inclination”, they informed the captain a signal of “OK”, thus the aircraft commenced to transport the cargos.

It is probable that the ground worker, who added the wires (a, b and c), removed the wire (b) that he had added, because the memory of the planned packing style became unclear due to the interruption of his work, which misled him to thinking that he might have attached one extra wire for the tools’ cargo. Therefore, it is somewhat likely that because the wire length of the tools’ cargo became short, the Wire Threading part of the cargo net was pulled up, and therefore, the knot of cargo net was loosened to create a gap.

Regarding why the knot of cargo net was loosened to create a gap, the wire was threaded through the other cargo net wrapping the cable; moreover, it is somewhat likely that because the aircraft flew with the cargo net tilted as the part of the Wire Threading was pulled up, since the total length of the sling wire for the tools' cargo was short rather than the planned length.

It is necessary to check the packing style at the beginning of the transportation, but immediately terminate the transportation when finding the packing style improper such as being tilted with slung cargo, and unload the cargo to check the packing condition, because it is possible that the cargo may drop or collapse due to wind pressure during flight if an aircraft transports the cargo in an improper packing style. In addition, it is also effective to tighten the gap leading the knot of cargo net in order to prevent the cargo from collapsing or dropping.

- (1) When multiple cargos are slung at the same time, if there is something wrong in the packing style in the suspended state, including the case where the slung cargo is significantly tilted, the cargo shall be unloaded on the ground to reconfirm the packing condition.
- (2) When a cargo is wrapped in cargo net, another cargo net shall be used to cover the wrapped cargo, or the gap leading the knot of cargo net shall be tightened. Unless those measures are taken, the cargo shall not be transported.
