AA2020-2

**AIRCRAFT ACCIDENT
INVESTIGATION REPORT**

**TOHO AIR SERVICE CO., LTD.
J A 9 6 7 2**

**UNCONTROLLED CRASH
TOHO AIR SERVICE CO., LTD.
AEROSPATIALE AS332L (ROTORCRAFT),
REGISTERED JA9672,
IN UENO-MURA, TANO COUNTY,
GUNMA PREFECTURE, JAPAN
AROUND 14:29 JST, NOVEMBER 8, 2017**

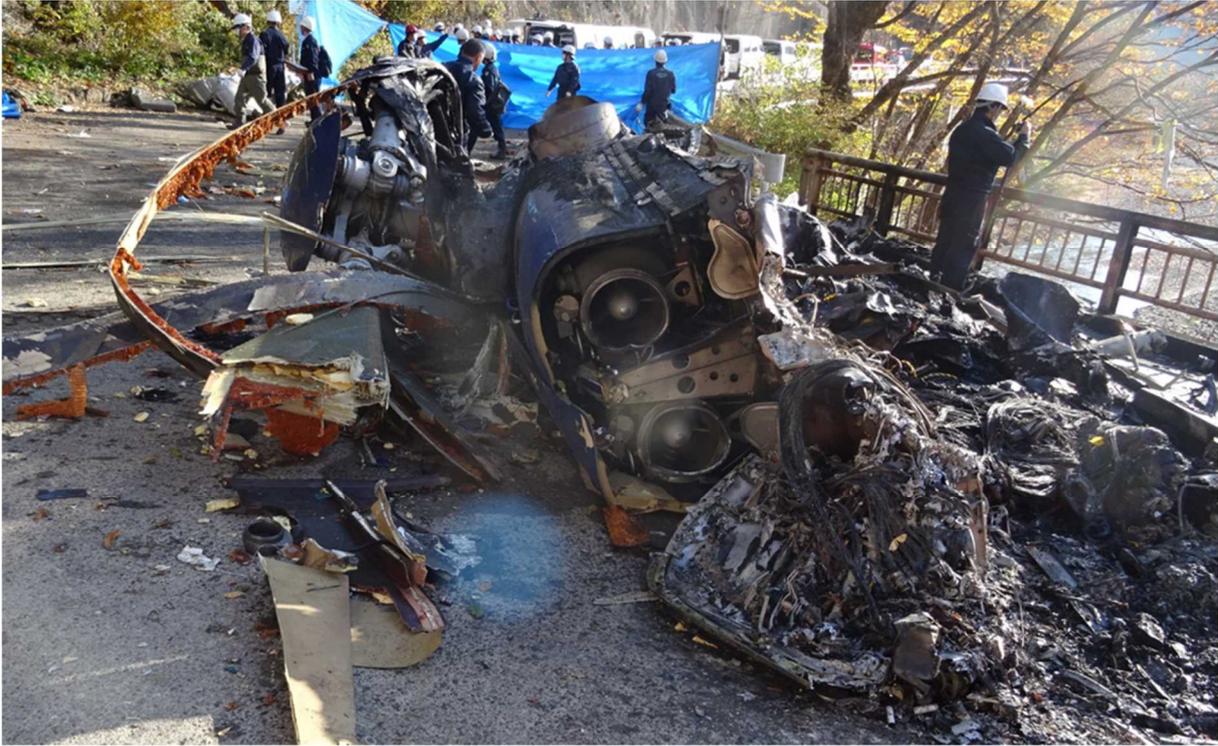
- (1) Fuselage: burned out
- (2) Tail assembly: separated and damaged
- (3) Engines: damaged and deformed
- (4) Rotor system: damaged
- (5) Control system: partially burned out system out in fuselage, and damaged in tail boom

Figure 7: Damaged airframe conditions at the accident site

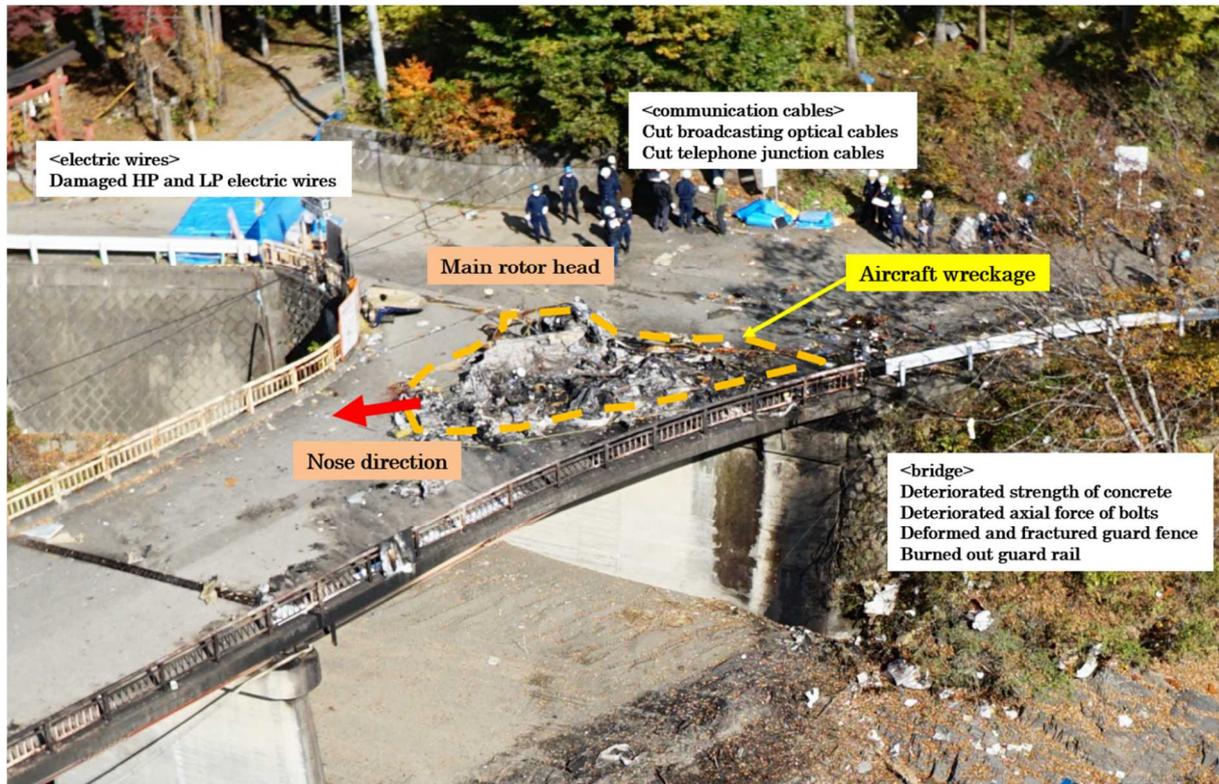
- Deteriorated concrete strength and axial force of bolts
- Deformed and fractured guard fence
- Burned out guard rail

- Damaged high voltage and low voltage electric wires
Damaged wires caused blackout in Ueno-mura from 14:29 until 16:19.
- Cut broadcasting optical cables
- Cut telephone junction cables

Figure 8: Damaged conditions other than the Aircraft

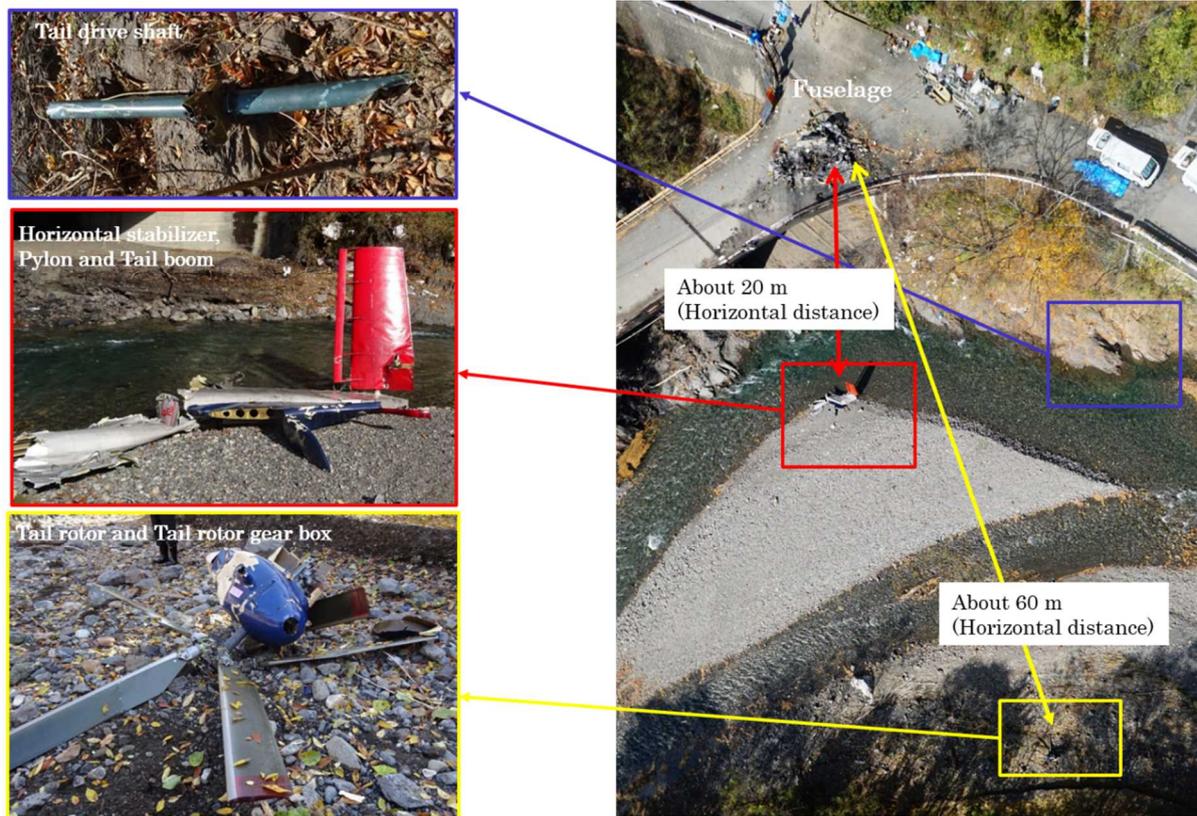
- The tail boom dropped on the location about 20 m away from the airframe and the tail rotor dropped on the location about 60 m away from the airframe, respectively.
- The tail boom had two contact marks with the MRB and was fractured into pieces as shown in Figure 10.
- Third and sixth tail rotor drive shafts had contact marks with the main rotor that fractured them. (See Appended Figure 5: Tail Rotor drive shaft had contact marks)
- The tail rotor drive shaft had contact marks with the drive shaft guide, twisted at the joint and separated.
- Upper section of the inclined drive shaft had contact marks with the pylon fairing.
- The spindle bolt at the flapping hinge of the White Blade of the tail rotor was fractured and the White Blade slid off from the hinge (see Figure 11: Fractured spindle bolt of the White Blade).

Figure 9: Locations where major parts of tail assembly were found

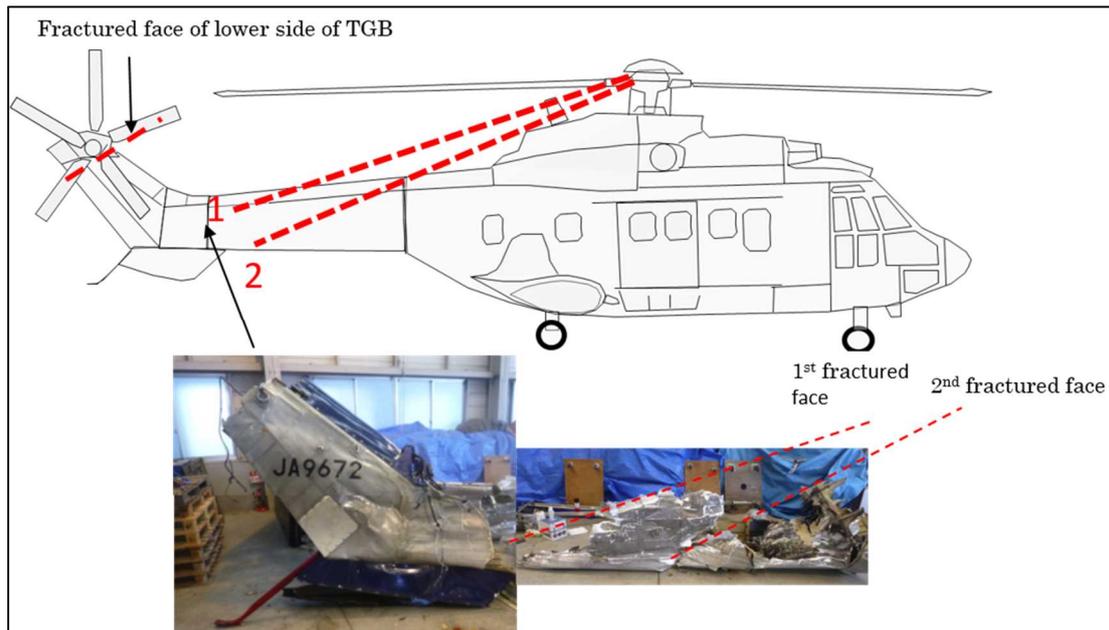
Figure 10: The sections of airframe and its lower side of TGB fractured by main rotor

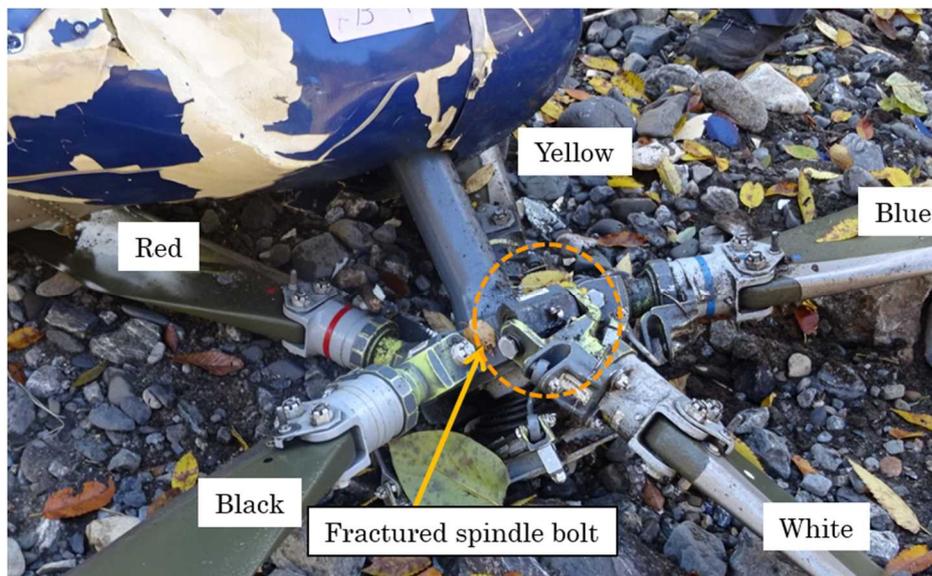
Figure 11: Fractured spindle bolt of the White Blade

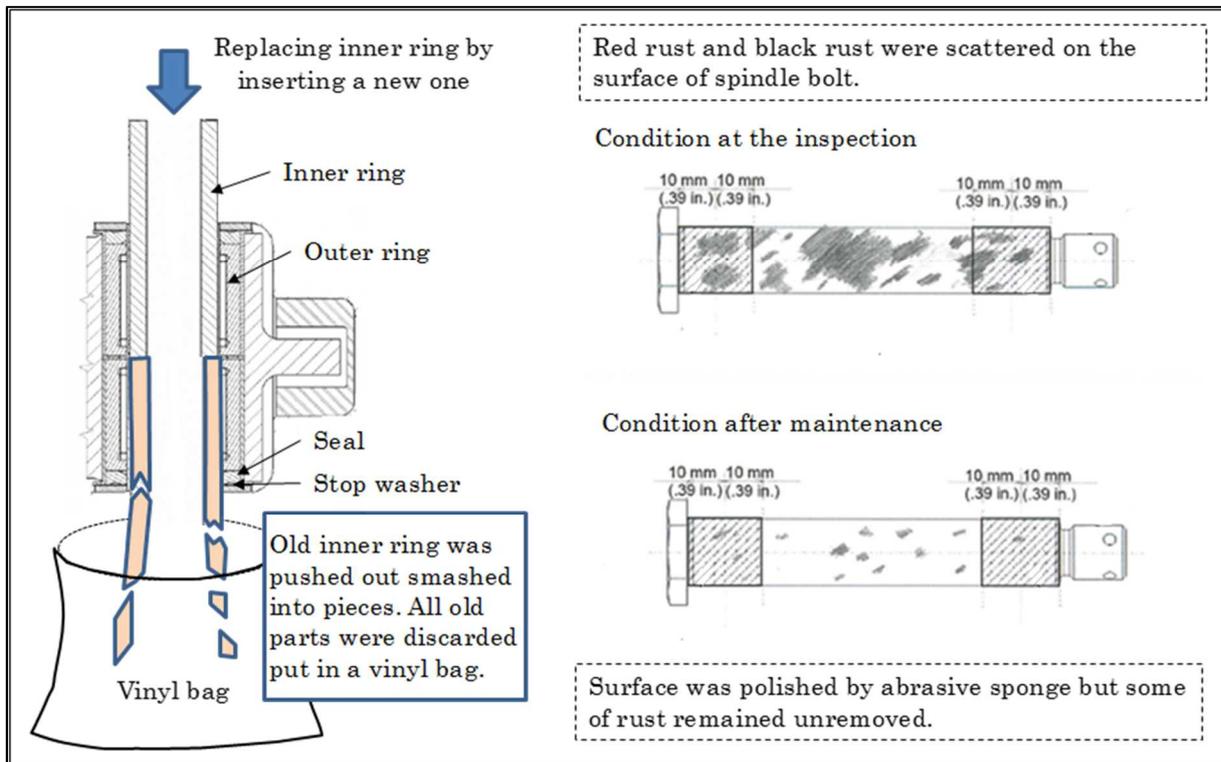
Because checking the removed spindle bolt revealed the existence of red rust and black rust scattering on it, the surface of which was polished by an abrasive sponge. The spindle bolt was pasted by grease without completely removing the rust, and was installed in the flapping hinge.

In checking after the replacement, the White Blade moved smoothly in the direction of flapping; however, the drag play still remained.

Figure 18: Way of replacing inner ring and condition of spindle bolt

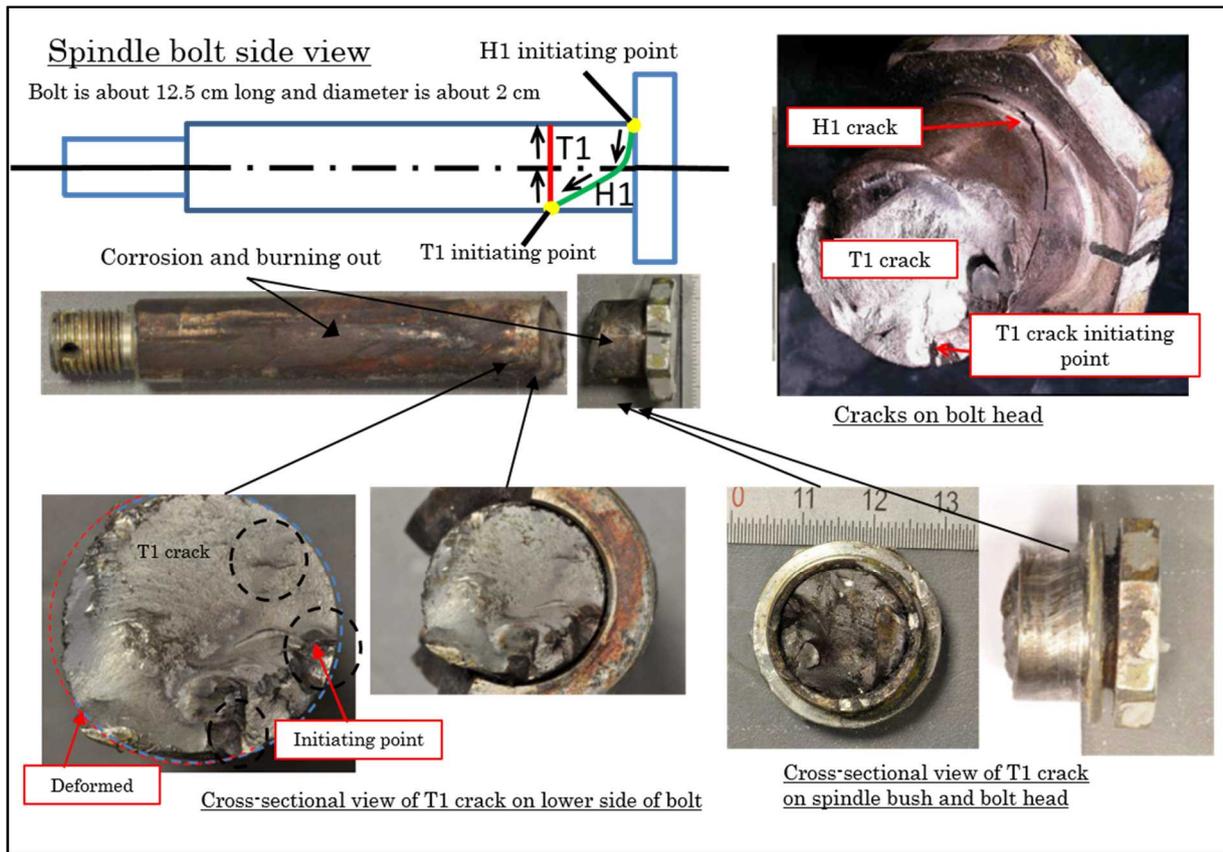
The spindle bolt of the White Blade showed a fatigue fracture generated by cracks with two initiating points as shown in Figure 20. H1 crack with the initiating point at the bolt head propagated in the direction of 45 degrees. T1 crack propagated in the direction perpendicular to the axis and fractured the bolt.

Figure 20: Fractured spindle bolt

As described in 2.14.3 (1), cracks were propagating from the bolt head of the spindle bolt of the White Blade of the Helicopter. The spindle bolt under normal condition with normal bearings receives load in axial direction initiating from CF and lead-lag moment and some shearing load as shown in Figure 27; however, flapping moment is as low as negligible and the spindle bolt does not receive the torsional load.

Propagation of the cracks of the spindle bolt of the Helicopter shows torsional condition, which indicates that it received unexpected fatigue load. In the event that torsional load occurs on the bolt head, flow of the torsional load propagates in the spindle, and load is generated by occurs on the boundary between the spindle bolt head and the spindle as shown in Figure 28. It is highly probable that the cracks were generated on the contact face between the spindle bush and the bolt head, which was added by the torsional load leading to the fracture of the spindle bolt.

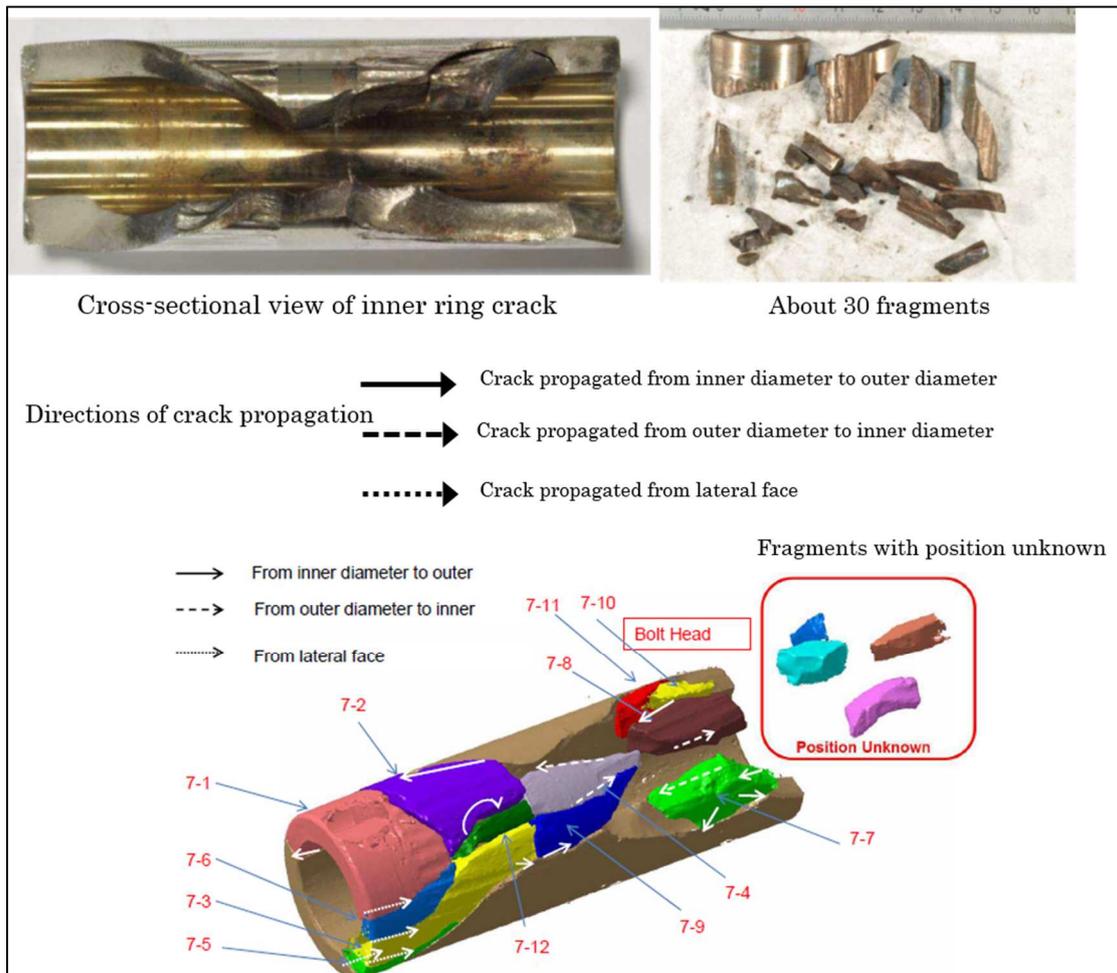
The inner ring was found in a fractured condition together with many fragments as shown in Figure 21. Due to some fragments lost, a partial restructuring of the inner ring indicated that the fractured sections of the inner ring lost some fragments equivalent to 8% in weight. Investigation of the fractured face revealed that propagating cracks were generated in many different sections of lateral face, inner face, and outer face. The cracks were propagated in the directions from inner diameter to outer diameter, from outer diameter to inner diameter, and from lateral face; however, it was impossible to identify all initiating points of cracks. Besides, corrosion was not identified in the initiating areas. Half around of the outer diameter section suffered damage from false brinelling.

Figure 21: Damaged inner ring

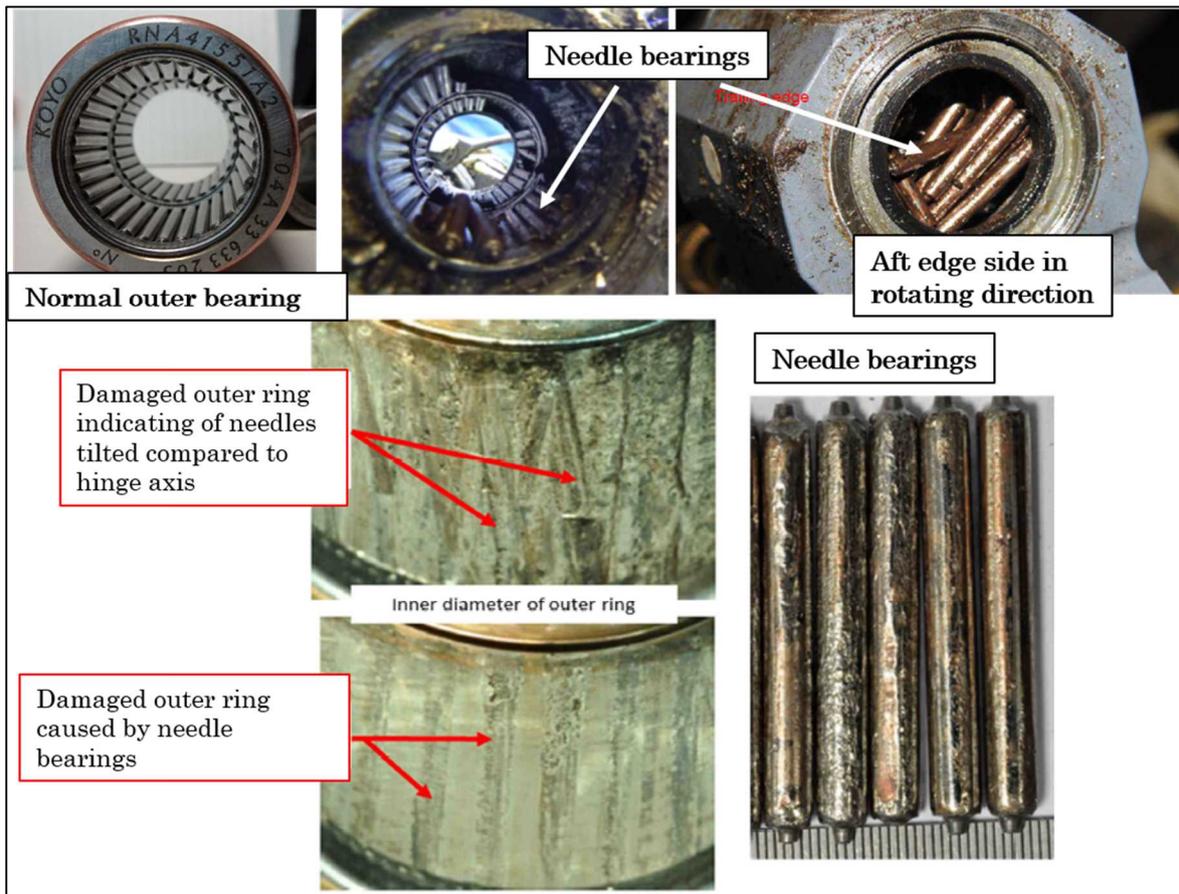
The highest damaged area of the outer bearings received damage from false brinelling wear and spalling peeling. Examinations of the bearings did not allow to characterize their state when the Old Inner Ring was replaced by a new one. Inner diameter faces of the outer bearings showed both damage of indicating the needle bearings tilted axis, and pushing out of the needle bearings in axial direction.

Figure 22: Damaged outer ring (white blade)

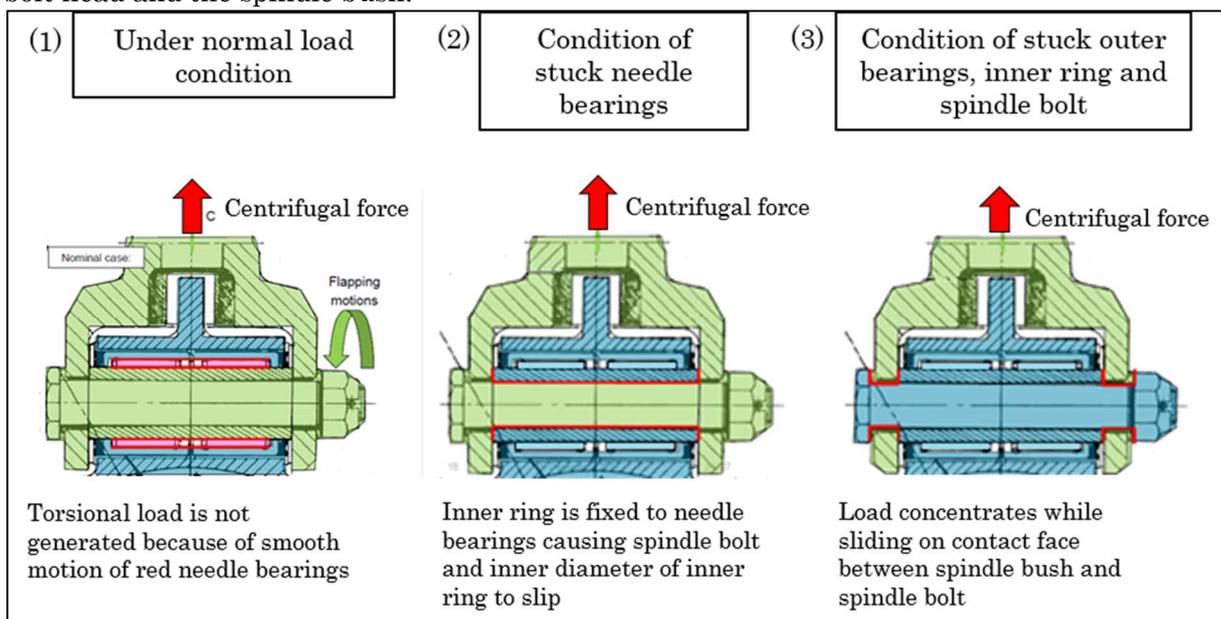
The following are probable factors causing the torsional load in the spindle bolt. As seen in Figure 29 (1), there occurs no torsional load when the spindle bolt is under normal condition because the needle bearings in the outer bearings in red smoothly move. With regard to the principle that the torsional load is generated in the spindle bolt, in the event that the needle bearings stick due to damage or some other factor, the inner ring is fixed to the needle bearings causing the spindle bolt to slide on the inner diameter of the inner ring as seen in Figure 29 (2). Furthermore, in the event that the outer bearings, the inner ring and the spindle bolt stick, load concentrates on contact face while the spindle bush and the spindle bolt are sliding as seen in Figure 29 (3). The spindle bolt is added by three different pressures of tightening pressure, spindle pressure and inner ring pressure as seen in the left picture of Figure 30. In the event that the bearing sticks, the inner ring receives load in the circumferential direction by flapping of the blade as seen in the right picture of Figure 30. This load is added to the bolt as tangential force passing through the boundary between the inner ring and the bolt. Torsional load added to the spindle bolt is generated, by friction or burning between the spindle bolt head and the spindle bush.

Figure 29: Stuck flapping hinge

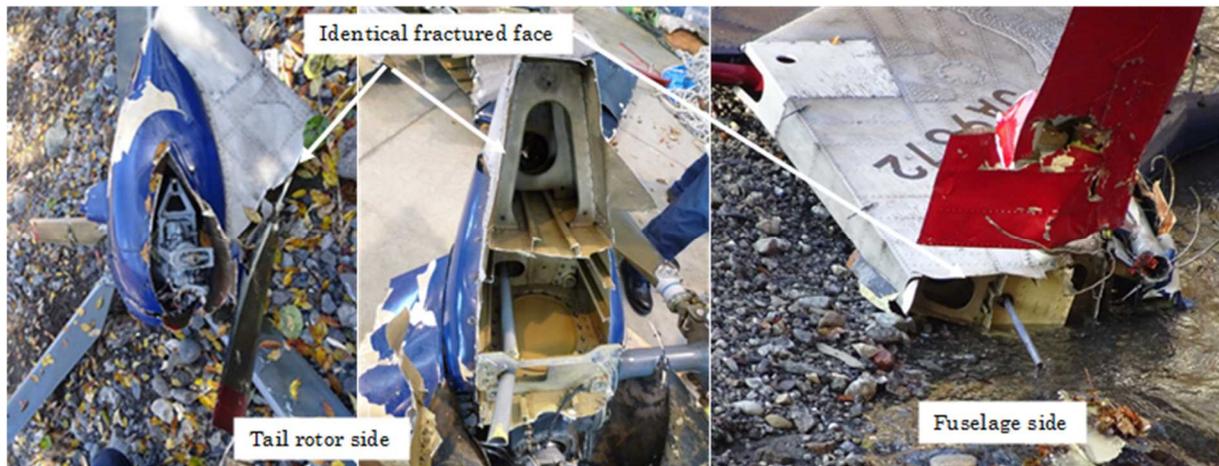
It is probable that excessive load was imposed on the structure parts that led to the separation of the tail rotor because the frame of the section where the lower side of the tail rotor was fractured had marks of the load, cracks were generated in some part of the frame, and the rivets were damaged as seen in Figure 32. Besides, from the damaged condition of the tail rotor drive shaft and the pylon, it is probable that contact marks on attaching side of TGB in the inclined drive shaft within the pylon as seen in Appended Figure 5 was left when the tail rotor was separated together with TGB.

Figure 32: Fractured face of tail rotor lower side separated from airframe

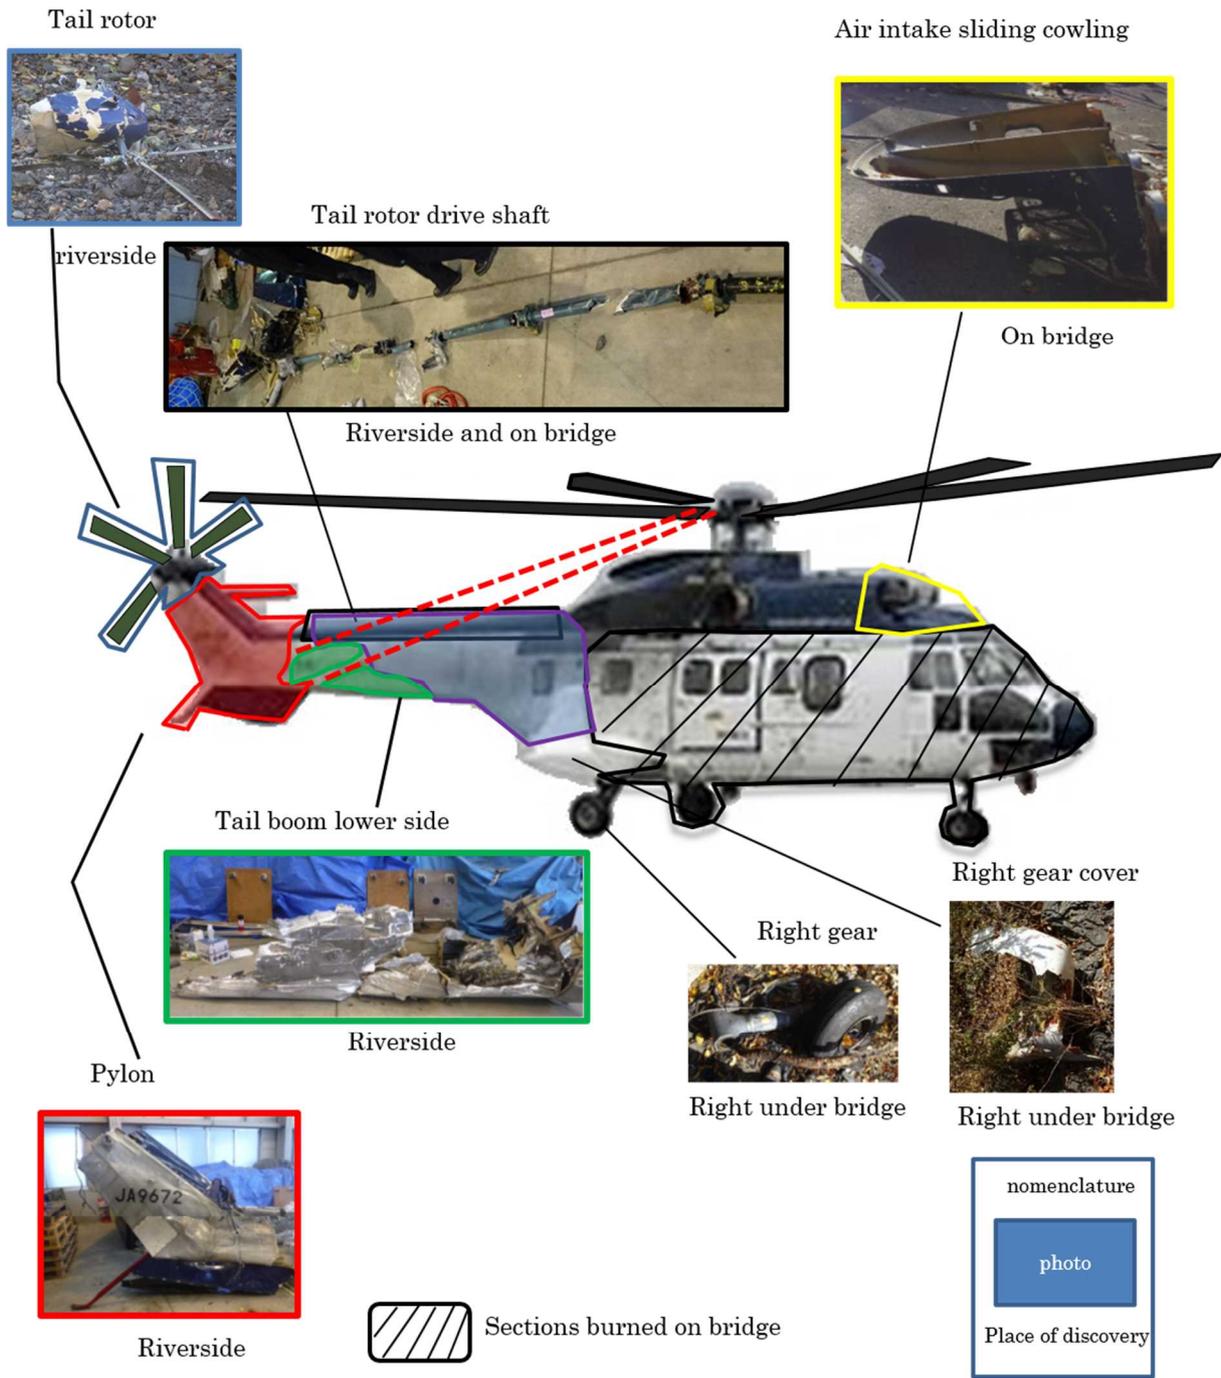
Appended Figure 4: Detailed Conditions of Wreckage

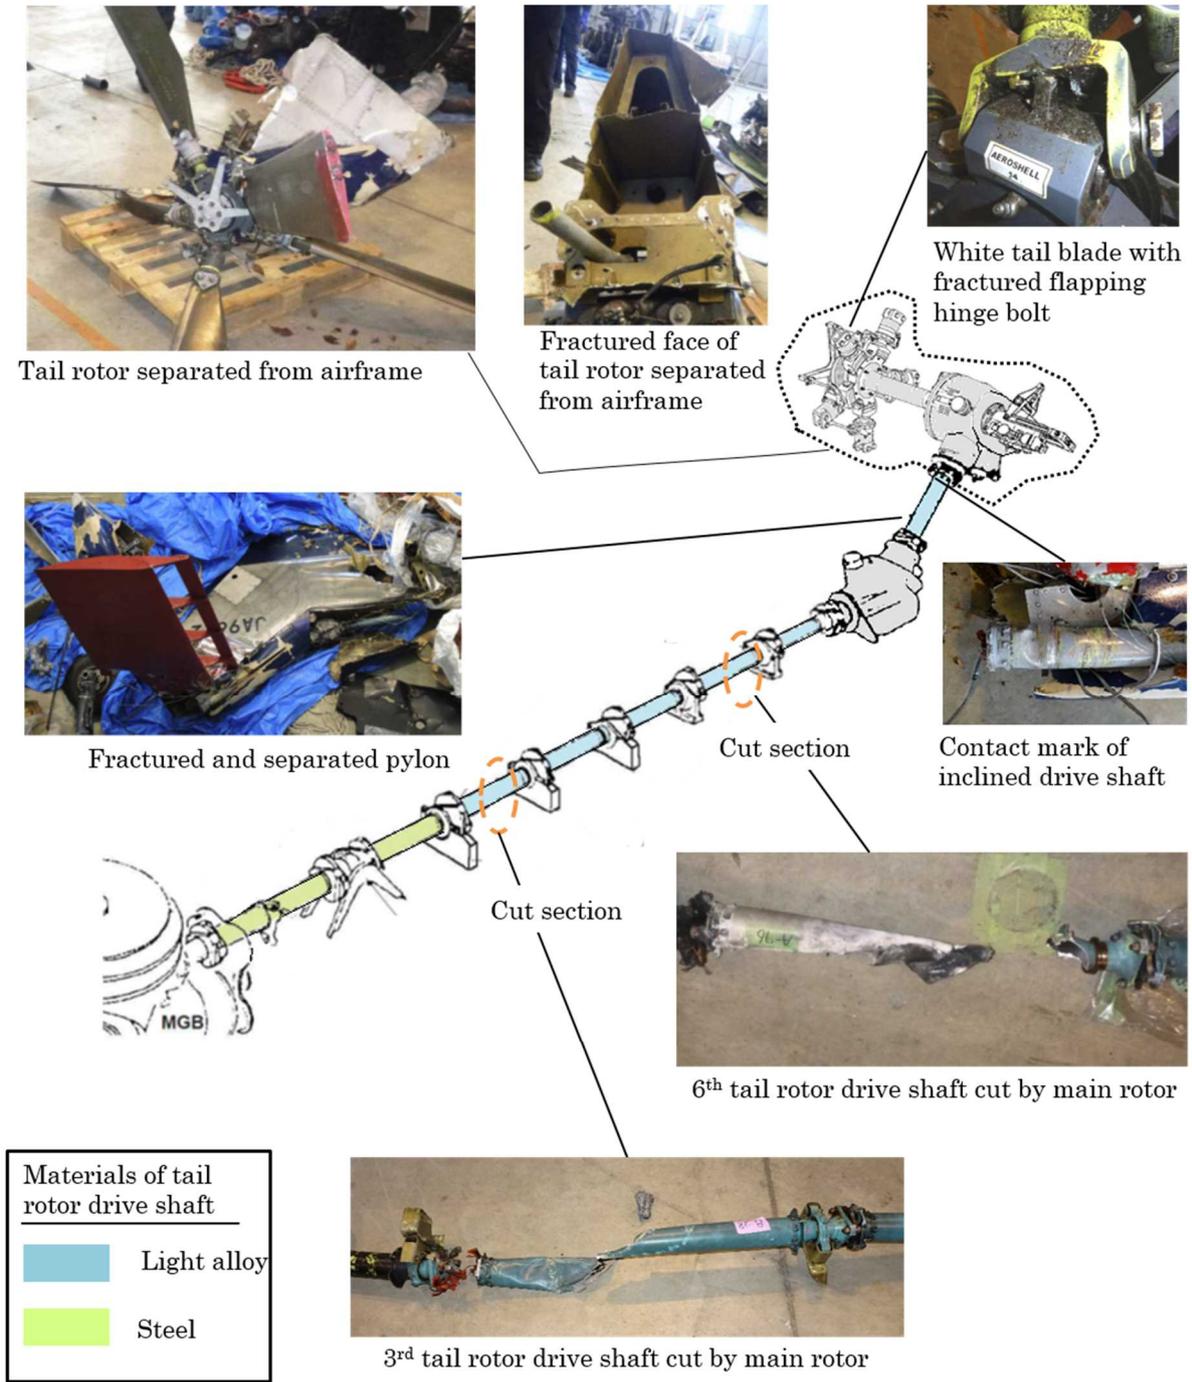
Appended Figure 5: Tail Rotor drive shafts had contact marks
