AI2016-5

**AIRCRAFT SERIOUS INCIDENT
INVESTIGATION REPORT**

AERO ASAHI CORPORATION
AÉROSPATIALE AS332L1 (ROTORCRAFT)

DROPPING OF OBJECT
DURING EXTERNAL CARGO SLING OPERATION
ITOIGAWA CITY, NIIGATA PREFECTURE, JAPAN
AT AROUND 11:13 JST, OCTOBER 2, 2015

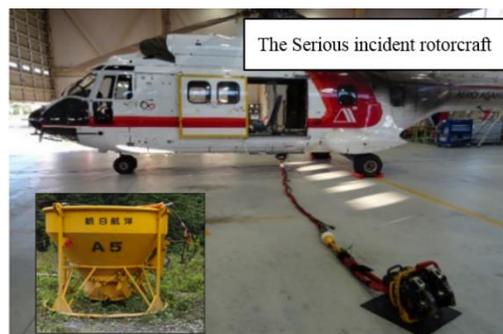
Photo 1 Cargo hook and bucket

The rotorcraft was equipped with two cargo hooks painted red and yellow, respectively (the red hook and the yellow hook).

The rotorcraft was scheduled to perform 27 cargo transport operations on the day, and on the second flight, it transported a bucket filled with ready-mixed concrete, slung on the red hook, from the cargo sling point to the cargo unloading point at the new transmission tower construction site (hereinafter referred to as “concrete unloading point”). When doing so, the captain and the operator visually confirmed that the bucket was slung on the red hook.

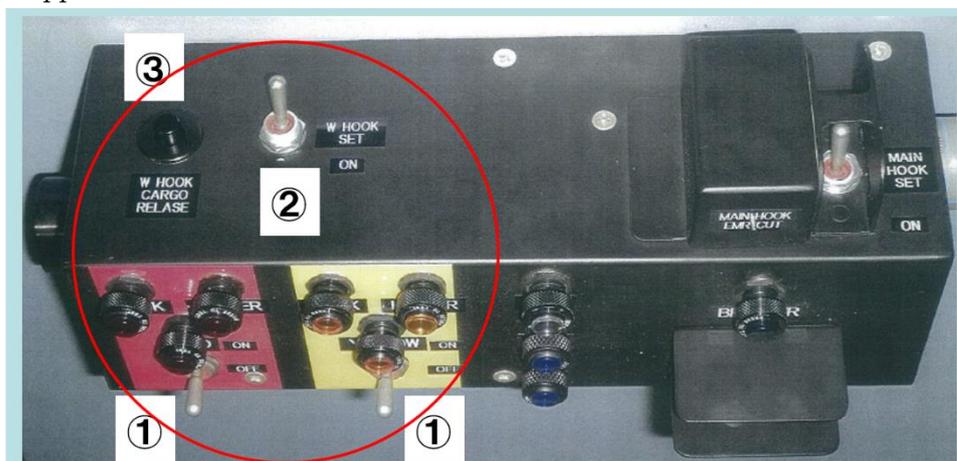
Fig. 2 Operation of the switch box

After the rotorcraft had arrived at the concrete unloading point, the ready-mixed concrete was unloaded from the bucket via remote-control operation by the operator, then, with the empty bucket being slung, the rotorcraft flew lock toward the cargo sling point to carry out the next cargo transport operation. During the flight, the operator saw the caution lights illuminating on the switch box, and noticed that the yellow hook, from which the bucket was not slung, was also locked. The operator then decided that the bucket would be slung from the yellow hook for the next cargo transport operation, by way of alternating between the hooks and thus preventing deterioration of the hooks. Although in flight, The operator decided to operate the switch box and release the lock on the yellow hook, with the intention of reducing lock release work by the ground staff. The operator notified the captain only that he was going to release the lock on a hook, but did not specify which hook, and on operating the switch, mistakenly released the lock on the red hook from which the bucket was slung, causing the bucket to be dropped.

1. Switches ① are used to select the red or yellow hook to release the lock.
2. Switch ② is used to set the hooks.
3. Button ③ is pressed to release the lock.

It is probable that the operator released the lock of the hook in flight with the intention of reducing work for the ground staff as far as possible. In addition, It is also highly probable that he released the lock of the hook from which an object had been slung because he mistook it for the operation of releasing the lock of a hook from which no object was slung.

- ① Hooks shall not be operated while on in flight route and while cargoes are suspended.
- ② Captain and operator shall carry out mutual confirmation when operating hooks. In addition, the terminology used when making this confirmation shall be made uniform.
- ③ In pre-flight meetings, the operation of the hooks shall be confirmed together with the ground staff.

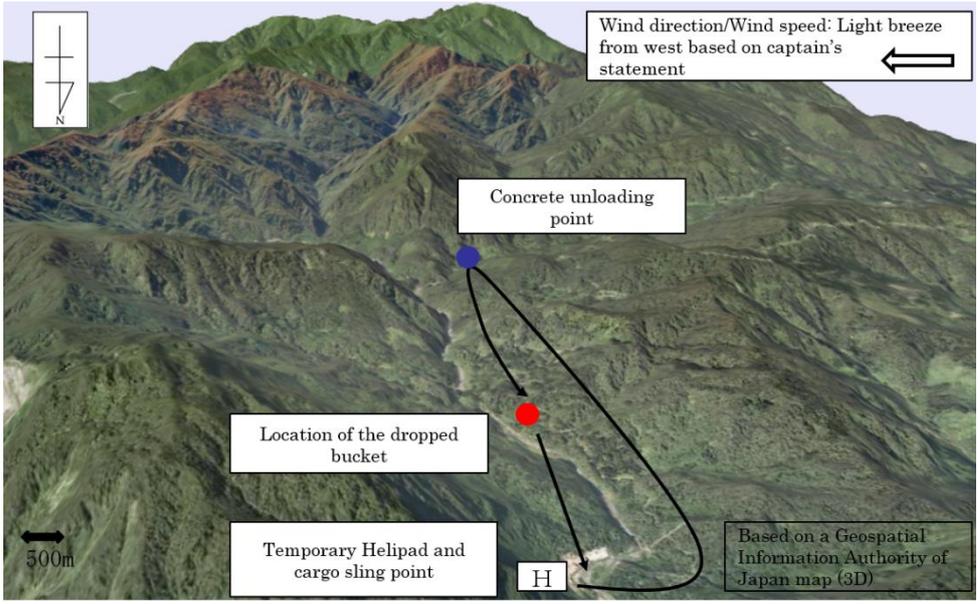
This serious incident occurred at around 11:13 on October 2, 2015, in a mountain forest on the return route from the concrete unloading point to the cargo sling point at Oumi, Itoigawa City (36°58'13"N, 137°45'31"E).
