**AIRCRAFT SERIOUS INCIDENT
INVESTIGATION REPORT**

**AERO ASAHI CORPORATION
JA 9678**

AERO ASAHI CORPORATION
AÉROSPATIALE AS332L1 (ROTORCRAFT)
JA9678

DROPPING OF OBJECT
DURING EXTERNAL CARGO SLING OPERATION
MIHAMA TOWN, MIKATA-GUN,
FUKUI PREFECTURE, JAPAN
AT AROUND 10:08 JST, MARCH 1, 2016

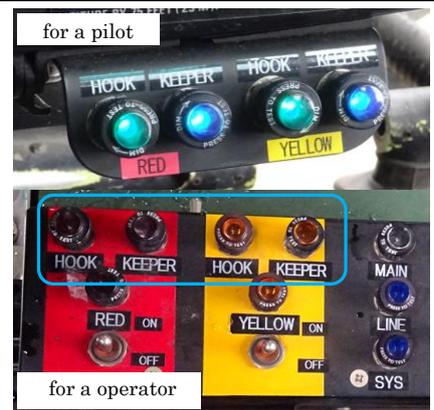
Photo 2: Indicator

The operator saw outside of the rotorcraft and confirmed that the one of the wire’s eyes on the yellow hook was off and one cargo was dropping. At this time, all of indicators for keepers and load beams^{*3} were lighted on at the captain seat and the guiding seat.

As described in (1) and (2), it is somewhat likely that because the improper wire roping occurred when the keeper was not locked, the event described in 2.7(5)④ and ⑤ had occurred and the indicator was lighted on. It is highly probable that the captain and the operator checked that all light of the indicators on the instrument panel at pilot seat and the switch box were lighted after passing over the transmission tower and they were aware that the keepers and the load beams of the yellow and the red hooks were locked.

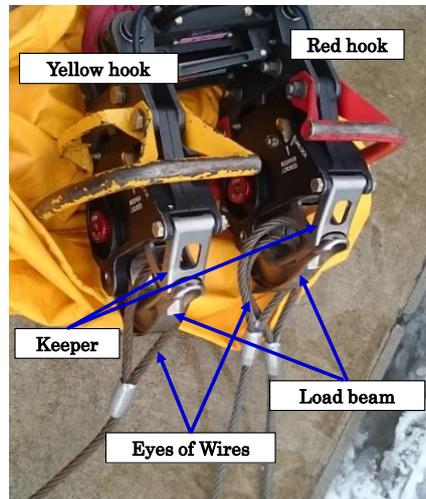
Photo 3: Hooks Condition right after the accident

At the time, the keepers of both hooks were locked and the single eye remained on the load beam of the yellow hook.

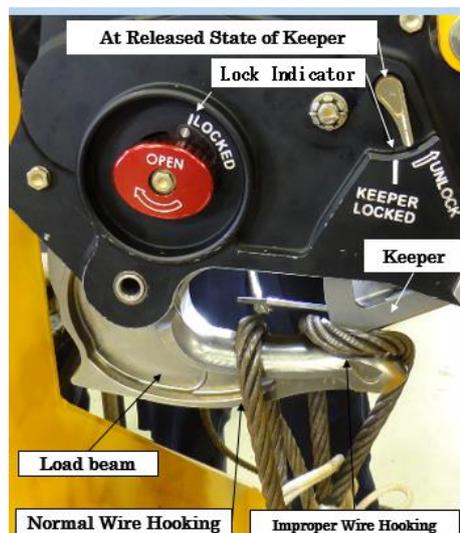
Photo 4: Improper Wire Hooking

*⁴ “Improper wire roping” means that a roping should astraddle a load beam, instead it straddles between a load beam and a keeper, which are merely closed in contact by a force of spring.

② Under the condition of ①, if a keeper was not locked, because an eye will move the keeper upward, a space is occurred on a tip of a load beam and the improper wire roping was caused. (See Photo 4)

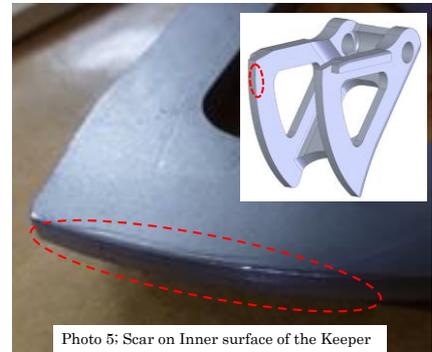
The result of the Hook Teardown Investigation carried out in the presence of the person who designed and developed the hook revealed a scar at the pushrod side of the inside of the keeper which generated due to the contact with a sharp edge. (Photo 5)

Besides, the hook is structured with enlarged gaps between each parts in order to prevent earth and sand from clogging.

② Issue the Service Bulletin No. 159-038-00 and instruct to replace the pushrod to the one with tip of increased thickness (from the one of approximately 4 mm to the one of approximately 7 mm).

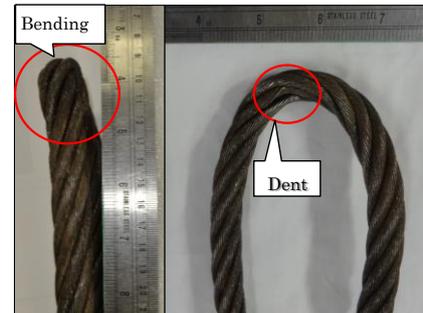
Checking the wire hooking on the yellow hook, one eye had an acute angle formed dent and the tip of the eye was bended. The result of recreating the improper wire roping to verify, was able to recreate the same dent and the

Photo 6: Condition of Improper Wire Hooking

same bent on the wire. (Photo 6)

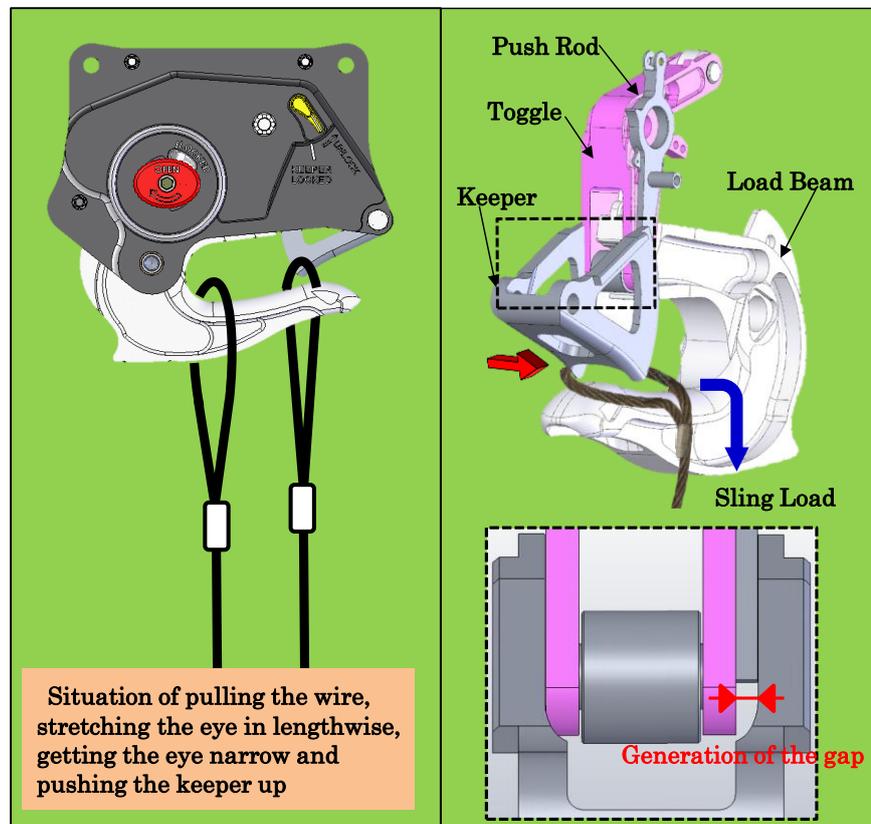
③ When the improper wire roping occurs, the load on the sling cargo which acts on the eye, applies on the keeper due to a horizontal force (a red arrow), it pushes the keeper to one side at the same time the eye ring is getting narrowed to push the keeper upward because of the load and is off from the hook. (Figure 5)

④ If the keeper was pushed aside to the pushrod, the gap between the toggle and the keeper is enlarged. (Figure 5)

Figure 5; Gap generated by Improper Wire Hooking

<p>⑤ In this case, because the pushrod which was moved to the lock position of the keeper due to the sling load enters in the gap created at ④ and activates the switch detecting the locking status, the keeper indicator was lighted without being locked.</p> <p>Moreover, the indicator system of the rotorcraft had no electrical issue.</p> <p>(6) Injury to persons and Damage to objects on ground</p> <p>The cargo (weight about 800 kg) fell onto a mountain forest on the flight route, however there was no injury or damage to the person or the object on ground.</p> <p>(7) Flight Route for the cargo transportation</p> <p>The rotorcraft flew on the predetermined route over a mountain area that would not cause safety issues to the ground, in line with the operational guidelines of the company. On that day, moreover, a confirmation flight was carried out before starting transport.</p>
--	---

As described in 2.7(5), it is somewhat likely that because the pushrod entered into the gap generated by a horizontal force onto the keeper between the toggle and the keeper. Moreover, it is somewhat likely that the large gap between each part of the hook is involved with the pushrod getting into the gap.
