AIRCRAFT ACCIDENT INVESTIGATION REPORT

**Aero Asahi Corporation Aerospatiale AS332L, JA9690
UNAZUKI, SHINKAWA COUNTY, TOYAMA
(Merged into KUROBE City on March 31, 2006)
October 18, 2005**

July 28, 2006

**Aircraft and Railway Accidents Investigation Commission
Ministry of Land, Infrastructure and Transport**

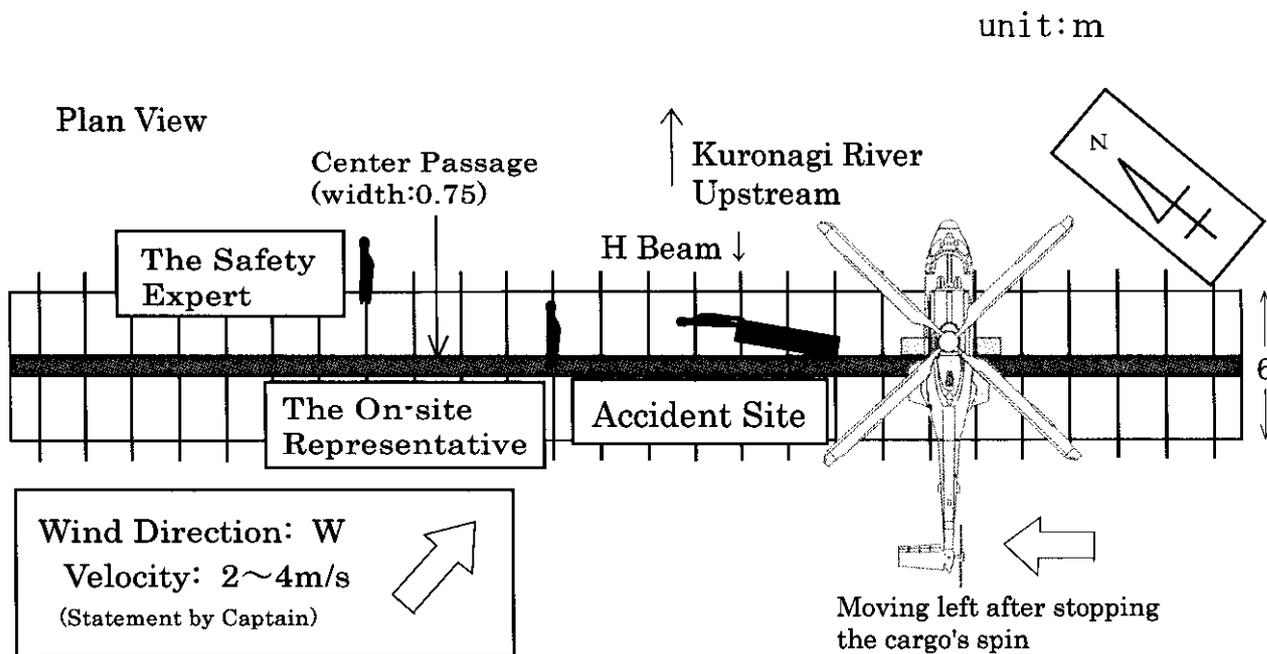
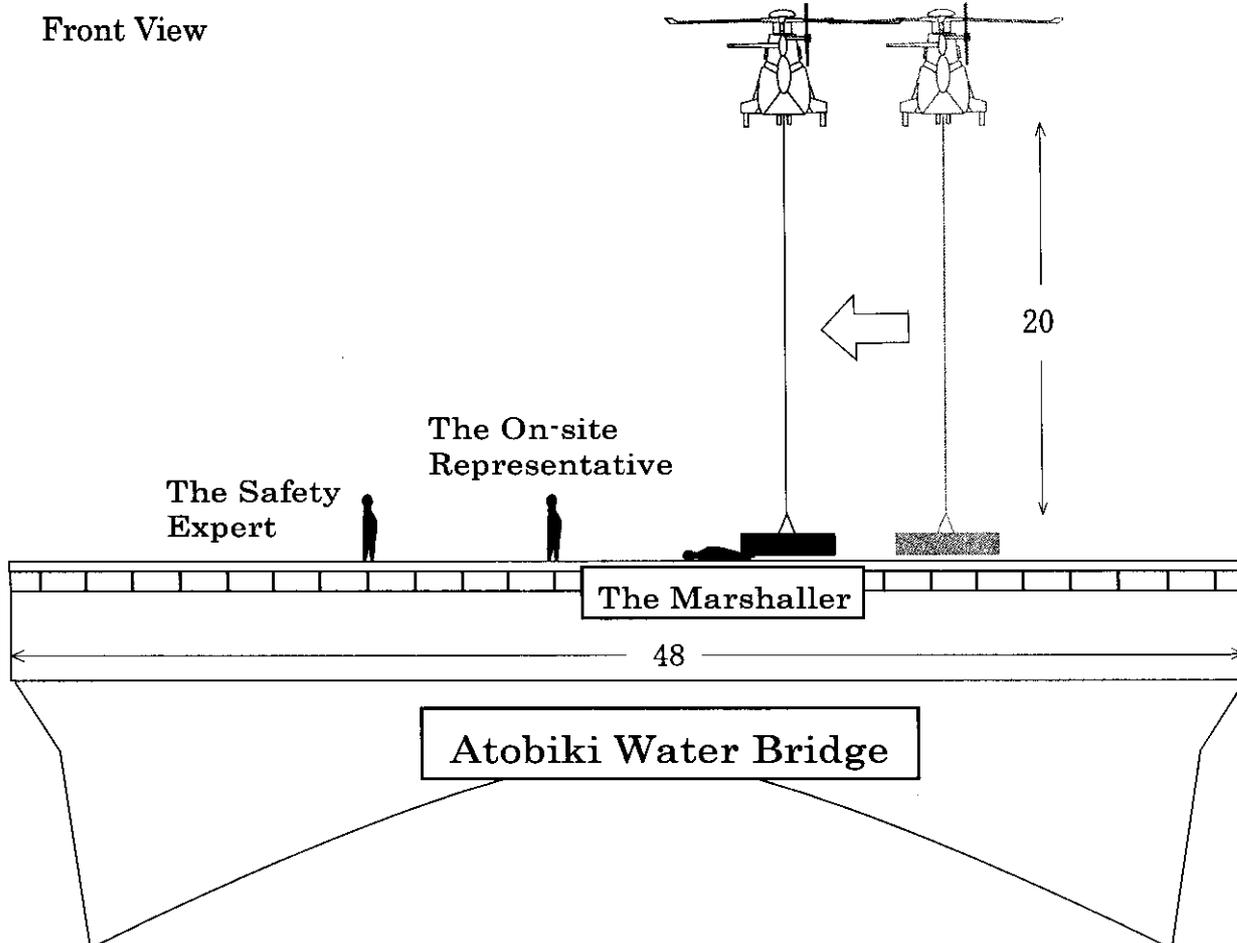
Figure 2 Accident Site Layout

The marshaller signaled the mechanic to lift and displace the seventh cargo to his intended position. At that time the marshaller was signaling the aircraft, walking not in the passage laid in the center of the bridge but on the bridge surface where H beams were laid. When he strode over the H beam to step backward, the suspended cargo swung toward him and his right leg was sandwiched between the cargo and an H beam. It is estimated that he sustained fracture on his right lower leg bones.

In this accident, when the pilot grounded the suspended cargo on the bridge following the marshaller's directions relayed by the mechanic followed by the marshaller's trial to have it displaced, it is estimated that the cargo moved toward him and seriously injured him by sandwiching his right leg between itself and the H beam laid on the site.

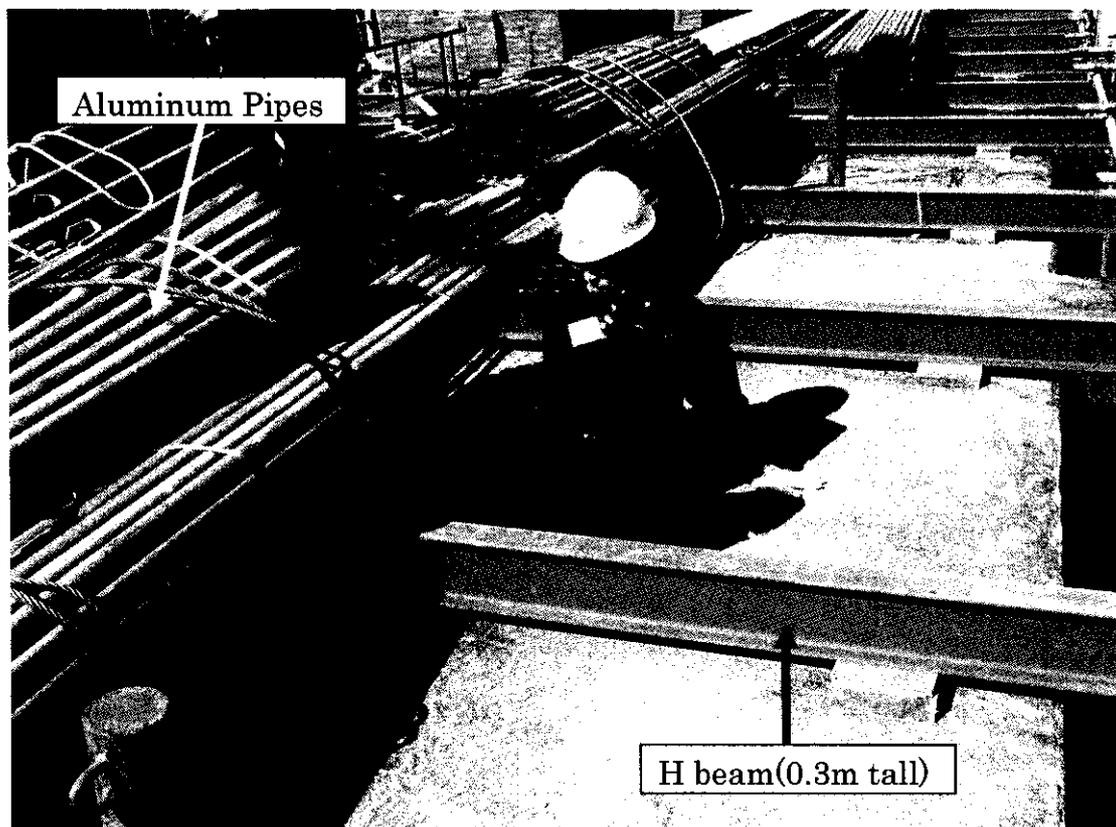
Photograph 2 Marshaller's Situation(simulated)

By the occurrence of the accident, the cargos of six flights were unloaded on the points where I planned. But as to the seventh unloading, the cargo was unloaded slightly out of alignment from where I planned during the initial phase of operations. So I wanted to displace the cargo and gave the hand signal to the mechanic to lift and displace the suspended cargo slightly. At that time, the edge of the bundle of aluminum pipes (3m long) hit my right leg and I fell backward because my leg was sandwiched between the edge of it and one of the H beam set 30cm up on the bridge. The fractured part of my right low leg was just the part sandwiched between them.

As mentioned in Section 2.9.2, no descriptions on the marshaller's precautions to secure his footholds during his duty were found in the "Flight operating procedure". Therefore, for the better operations in the space-limited area like the area of this accident, provisions as to the marshaller's safety measures, namely to secure footholds, should be enriched. Furthermore, as it is expected that

the unloading area will be occupied by the unloaded materials leaving smaller space for the marshaller, the company should hold daily before-operations meeting and let all persons concerned know necessary safety measures.
