**AIRCRAFT SERIOUS INCIDENT
INVESTIGATION REPORT**

**AERO ASAHI CORPORATION
J A 9 6 9 0**

CASE EQUIVALENT TO LANDING ON A RUNWAY
BEING USED BY OTHER AIRCRAFT
ON RUNWAY AT TOYAMA AIRPORT, JAPAN
AT ABOUT 14:05 JST, JULY 9, 2018
AERO ASAHI CORPORATION
AEROSPATIALE AS332L (ROTORCRAFT), JA9690

February 22, 2019

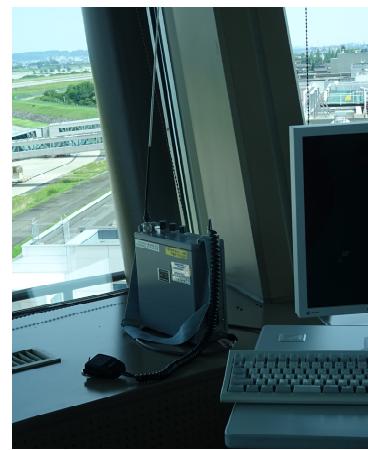
Figure 4:
Emergency Radio

When the Aircraft A called the Tower, the Tower Controller was inspecting an emergency radio (Figure 4) located about 2 m away from the tower control position. At this time, the voice messages on the radio call from the Aircraft A was difficult to listen because it was coming simultaneously from both speakers of the emergency radio and the tower control position, therefore, the Tower Controller returned to the tower control position in order to communicate with the Aircraft A.

At 14:00:00, when the Tower Controller was again moving to the emergency radio in order to return from the Tower frequency that had been changed for the equipment check to the original emergency frequency, another call came on the specified frequency from the Vehicle B to request permission to enter the runway this time. The Tower Controller hurried to return to the tower control position and answered to the Vehicle B saying "It is cleared to enter the runway".

At this time, the Tower Controller again moved to the emergency radio in order to return its frequency to the original one without attaching the reminder (Figure 6) indicating "Runway Closed" on the wind indicator. And then, after returning to the tower

- (2) Toyama aerodrome control tower took the following measures to prevent its recurrence.
 - a. It changed the install position of the emergency radio so that the controllers are able to operate it without leaving his or her seat of the tower control position.

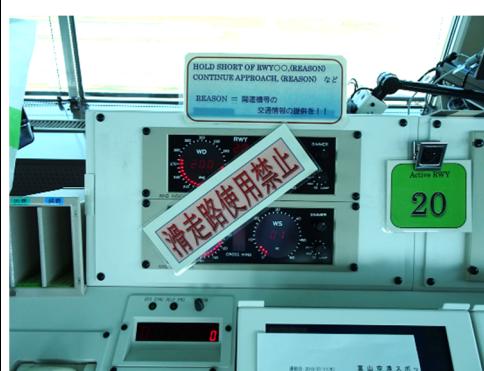
Figure 6: Reminder

It is probable that the Tower Controller issued a landing clearance to the Aircraft A on the runway, while forgetting about the presence of the Vehicle B engaging in the runway inspection, because the Tower Controller did not scan the full length of the runway appropriately when issuing the landing clearance, and besides, it was related to the fact that she did not use the reminder that should be used when a work vehicle enter the runway for a runway inspection.

- a. The CAB instructed all the aerodrome control towers nationwide to strive to use the remainder appropriately and notified that they should ensure to use the reminder by providing on-site specialized training courses.

- c. It decided to also use the reminder of the Runway Closed at the tower control coordinator position by mutually checking with the tower control position.
