**AIRCRAFT SERIOUS INCIDENT  
INVESTIGATION REPORT**

**NAKANIHON AIR SERVICE CO., LTD.  
JA9743**

**DROPPING OF OBJECTS  
DURING EXTERNAL CARGO SLING OPERATION  
TOUBETSU, TESIKAGA TOWN, KAWAKAMI-GUN  
HOKKAIDO, JAPAN  
AT AROUND 11:58, APRIL 27, 2017**

**NAKANIHON AIR SERVICE CO., LTD.  
AEROSPATIALE AS350B1(ROTORCRAFT), JA9743**

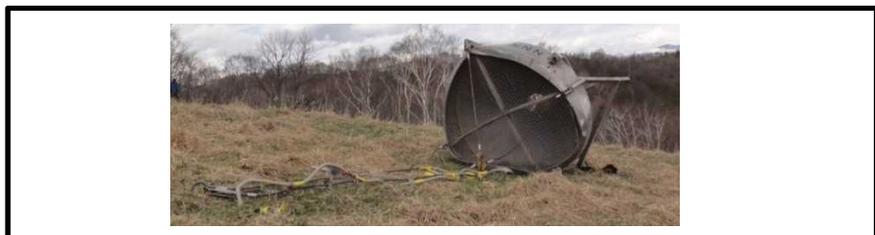
**Photo 2.** The fallen spraying device (Site of fall point)

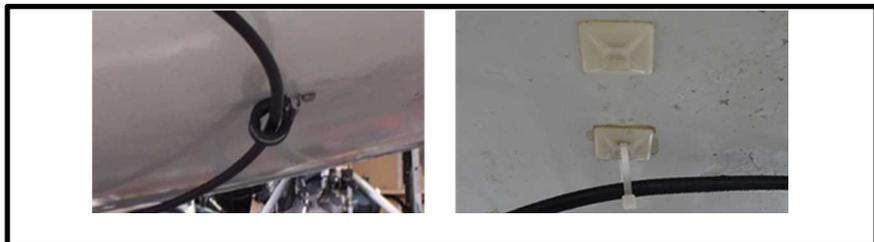
On the other hand, the cable of the rotorcraft was fastened at three locations, one of these was at the regular routing position but two of the rest were fastened at the irregular routing position. One location of these was at the far rear than the regular routing position (Photo 4) and in addition these were a nylon tie used instead of a clamp (Photo 3). The use of a nylon tie instead of clamp generates bigger friction, and when the cargo swing shakes due to flight or others, it was confirmed that the Cable could not follow the movement, smoothly.

**Photo 3.** Clamp (left) and nylon tie (right)

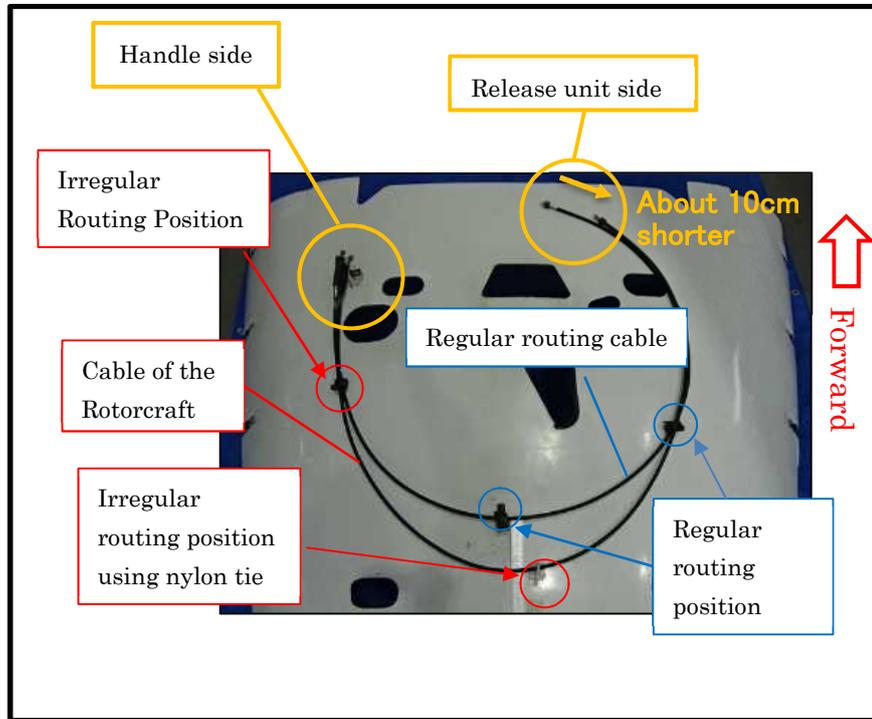
When comparing the cable of the rotorcraft with the regular routing cable, the Cable of the rotorcraft was short by about 10 cm (Photo 4) at the connecting side of the release unit. Because of this, it was confirmed that the cable was bended (Photo 5) due to application of the strong bending force to near the cable fitting at the release unit side.

**Photo-4.** Bottom surface of the fuselage comparison of the cable of the rotorcraft and regular cable routing

- (1) The cables which were equipped for all rotorcraft with the same type cargo hook devices in the company were replaced. Furthermore, an exchange timing for a cable shall be set and the used cable shall be discarded after the installation for five years.
- (2) Regarding the following remarks, special training to the staff of working at the maintenance section and the flight operation section mainly was implemented.
  - ① Concerning the routing and the inspections of the mechanical control cable;
  - ② Concerning the setting of the time management of the control cable;
  - ③ Concerning the operation checks prior to its operation of cargo transportation of external cargo sling operation as a whole;
- (3) Have all personnel know the importance of the configuration management and when installing optional equipment, it must confirm to be a normal configuration including the accessories.

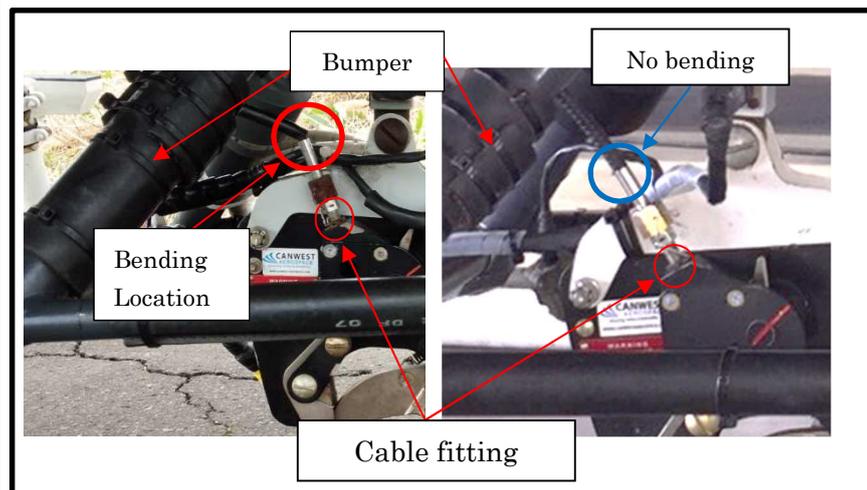
**Photo 5.** Cable fitting and the release unit  
(The cable of the rotorcraft(LH) and a regular routing cable(RH))

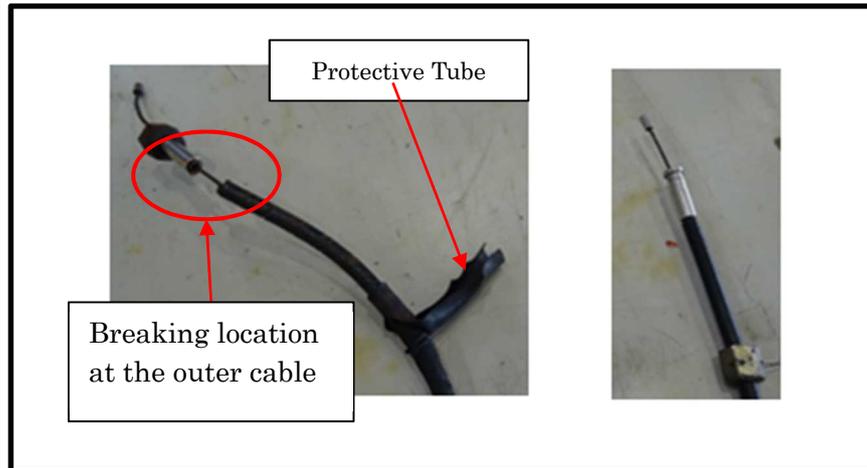
Regarding the cable of the rotorcraft, the outer cables were bended near the cable fitting at release unit side and were broken, and it resulted in exposing the inner cable. (Photo 6)

**Photo 6.** Broken cable (LH) of the rotorcraft and normal cable (RH)

<b>3.1 Involvement of weather</b>	None
<b>3.2 Involvement Of pilot</b>	None
<b>3.3 Involvement of equipment</b>	Yes
<b>3.4 Analysis of known items</b>	<p>(1) Damages of the cable</p> <p>The Cable of the rotorcraft did not have a sufficient length at the release unit side in comparison with a regular cable routing. Consequently, it is highly probable that because the cargo swing was shaking during the flight up to then, severe forces was acting</p>

<p>on the outer cable near the cable fitting and caused bending, deterioration and break of the cable at the spot during the turn when the serious incident occurred.</p> <p>When inspecting the cargo swing, it is highly probable that because the outer cable was covered by the protective tube, the deterioration of the outer cable could not be found.</p> <p>(2) Drop of the Spraying System</p> <p>The inner cable of the rotorcraft had been exposed because the outer cable was broken. Because of this, it is highly probable that when the cargo swing was shaken due to the right turn following an acceleration of the rotorcraft, because the outer cable which was constricted the movement by the nylon tie, broke, this caused the same tension as the gripping the handle to the inner cable, therefore, the release unit was activated, was opened the cargo hook system and let the slung spraying device dropped.</p> <p>(3) Configuration Management</p> <p>The Cable of the rotorcraft was differed from the normal routing configuration, the nylon tie instead of the clamp and the nylon tie was used to place at the irregular routing position, however, the reason could not be clarified. Maintaining the regular configuration is important for the safe operation, and it is necessary to reconfirm the method to maintain the appropriate configuration management like how to maintain the configuration or how to keep the records of the configuration changes.</p> <p>(4) Maintenance Works based on the Maintenance Manual</p> <p>On the premise of the configuration management described in (3), if the work was appropriately implemented as the procedure provided in the maintenance manual, it is probable that it could prevent to have unnecessary force applied on the cable.</p>
