**AIRCRAFT ACCIDENT
INVESTIGATION REPORT**

NAKANIHON AIR SERVICE CO., LTD.

J A 9 9 6 5

INJURY TO A HANDLER DURING CARGO SLING WORK NAKANIHON AIR SERVICE CO., LTD. AÉROSPATIALE AS332L1 (ROTORCRAFT), JA9965 MT. SHAKA LOADING AND UNLOADING SITE IN KITAHIRA, OTSU CITY, SHIGA PREFECTURE AT ABOUT 13:50 LOCAL TIME, NOVEMBER 19, 2012

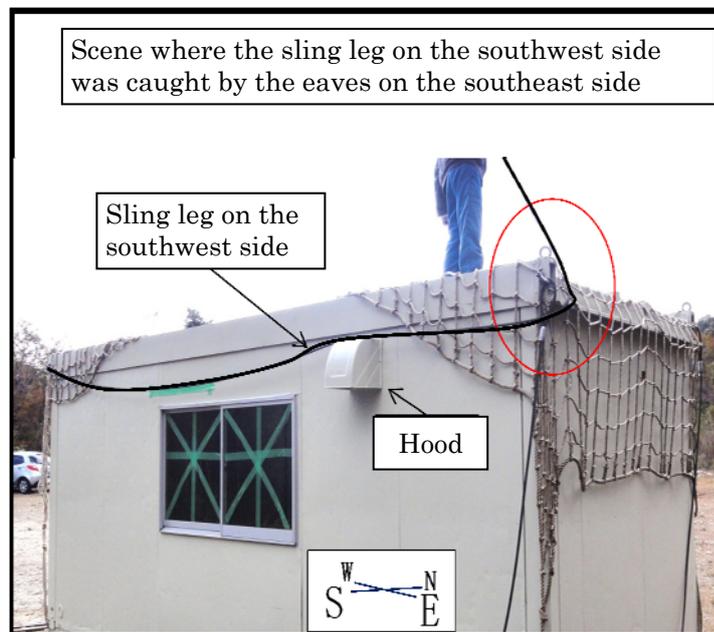
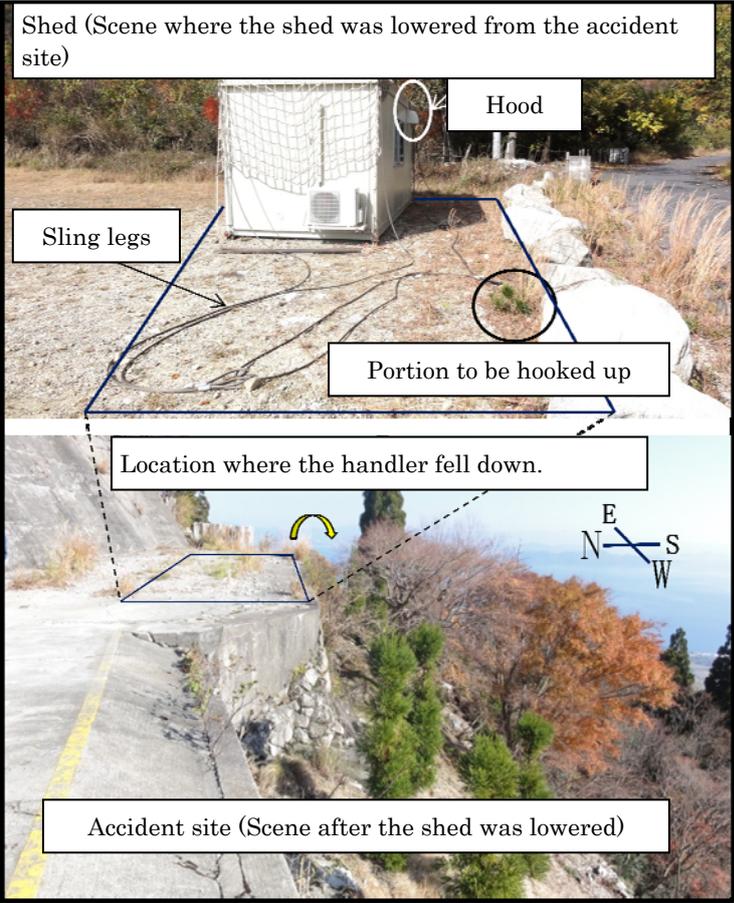
<p>Shed (Scene where the shed was lowered from the accident site)</p> <p>Hood</p> <p>Sling legs</p> <p>Portion to be hooked up</p> <p>Location where the handler fell down.</p> <p>Accident site (Scene after the shed was lowered)</p>
<p>2.2 Injuries to Persons</p>	<p>One handler suffered a bone fracture, which was classified as a serious injury.</p>
<p>2.3 Damage to Aircraft</p>	<p>None</p>
<p>2.4 Personnel Information</p>	<p>Captain: male, age 48</p> <p>Commercial pilot certificate (Rotorcraft): February 13, 1990</p> <p>Type rating for Aérospatiale SA330: September 1, 2008</p> <p>Class 1 aviation medical certificate:</p> <p>Validity: February 16, 2013</p> <p>Total flight time: 7,729 hours 18 minutes</p> <p>Total flight time on the type of aircraft: 1,009 hours 8 minutes</p> <p>Training Pilot: male, age 47</p> <p>Commercial pilot certificate (Rotorcraft): February 1, 1988</p> <p>Type rating for Aérospatiale SA330: June 5, 2012</p> <p>Class 1 aviation medical certificate:</p> <p>Validity: December 7, 2012</p>

Work was performed in this situation. It is probable that the shed in a partially lifted state with only its southeast portion off the ground due to the sling leg that had been caught by the eaves, moved to the valley side, and the handler who dashed to the affected area came into contact with the shed, resulting in his fall on the valley side of the area and subsequent injury.

It is highly probable that as the helicopter was about to lift the shed, a sling leg was caught by the eaves, bringing the shed into a partially lifted state, and that the shed moved in this state to come into contact with the handler, who had dashed to the area, resulting in the handler's fall on the valley side of the area and subsequent injury.

- 1) Regarding risk prediction activities prior to starting work, not only will work contents be thoroughly defined, but safety education based on safety education material prepared by the aviation company will be repeated.
- 2) Work area will be firmly established. No one other than signalman and handler hooking cargo shall enter work area.
- 3) After cargo is hooked up, all persons shall move to outside of the work area. Under no circumstances shall anyone touch a cargo after it has been hooked up.

- 1) Safety education procedures for ground operators will be reconfirmed.
- 2) Prior to the starting work, it will be confirmed that ground operators who have received the safety education have been sent out.
- 3) During the implementing work, it will be confirmed that no ground operators will approach cargoes that have already been slung.
