AI2012-1

**AIRCRAFT SERIOUS INCIDENT
INVESTIGATION REPORT**

Japan Transport Safety Board

UNITED AIRLINES, INC.
BOEING 777-200, N219UA
AT ABOUT 11,700 FT, ABOUT 46 KM EAST-SOUTHEAST
OF NARITA INTERNATIONAL AIRPORT, JAPAN
AROUND 18:04 JST, JULY 28, 2010

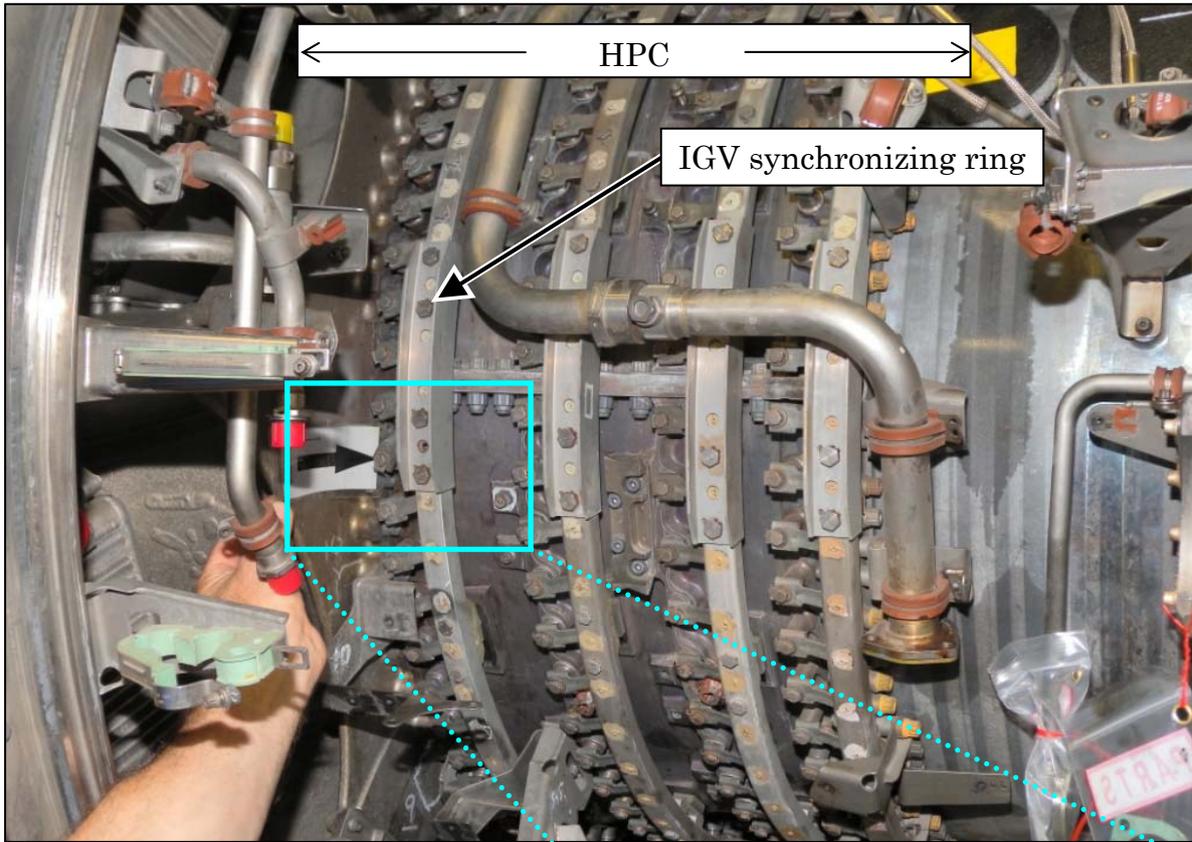
Photo 2 HPC

- (1) The trailing edges of all 4th stage LPC rotor blades were severely damaged. Almost all of the trailing edges of the 4th stage vanes had cuts.
- (2) All of the VSVs and HPC rotor blades were damaged.
- (3) The #73 Arm (viewed from the rear of the engine, Arms are numbered clockwise, with the right outermost Arm as #39), which was connected to the inlet guide vane (IGV), located foremost among the VSVs of the HPC, was deformed into the shape of a "Z." Contact marks were evident on the Ring, which appeared to have been caused by interference with the Arm. The Pin connecting the #73 Arm and the Ring was missing.

It is considered probable that the serious incident occurred because one of the IGVs of the HPC became uncontrollable and moved to the closed position. It is considered highly probable that the cause of the above was the broken Pin for the IGV Arm of the HPC. In the closed position, this single vane obstructed the air flow in the HPC. Downstream from the IGV of the HPC were the 5th stage rotor blades. These blades were subjected to pulsating air flow caused by the closed vane, instead of ordinary uniform air flow from the IGV. The HPC rotates at about 10,000 rpm. Therefore, the 5th stage HPC rotor blades were subjected to pulsation of 10,000 times per minute. This could be the cause of the vibration leading to fatigue fracture. To find the evidence of the fatigue fracture, it is recommended that the 5th stage HPC rotor blades be thoroughly analyzed.

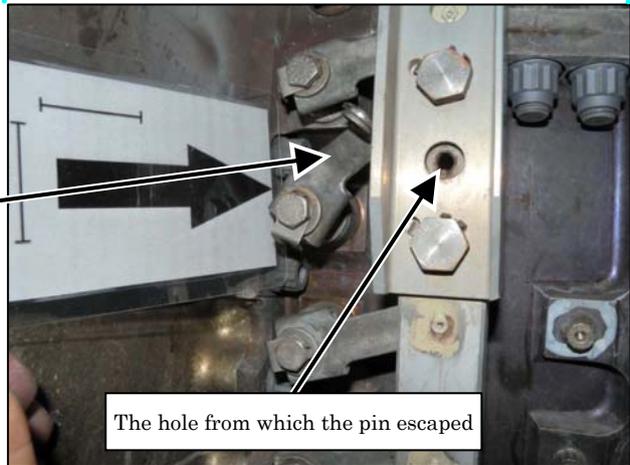
Deformed lever arm

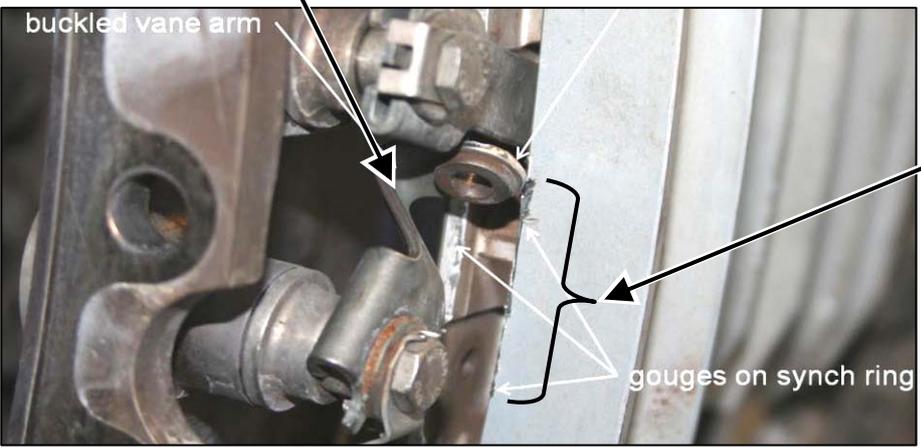
Microscopic examination of the lower IGV Ring revealed the following: Nine (#46, #49, #51, #55, #62, #63, #65, #67 and #74) of the 36 Pins could be rotated in their pin holes because the fractured welds. The remaining Pins, except #45, #60 and #74, more or less had various cracks in the welds. The pin hole of the missing #73 Pin had become slightly oval.

The hole from which the pin escaped

Contact marks

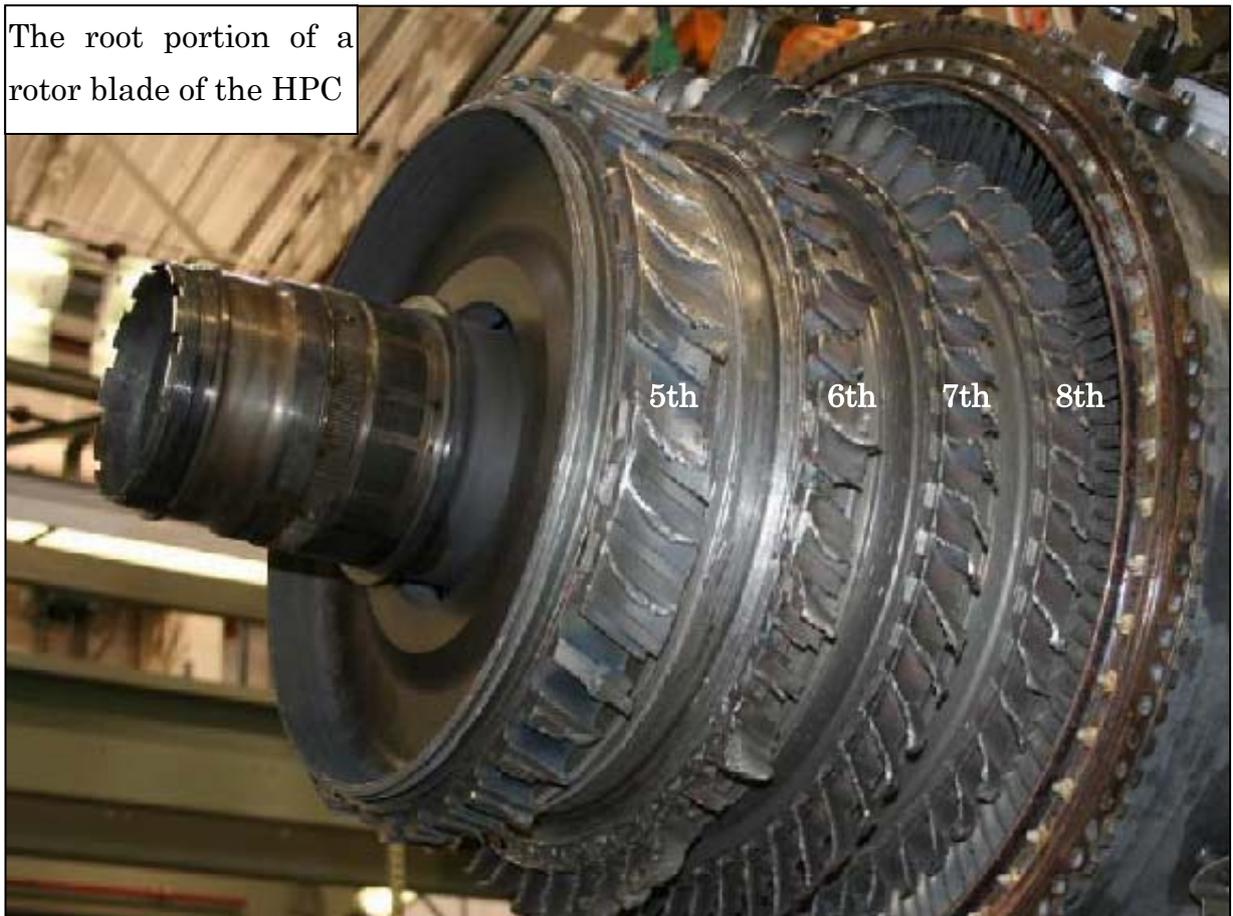
Photo 3 Damage to the Inside of the HPC

All of the 5th stage rotor blades were broken. The mounts for several of these blades were also missing. Two mounts clearly showed the marks of high-frequency fatigue. Several 5th stage HPC disc lugs were broken off.

- (2) The 5th stage HPC rotor blades just downstream from the IGV of the HPC were subjected to pulsating air flow caused by the closed vane, instead of a uniform air flow. As a result, the rotor blades broke due to high-frequency fatigue as described in 2.11 (2) ③. Subsequently, the 5th stage VSVs and the HPC rotor blades and VSVs of later stages, located further downstream, broke in rapid succession.

The root portion of a rotor blade of the HPC

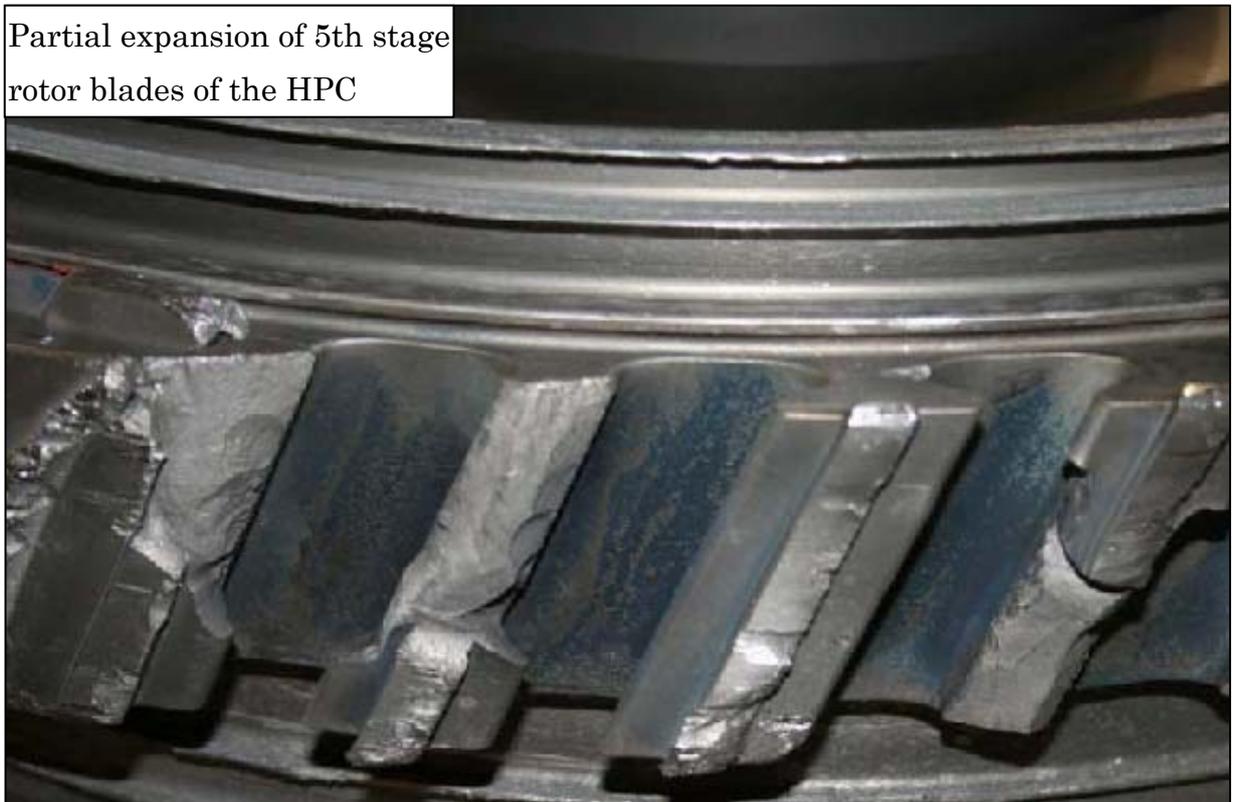
- (4) Of the 40 5th stage HPC rotor blades, only three remained on their mounts while the other blades had broken off at their mounts.
- (5) About half of the 5th stage VSVs of the HPC had broken off at their mounts. All of the remaining vanes were bent in the direction of rotation.
- (6) All of the 6th stage HPC rotor blades were broken. About half of the blades were broken on the outer sides and were bent in the reverse direction of rotation. Ten blades were missing, including their bottom portions.
- (7) All of the 6th stage and 7th stage VSVs of the HPC were in place, although they had tears and bruises on their leading and trailing edges.
- (8) All of the 7th stage HPC rotor blades were in place, although about half were severely broken. All of the blades were bent in the reverse direction of rotation.

Partial expansion of 5th stage rotor blades of the HPC

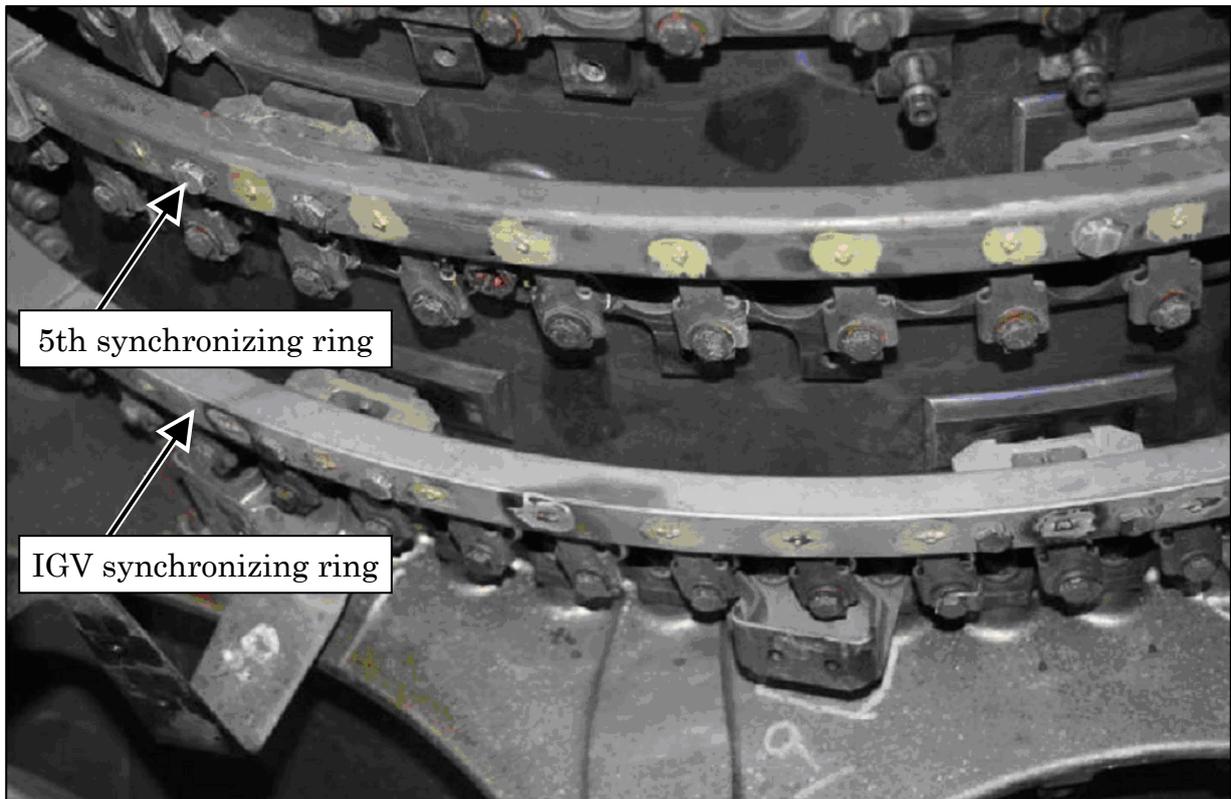
The analysis clearly shows that the lower IGV Ring had been repaired in the past, and the Pins for the Arms had been replaced. Before conducting welding to prevent rotation, it must be ensured that there is no clearance between the Pin and the pin hole. On the #73 Arm position, it appears that cracks had developed from a shrinkage porosity on the welds connecting the Pin and the Ring, eventually allowing the Pin to rotate. The Pin rotated in the pin hole every time the Ring moved, and the Pin and the pin hole underwent gradual wear. The wear progressed to the point of Pin escape, allowing the Arm to be released from the Ring. Eventually, as the Arm did not move smoothly with the Ring, the end of the Arm was bent by the Ring and became stuck. The #73 IGV became stuck at an angle about 90° relative to the air flow. Subsequently, the 5th stage HPC rotor broke due to high-frequency fatigue, resulting in major damage to the engine.

As described in 2.11 (1), the pin holes for the #63, #67 and #70 Pins were not coated with anticorrosive (aluminum enamel) and were discolored from heat. This indicates that the welded portions of these Pins had been repaired. Regarding this repair, as described in 2.12.3, UA stated that they did not have any repair records on the Ring. In addition, the engine manufacturer stated that they did not fully grasp the scope of the flight operation made with the Ring and the repair on the Ring. The engine manufacturer also stated that repair on the Ring was not performed at the repair facilities designated by the engine manufacturer, nor was it conducted by observing the procedure specified by the engine manufacturer. As described above, because of the incomplete history of engine operation and Ring's repair, it could not be ascertained where and how the repair in question was conducted.

Photo 4 (Upper) Conditions of the synchronizing ring
(Lower) Cracked pin weld

As described in 3.5, it is considered probable that the serious incident occurred as a result of a lever arm coming off from the IGV ring, contributed by the fracture of the welded points on a Pin (Part Number 54H727), the pivot of the Arm. As described in 3.6, it is considered possible that the pin flare and welded points were not performed in an appropriate manner during repair of the Ring. Therefore, any operator of an aircraft or engine must need to seek the system building to ensure repairing according to the procedures specified by the engine manufacturer.

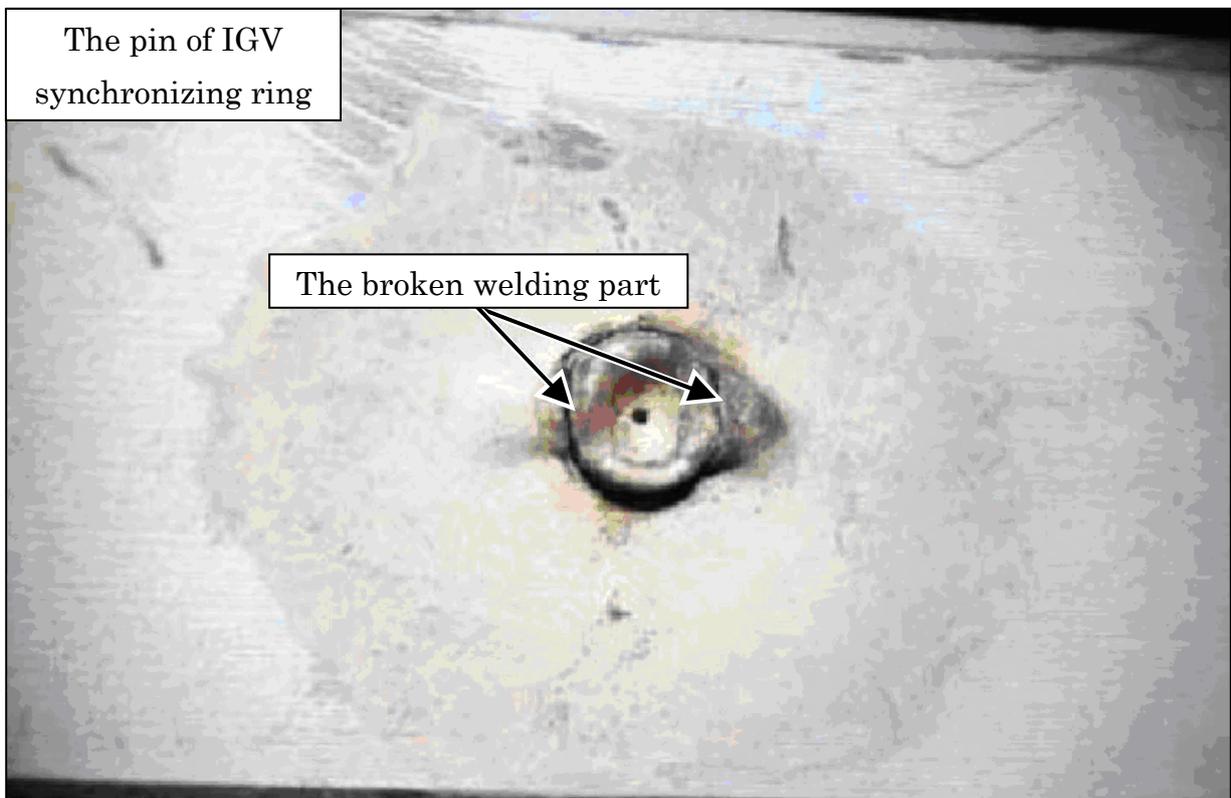
The Pins are permanently connected to the Ring with a flared head at installation and then secured with two small welds. However, the two welded points were broken. The fractured surfaces of the welds and holes were corroded.

The openings of the cracks at the welded portion were inspected through a microscope. The areas generally showed typical characteristics of internal dendritic fracture (hereinafter referred to as “solidification cracking”^{*6}). The fatigue fracture under the heat of a running engine seemed to have been caused not by overstress, but by solidification cracking.

- (4) It is considered highly probable that the succession of breakages described above led to the severe engine damage.
- (5) As to the fractured welds for the #73 Pin, the pivot for the #73 Arm, it is considered possible that the Pin flare and the welds had not been made in an appropriate manner given the following: in several spots of the cracked welds, there were cavities caused by shrinkage near the boundaries with the adjoining metal; in several locations, and examination of the cracked surfaces of the welds revealed marks of solidification cracking, as described in 2.11 (2) ①.
