# AIRCRAFT SERIOUS INCIDENT INVESTIGATION REPORT

NORTHWEST AIRLINES INCOPORATED  
BOEING 747-200B, N645NW  
ENGINE UNCONTAINED EVENT  
KANSAI INTERNATIONAL AIRPORT, JAPAN  
AT ABOUT 10:33 JST, JULY 29, 2004

Aircraft and Railway Accidents Investigation Commission  
Ministry of Land, Infrastructure and Transport

**NORTHWEST AIRLINES FLIGHT 905  
BOEING 747-200B, N645NW  
UNCONTAINED ENGINE FAILURE  
KANSAI INTERNATIONAL AIRPORT, OSAKA  
PREFECTURE, JAPAN  
AT ABOUT 11:33 JST, JULY 29, 2004**

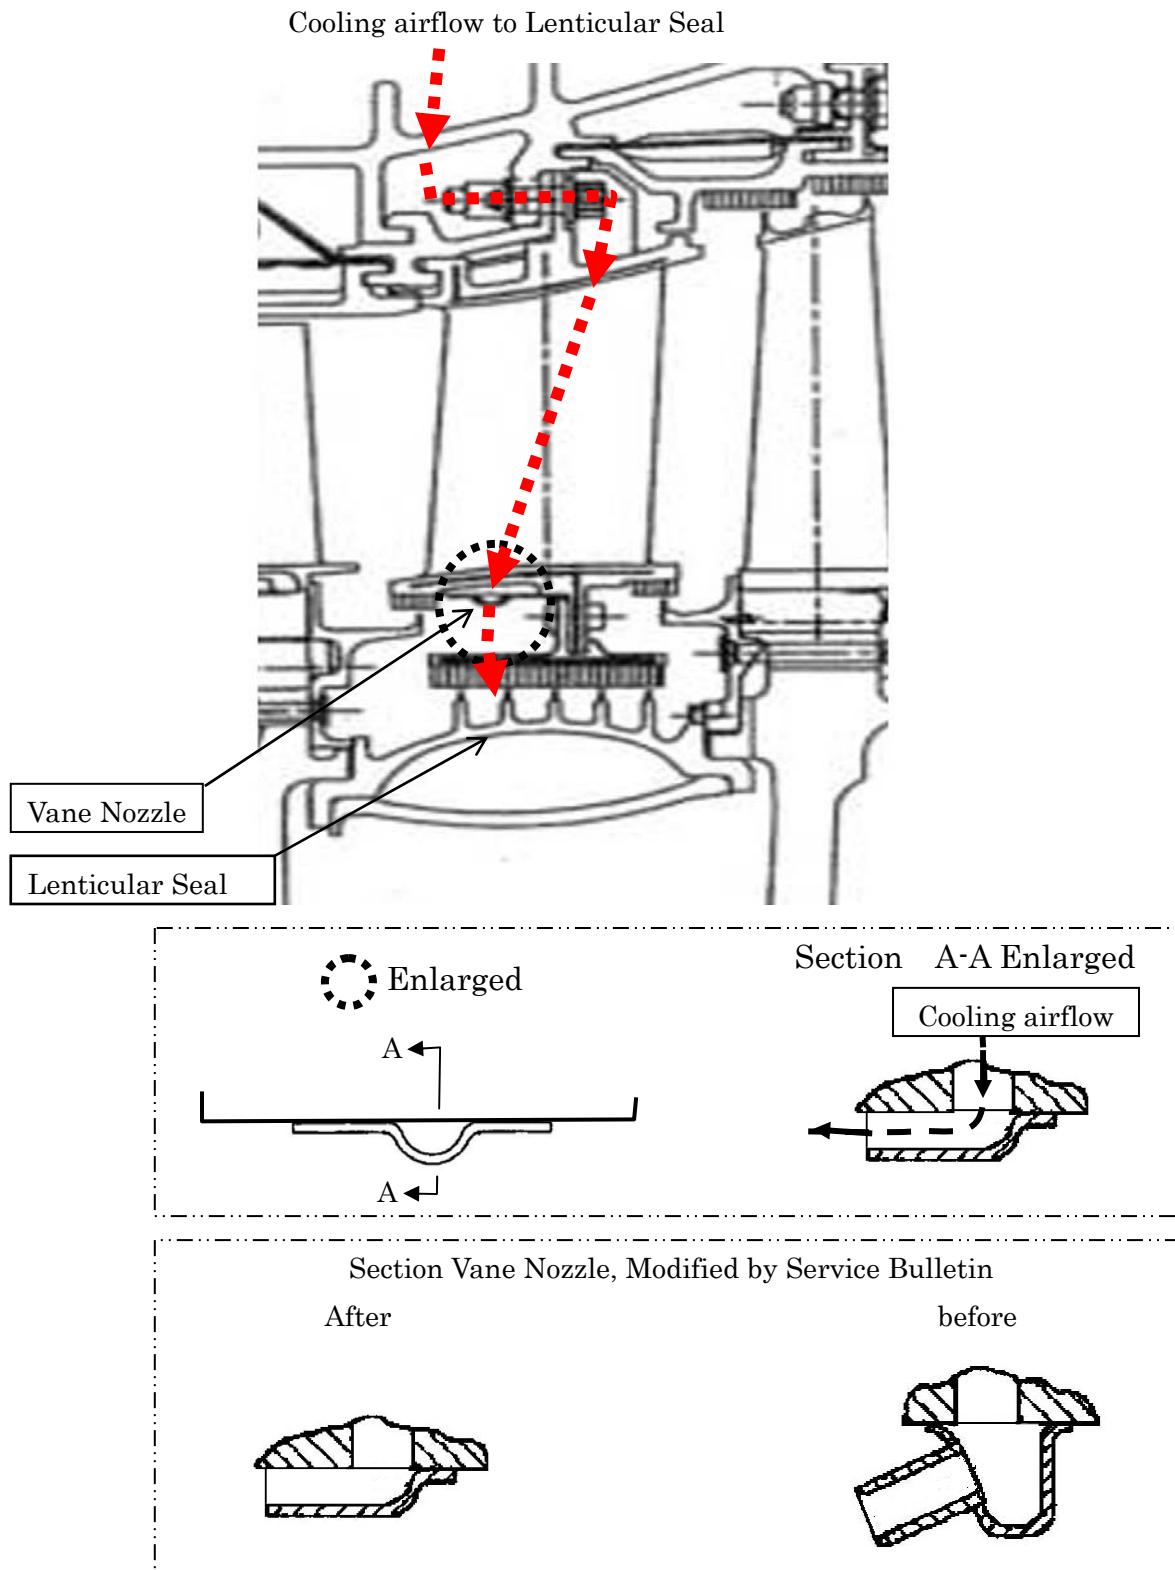
Figure 4 Cooling Airflow and Vane Nozzle

Bleed air from the high pressure compressor flows from along the inside of the high pressure turbine case through the HPT 2<sup>nd</sup> nozzle guide vane, cooling the nozzle guide vanes, and passes from the vane nozzle through the inner air seal to impinge on and cool the lenticular seal.

A service bulletin was issued by the engine manufacturer on June 14, 1985, which altered the shape of vane nozzle to reduce the cooling air flow. This was the shape of the

vane nozzle in the engine which failed in the serious incident.

It is considered that the damage to the lenticular seal was the result of heat stress due to insufficient cooling causing a crack to initiate and grow.

- Measures should be taken to ensure that there is no insufficiency of cooling of the lenticular seal of JT9D-7R4 series engine.

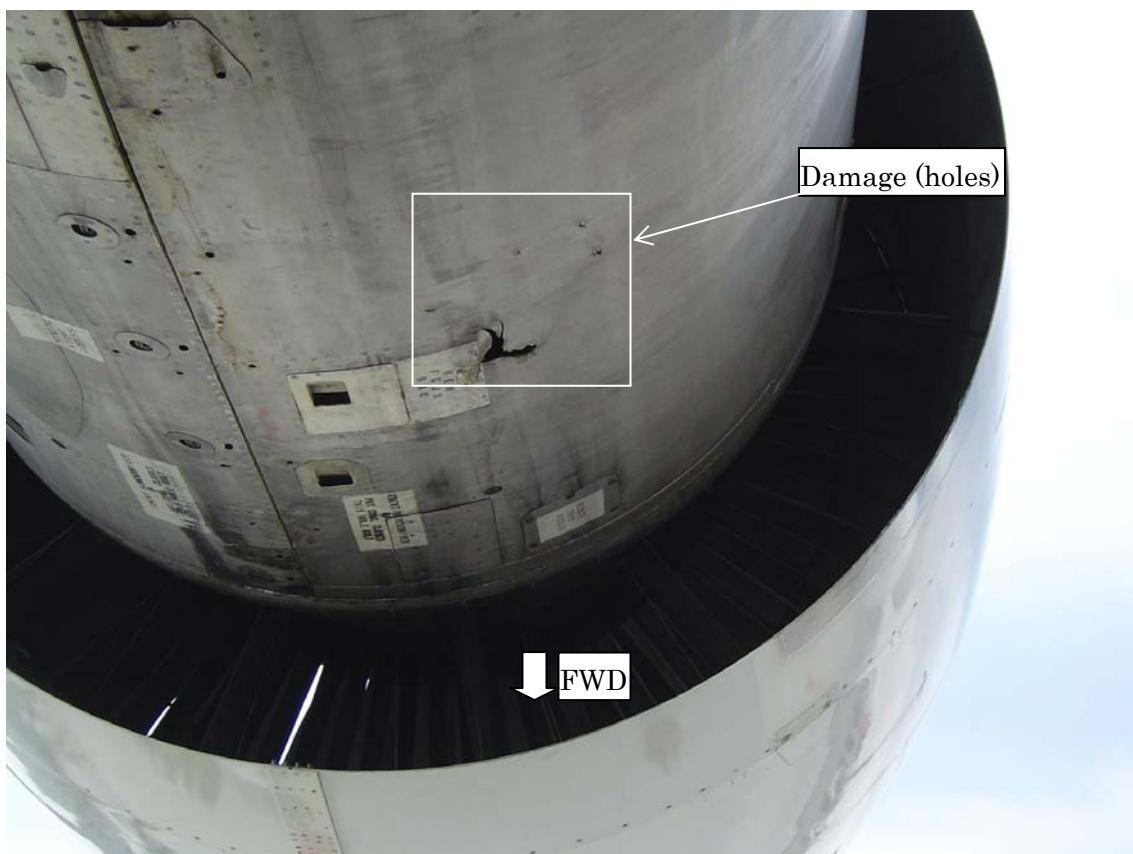
At approximately the 5 o’clock position (**Note 1**), there was key-shaped damage 3cm width, 11cm length and 8cm length at one location and four holes of around 1cm in diameter in the engine cowling.

Photograph 2 Holes on #1 Engine Cowling

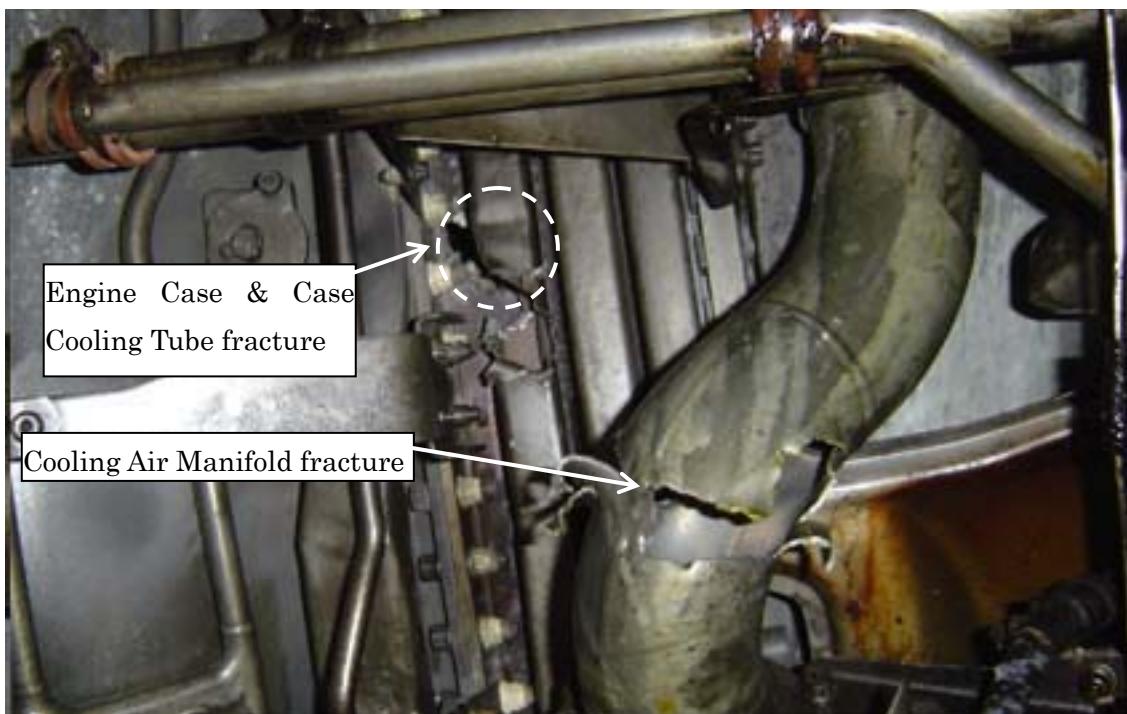
The high-pressure turbine (HPT) case exhibited an approximately 4cm by 2cm hole just forward of the HPT-to-low pressure turbine (LPT) case attachment flange at approximately the 5 o’clock position.

There was damage to the case cooling manifold, which is on the outside of the case, at the 5 o’clock position.

It is estimated that the holes in the turbine case were made when parts of the damaged and separated lenticular seal and/or ruptured turbine blades impacted the turbine case and passed through it.

Photograph 3 Engine Case Fractures

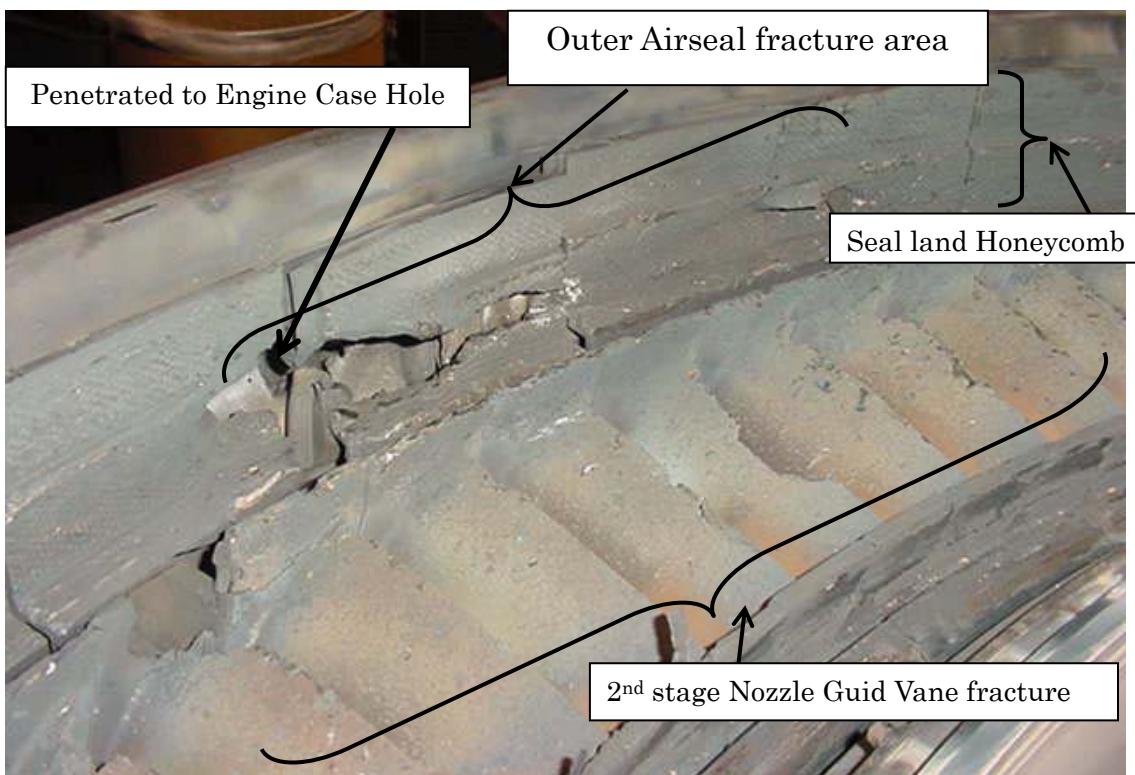
- (2) All the 2<sup>nd</sup> stage turbine blade outer air seal segments exhibited impact damage and almost all the honeycomb was worn away. Four consecutive seal segments, located in the vicinity of the 5 o'clock position, exhibited the worst damage. Two of the seal segments exhibited holes, one exhibited a deep trenching, and one was worn completely through the entire thickness.

Since various sections of honeycomb were found to be worn as described in paragraph 2.9.1(1), it is estimated that the damage to the 2<sup>nd</sup> stage turbine vane inner airseal and the 2<sup>nd</sup> stage turbine blade outer airseals were the result of damaged lenticular seal and ruptured turbine blade fragments lodging between the lenticular seal and inner air seal, and between the turbine blades and the outer air seal, and being carried round.

Photograph 4 Outer Airseal Fracture

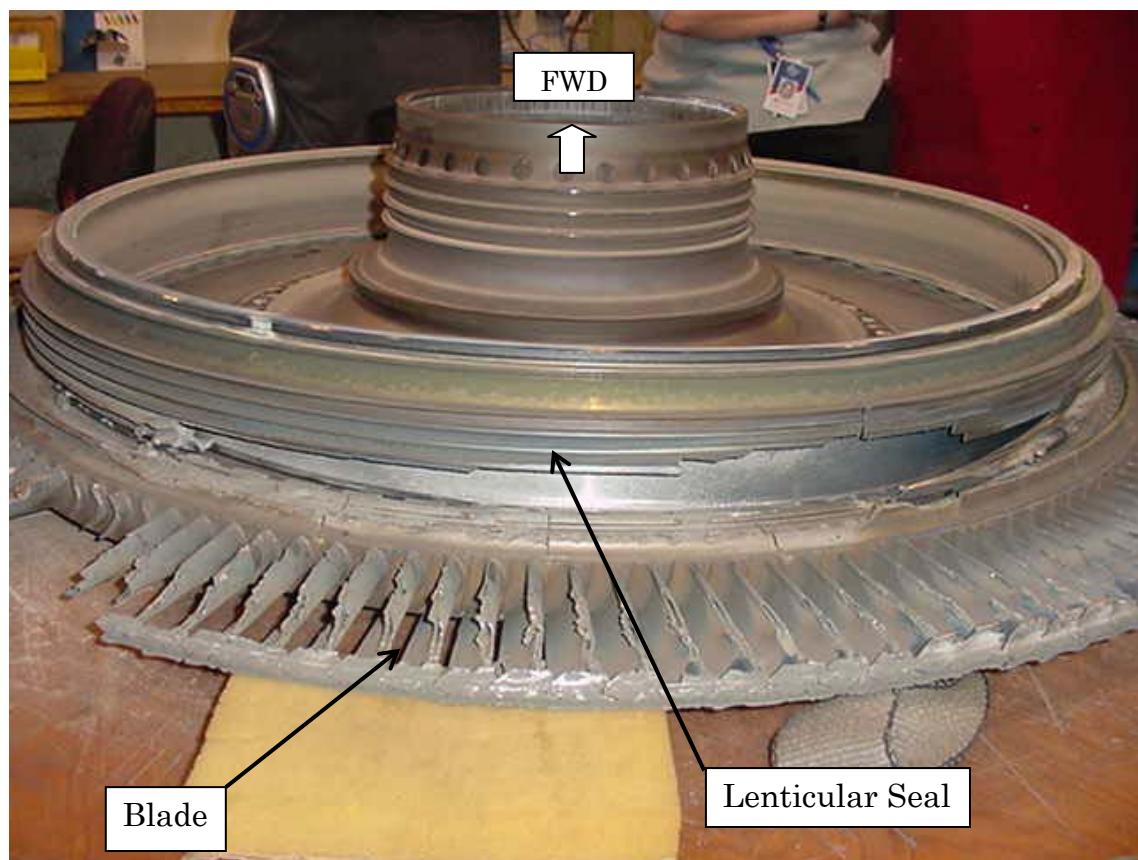
- (1) Twenty four 2<sup>nd</sup> stage turbine blades were fractured at various lengths, and their outer shrouds were missing. Four blades were fractured at the blade platform.

The lenticular seal (**Note 2**) was fractured and not fully engaged with the inner brace at two locations. The lenticular seal exhibited a 21.75-inch circumferential crack that progressed through the 4<sup>th</sup> (**Note 3**) and 5<sup>th</sup> seal teeth. The crack ran roughly through the axial center of the seal. An approximately 17.5-inch

From the impact damage traces on the second stage turbine blades described in paragraph 2.9.1(1), it is estimated that this damage was the result of the impact of ruptured 2<sup>nd</sup> stage turbine blade fragments and damaged portions of the lenticular seal.

Photograph 5 2<sup>nd</sup> Stage Turbine Blade of High-Pressure  
Turbines & lenticular Seal Fracture

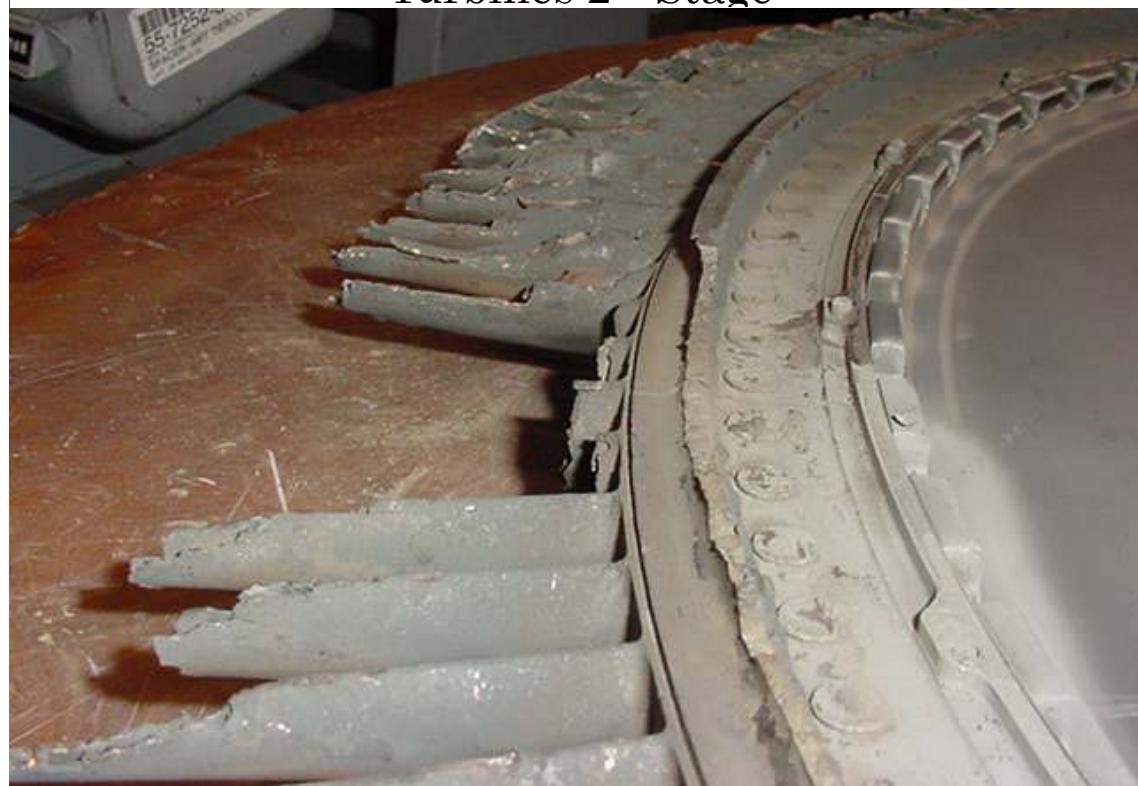
All the 2<sup>nd</sup> stage turbine blades exhibited a combination of leading edge impact damage, gouging, tears and missing material and all trailing edges exhibited minor impact damage.

Photograph 6 Turbine Blade of High-Pressure  
Turbines 2<sup>nd</sup> Stage

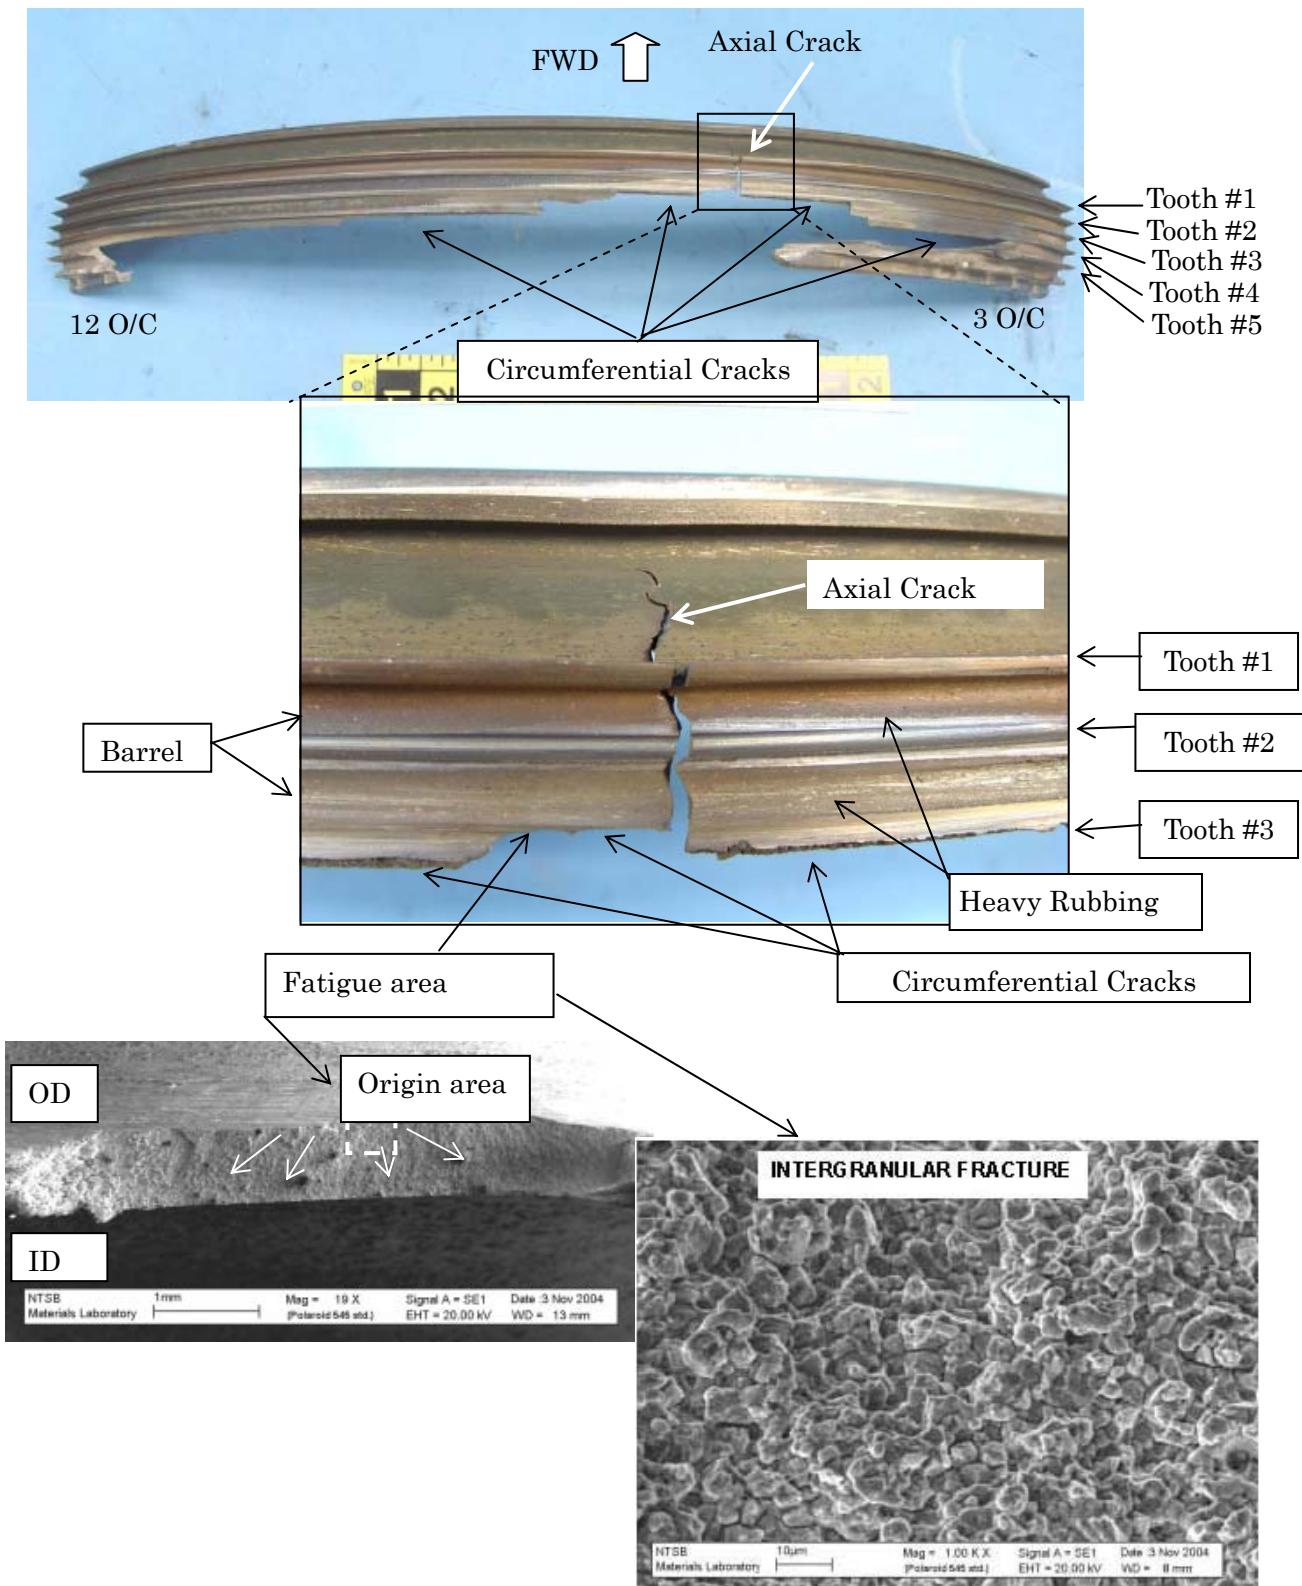
(1) The lenticular seal was missing a large section of the aft flange up to seal tooth No. 2 between the 12 and 3 o'clock position, measuring approximately 18 inches in length and around 2 inches in width. However, sections of the seal remote from the missing area were little damaged and in relatively good condition.

The inner brace was deformed significantly in two places and was uncoupled from the lenticular seal. A large axial crack propagated in the 1:30 position of the lenticular seal.

It is estimated that the cracks in the lenticular seal were the result of high temperature fracture and propagated from the surface to the interior, as described in paragraph 2.9.2.

It is estimated that initiation of the high temperature fatigue was the result of heat stresses due to insufficient cooling combined with the centrifugal force on the lenticular seal, and this caused repeated deformation of the inner brace and the lenticular seal which were attached between the turbine 1<sup>st</sup> and 2<sup>nd</sup> stage turbine disc.

## Photograph 7 Lenticular Seal Cracks

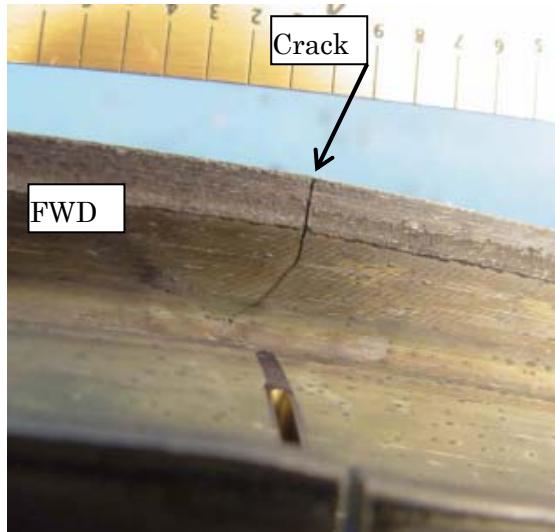
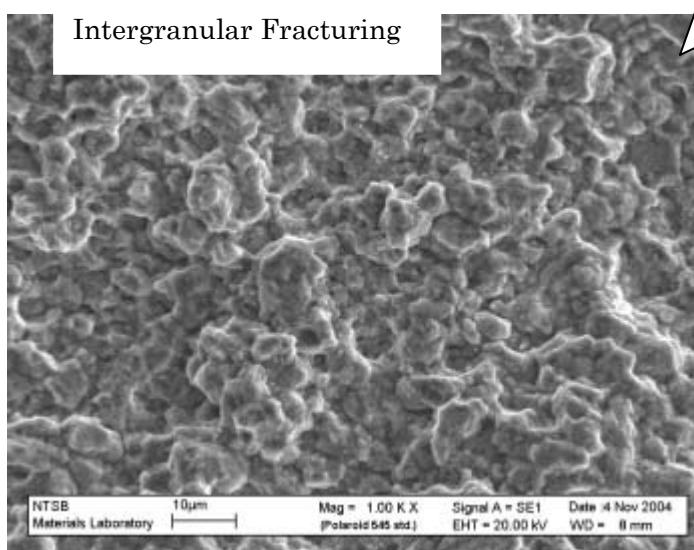
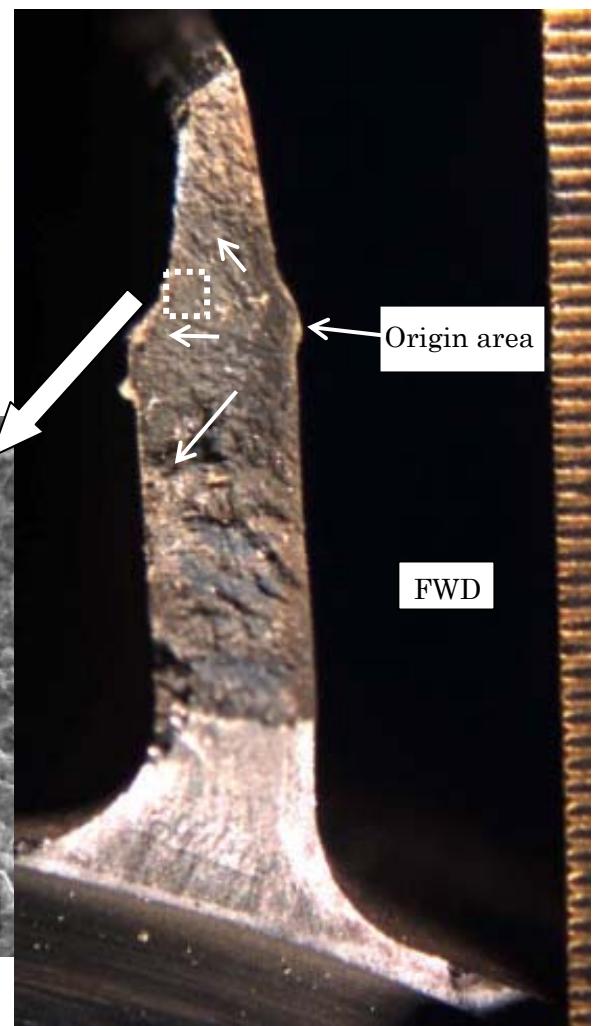
(2) While the nominal thickness of the lenticular seal barrel between the teeth is approximately 0.106 inches, significant non-uniform circumferential rubbing was found on the barrel, and near the missing portion of the seal the minimum thickness was measured at about the 1:30 position, where the barrel was thinned down to approximately 0.024 inches at several locations. At this location, an axial crack approximately 1.1 inches long was observed.

## Photograph 8 Lenticular Seal Tooth #1 Axial Crack

2 o'clock position Axial Crack

Approximately 0.3 inch long

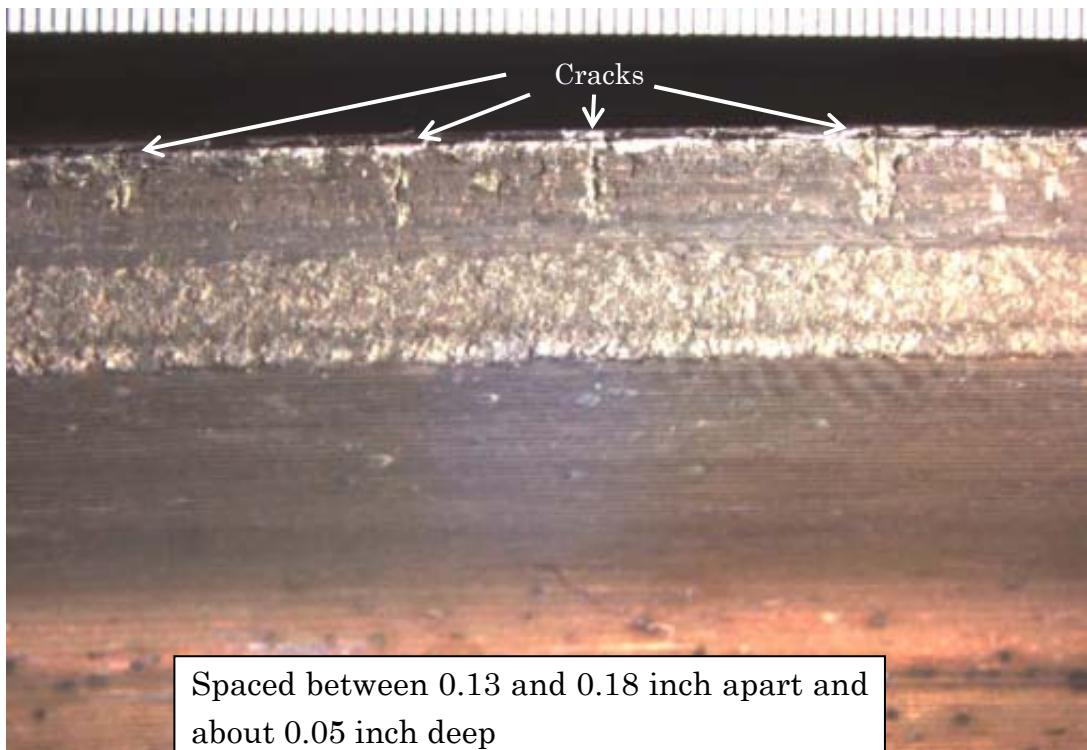
(3) Visual examination revealed that a small region of circumferential fracture in the rub area between tooth No. 2 and No. 3 was on a flat plane, indicative of fatigue cracking. Scanning Electron Microscope (SEM) examination of this region showed the fracture had a thumbnail shape and was entirely intergranular, consistent with high temperature fatigue.

The cracking extended from the outer diameter (OD) surface in the heavily rubbed region toward the inner diameter (ID).

Photograph 9 Lenticular Seal Tooth #1 Cracks

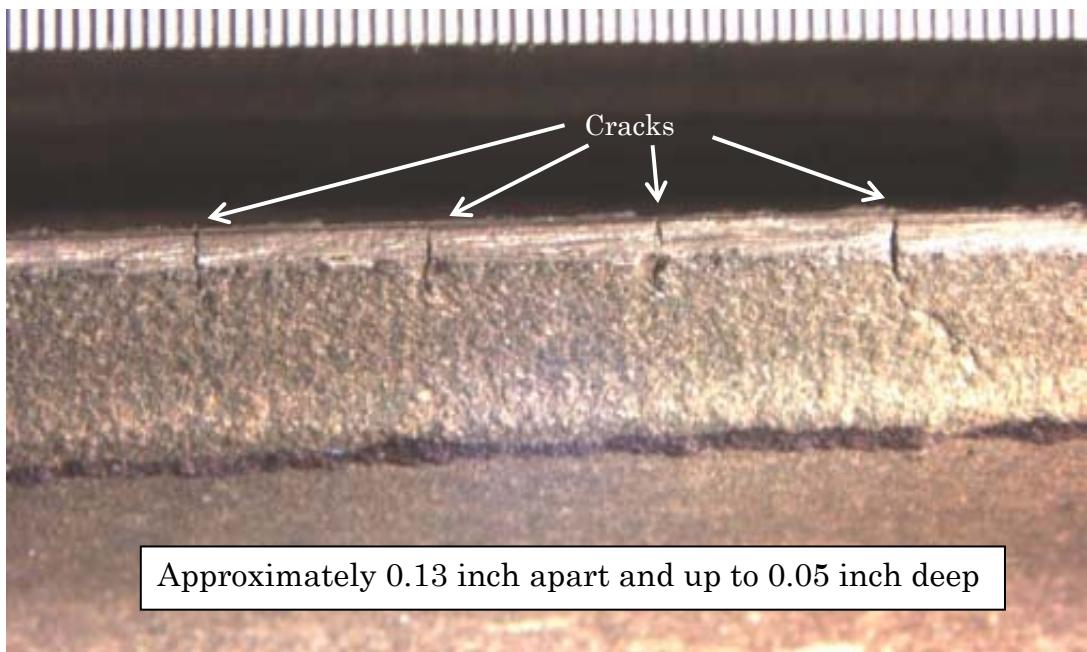
- (5) The fracture surface features of the larger circumferential fracture areas near teeth No. 3 and No. 4 were fairly rough. SEM examination revealed features consistent with high temperature rupture near the OD surface in the area of heavy rubbing. The metal composition in the axial cracking areas is consistent with the engine design specification of improved INCOMNEL 100 powder (PWA 1100 alloy).
- (6) Multiple axial cracks were observed at the tips of the teeth No. 1 and No. 4. These cracks appeared to have initiated from the tips of the seal teeth. SEM examination showed the fracture features to be entirely intergranular cracking, consistent with high temperature fatigue.

Photograph 10 Lenticular seal Tooth #4 Cracks
