AA2011-8

**AIRCRAFT ACCIDENT
INVESTIGATION REPORT**

Japan Transport Safety Board

**NORTHWEST AIRLINES INCORPORATED
BOEING 747-400, N676NW (THE UNITED STATES OF AMERICA)
IN THE AIR ABOUT 174 KM SOUTH-SOUTHWEST OF NARITA
INTERNATIONAL AIRPORT
AROUND 11:45 JST, FEBRUARY 20, 2009**

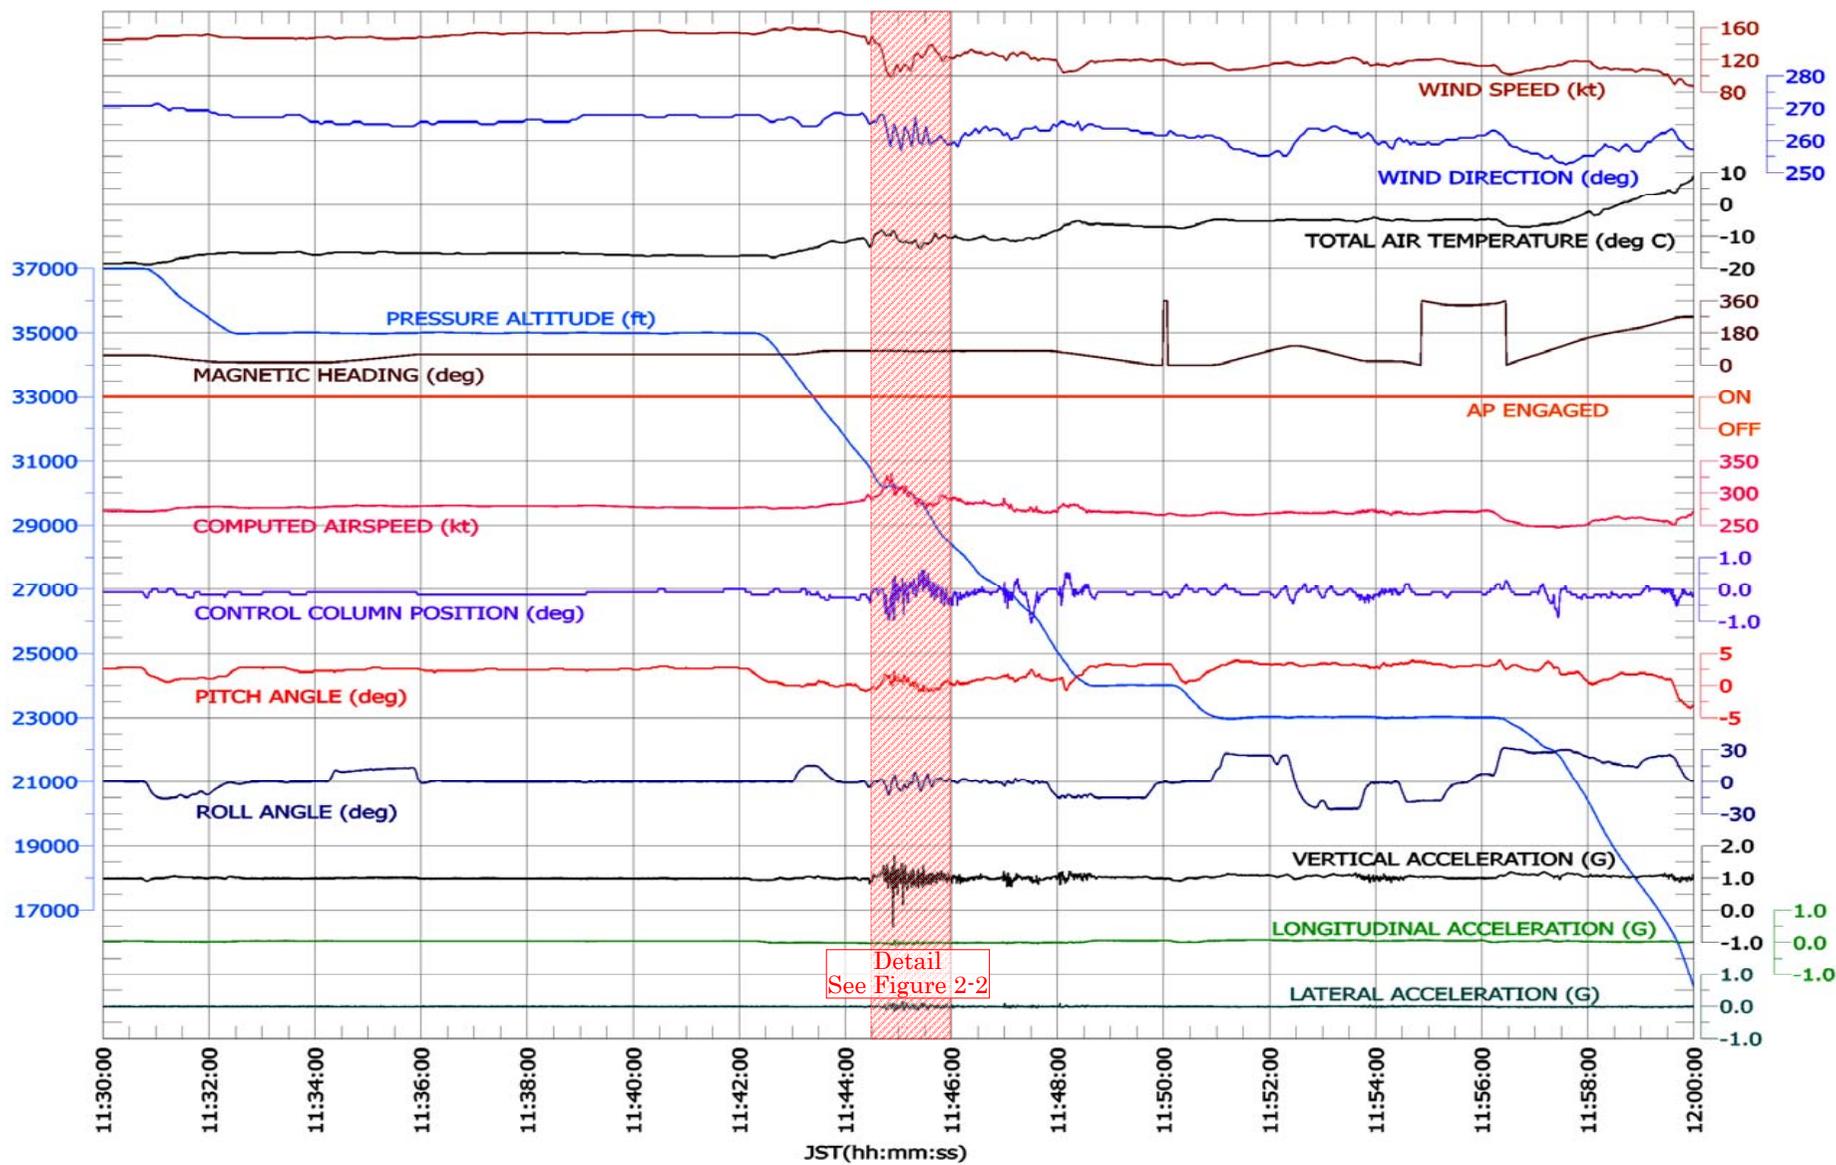
Figure 2-1 DFDR Records (1)

11:44:30 to 44:52 The wind velocity began to change. The wind velocity dropped to about 100 kt from about 150 kt when the Aircraft was descending by about 500 ft from about 30,700 ft. (The tail wind component for the Aircraft also decreased to about 100 kt from about 150 kt and as a result, the rate of climb changed to an ascent of about 300 fpm from a descent of about 1,100 fpm.

11:44:53 to 44:55 When the Aircraft was descending at an altitude of about 30,300 ft, the vertical acceleration changed; from +1.36G to -0.52G, then to +1.70G. At that time, the pitch angle of the Aircraft decreased by about 0.5 degree in the nose-down direction and after the decrease, quickly increased by about two degrees in the nose-up direction.

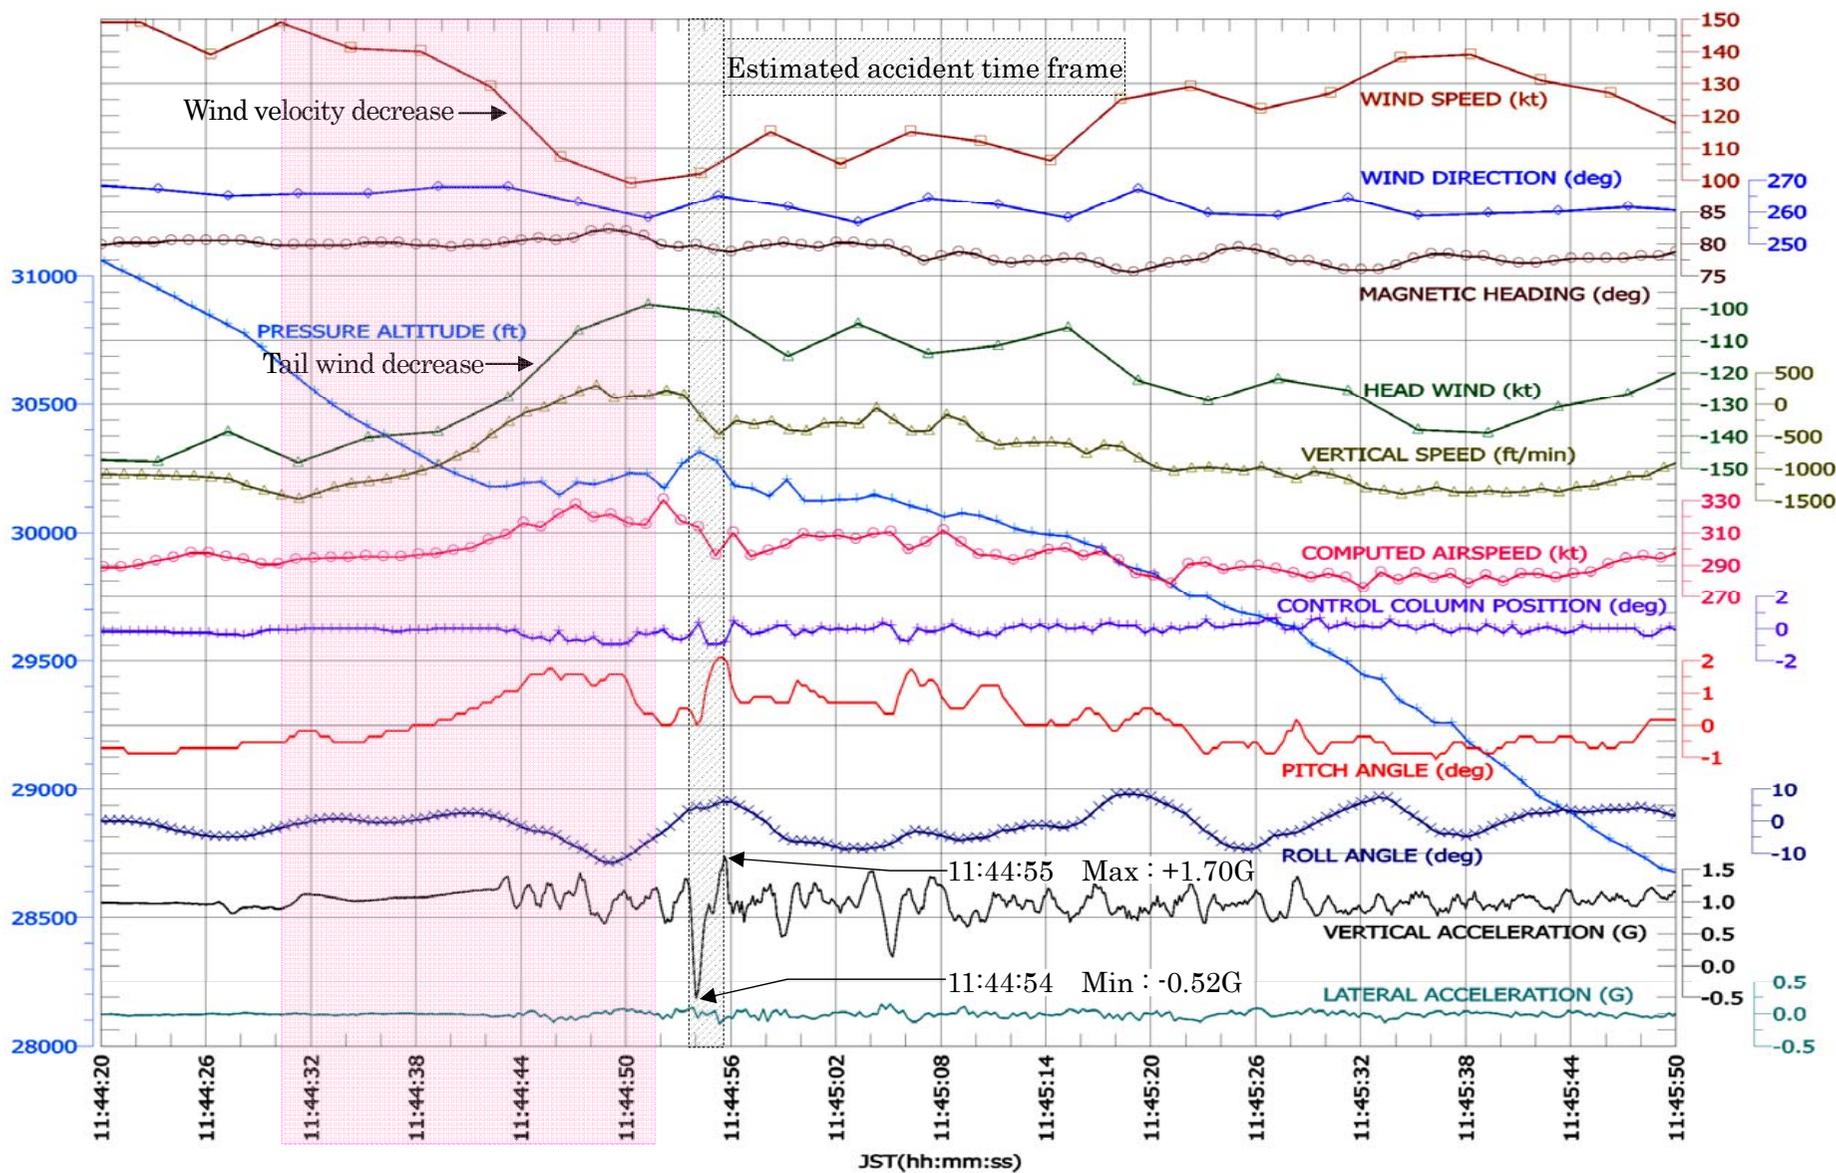
Figure 2-2 DFDR Records (2)

In the rest of the flight until landing, the vertical acceleration changed intermittently while decreasing. The Aircraft landed at Narita Airport around 12:19 and parked at Gate 24 around 12:25.

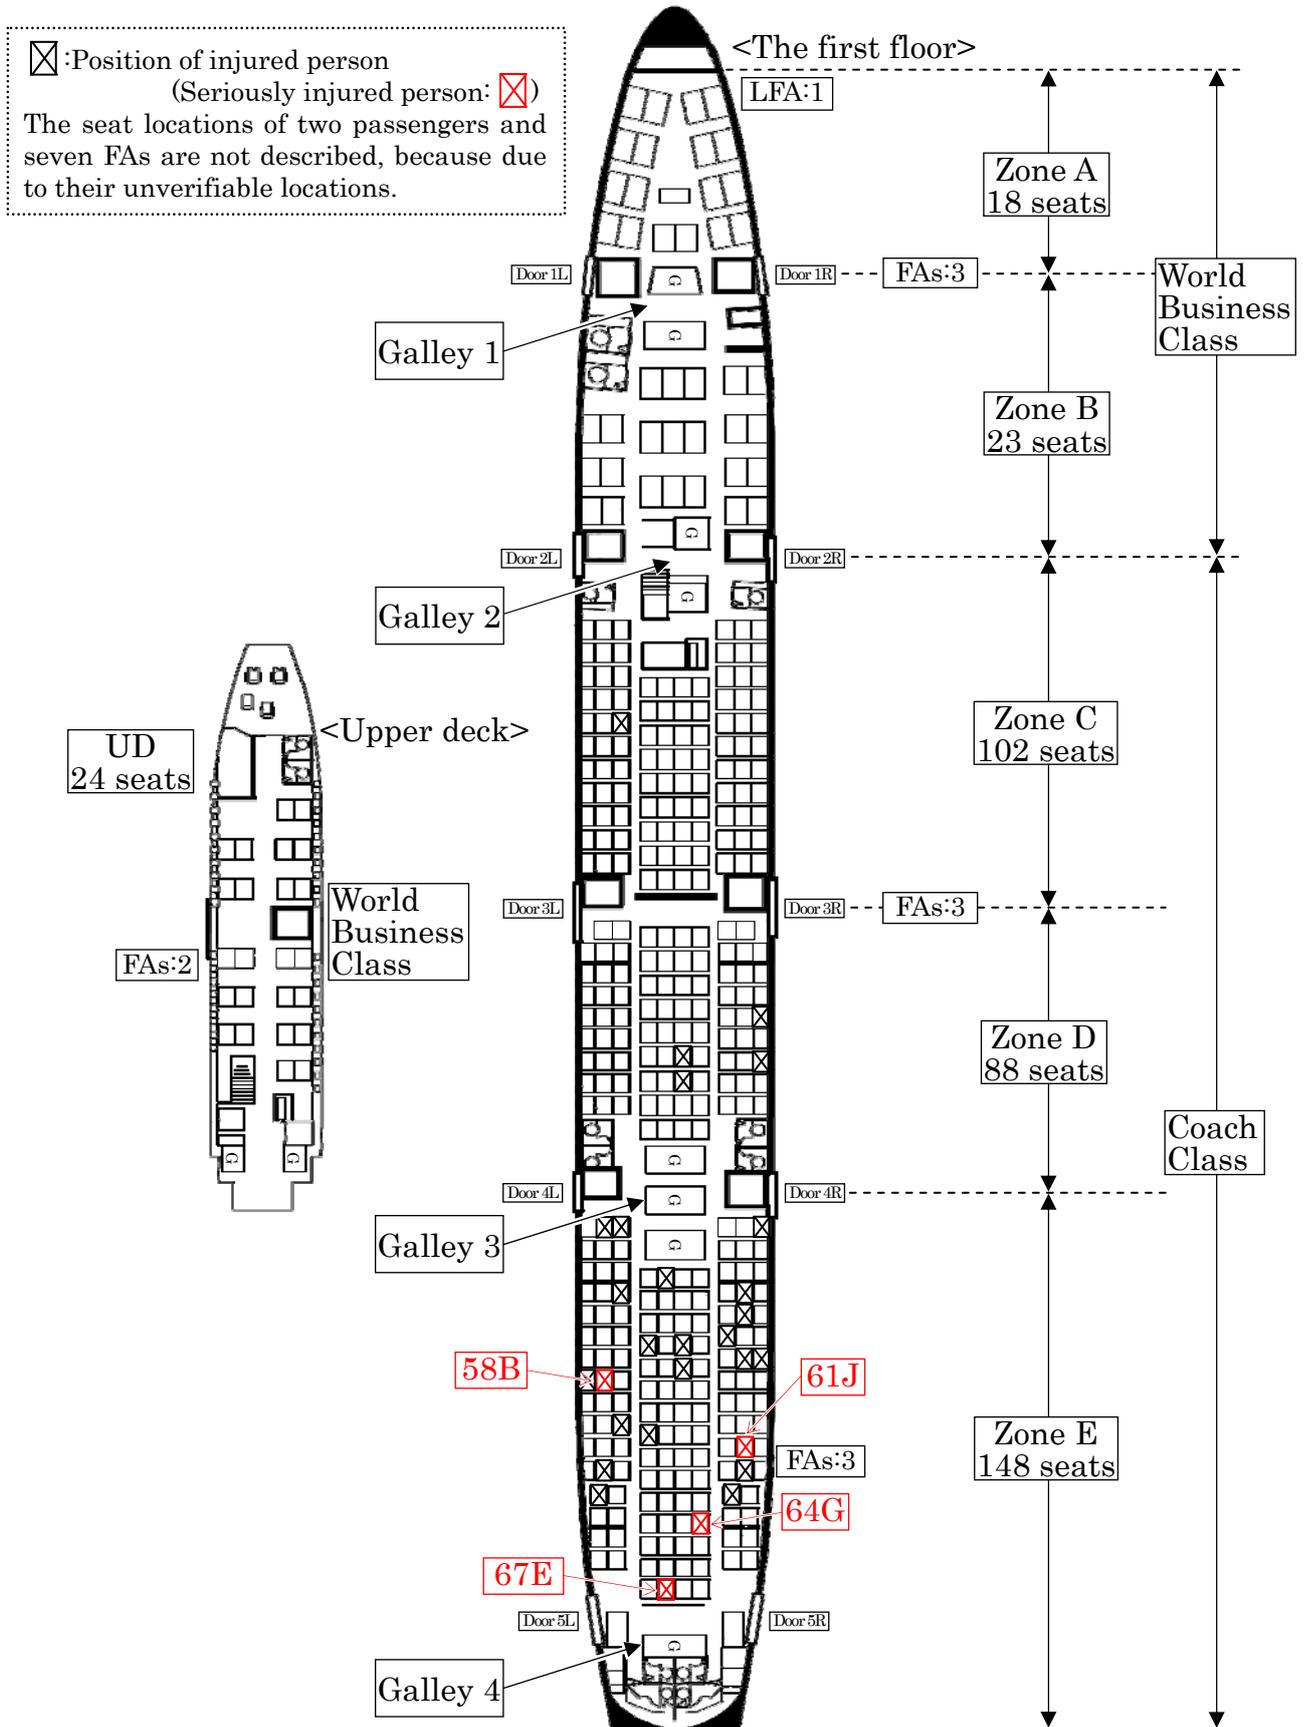
Figure 3 Seat Locations of Injured Persons

- (1) Injured Person A Multiple fracture of the costae
(Passenger in Seat 58B, Male, Age 65)
- (2) Injured Person B Avulsion fracture of the No. 2 cervical vertebra body,
Fracture of the left arch bone of the No.7 cervical
vertebrae
(Injured in the lavatory in the left aft section)
(Passenger in Seat 67E, Female, Age 35)
- (3) Injured Person C Compressed fracture of the No. 5 thoracic vertebrae,
Central damage to the cervical cord
(Passenger in Seat 61J, Female, Age 60)
- (4) Injured Person D Fracture of the No. 2 cervical vertebra body,
Fracture of the spine of the No. 6 cervical vertebrae,
Bruises in the head
(Passenger in Seat 64G, Male, Age 65)

It is considered somewhat likely that the following factors contributed to the serious injuries of aft cabin passengers: safety of passengers was not fully confirmed in the aft cabin section during the time frame between the seat belt sign illumination and the abrupt big aircraft pitching; and the aft cabin was exposed to a stronger negative vertical acceleration compared to the forward.

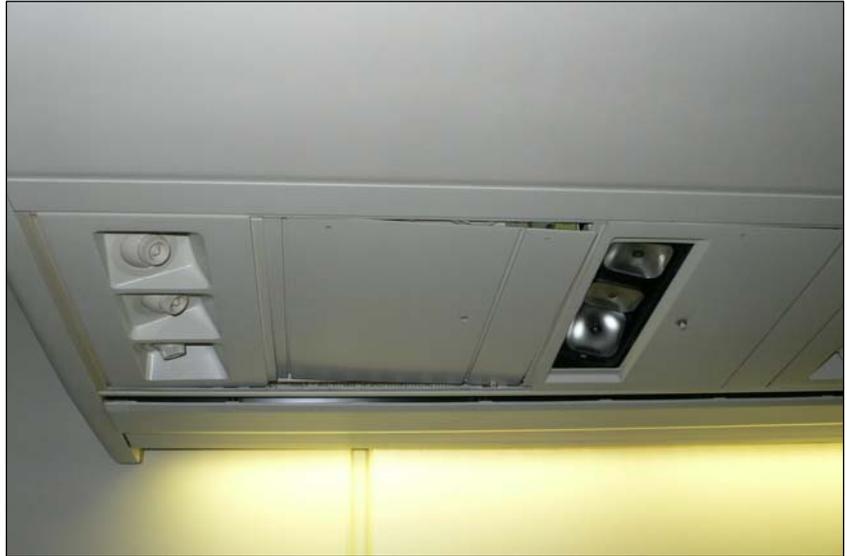
Cabin ceiling

(1) Damage to the cabin ceilings above the following seats.

Scratches: Seat 21B, Seat 59J

Wrinkles, dents: Seat 41B, Seat 62H

Detached panels, dents: Seat 51K, Seat 55J

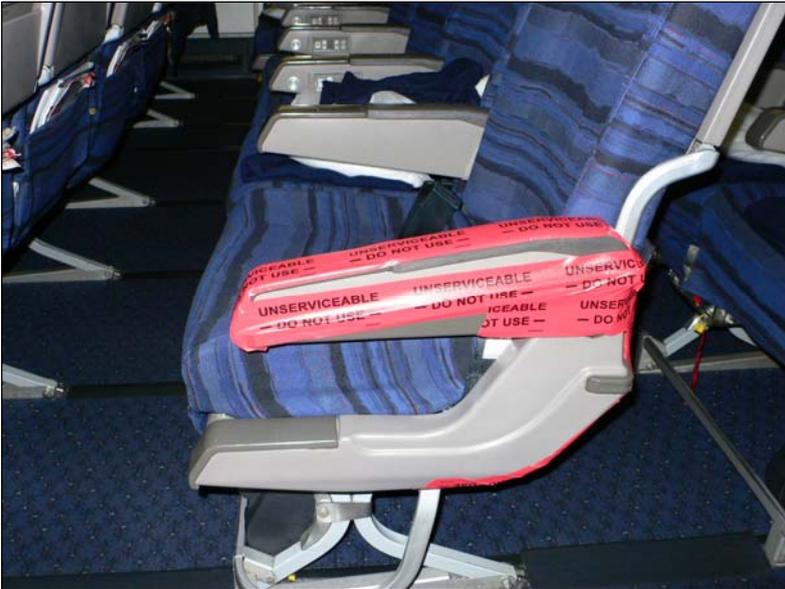
Armrest

(2) Damage to the seats

Armrests: Seat 40D, Seat 57B, Seat 58G, Seat 66G

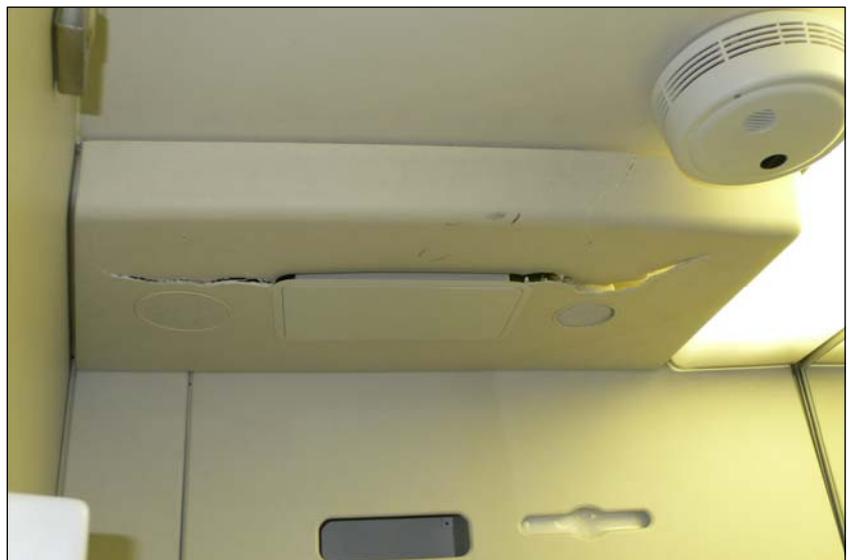
Lavatory ceiling

(3) Cracks and damage to the lavatory ceiling: In the aft left section.
