**AIRCRAFT ACCIDENT  
INVESTIGATION REPORT**

**PRIVATELY OWNED  
N 7 0 2 A V**

## CRASH DUE TO LOSS OF CONTROL DURING FLIGHT PRIVATELY OWNED SOCATA TBM700, N702AV IN YAMAZOE VILLAGE, YAMABE-GUN, NARA PREFECTURE AT AROUND 12:15 JST, AUGUST 14, 2017

June 14, 2019

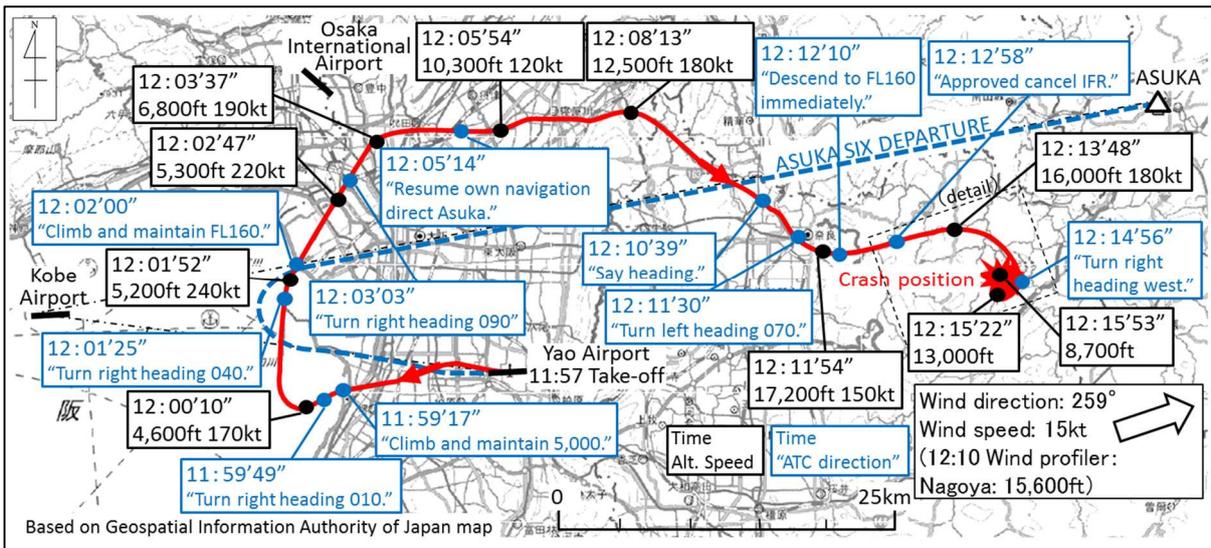
Figure 1: estimated flight route

According to the radar track records for air traffic control at Kansai Aerodrome control tower, the estimated flight route of the Aircraft after the take-off until the crash is as shown in Figure 1.

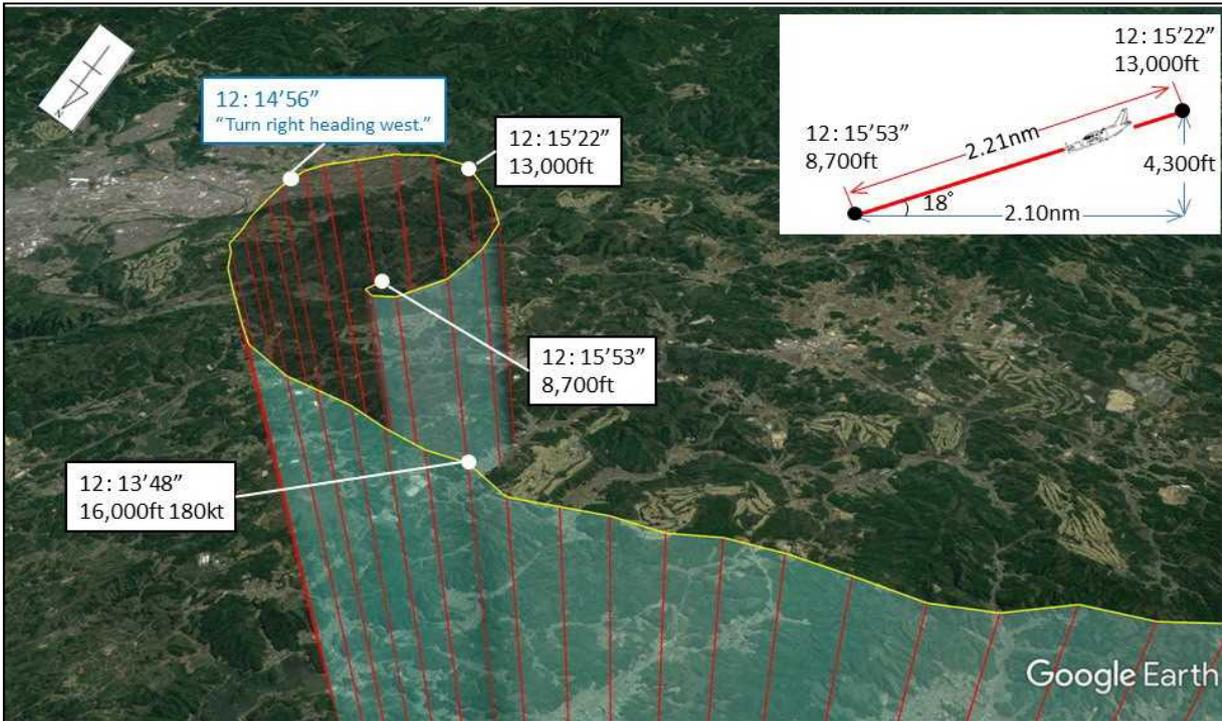
Figure 3: estimated flight route (detailed)

The flight route from 12:15:22 to 12:15:53 was about 2.21 nm in distance along the route and about 18° in descent angle. (See Figure 3.)

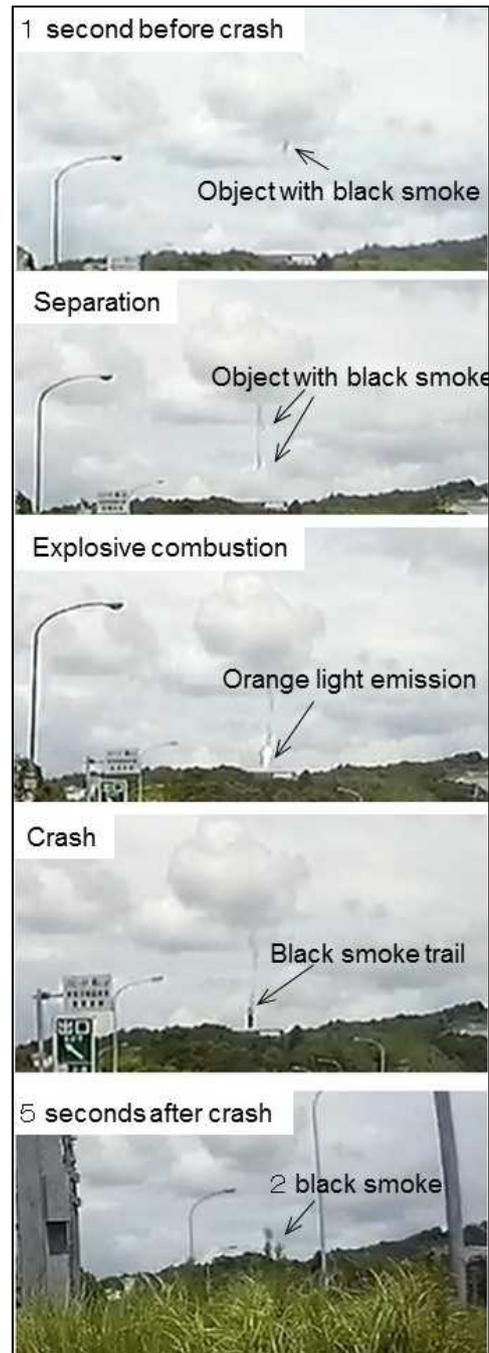
Figure 5: continuous photos of the dashboard camera

One second before the crash, an object that seemed to be the Aircraft emerged from the low cumulus layer trailing black smoke, and went falling down. Subsequently, an object separated from the object falling first came out trailing black smoke. The first emerged object burned explosively emitting orange light before impacting the ground. After the two objects had reached the ground, the trailing black smoke disappeared gradually. Five seconds after the crash, two columns of black smoke trailed from the vicinity of the crash site.

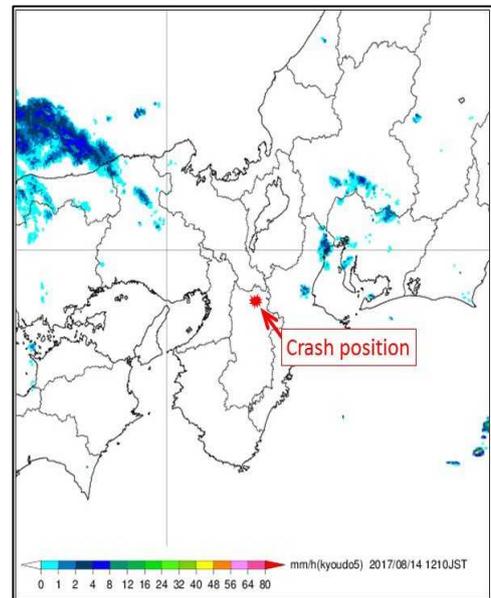
Figure 6: radar image (12:10)

The echo status of the weather radar (reflection intensity) near the accident site was as shown in Figure 6, and no noticeable echo was confirmed near the Aircraft's crash position.

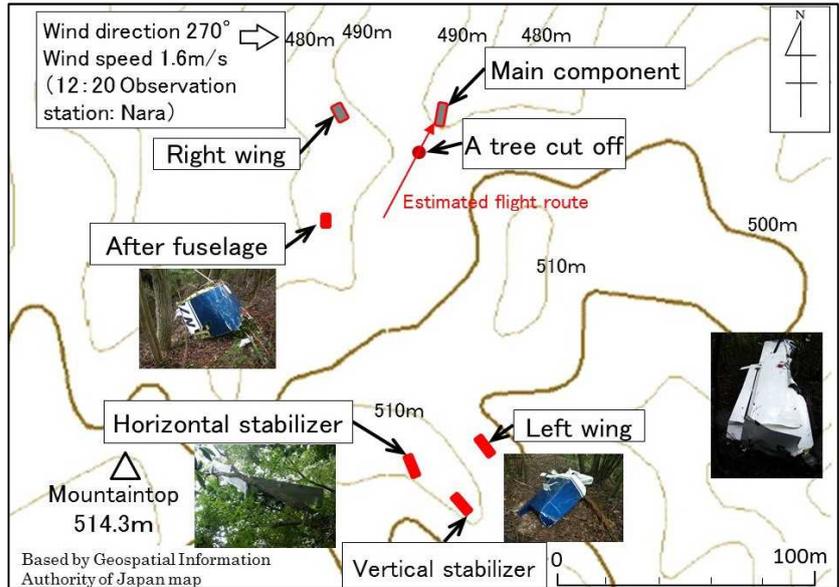
Figure 7: condition of the Aircraft scattering

The right wing was broken halfway and

found lying with its top surface facing up, on the ground of

right wing was entirely burned, particularly the fracture

surface was burned at high temperature, and therefore,

The broken fuselage aft was found on a slope over the

antenna of the emergency locator transmitter (ELT)

installed in the fuselage aft had fallen off.
