AI2021-7

**AIRCRAFT SERIOUS INCIDENT
INVESTIGATION REPORT**

**SILVER AIR CORP.
N 8 2 9 R A**

LOSS OF CABIN PRESSURIZATION SILVER AIR CORP. BOMBARDIER BD-700-1A10, N829RA AT FL250 ABOUT 92 KM NORTH-NORTHEAST OF NAHA AIRPORT AT AROUND 18:09 JST, FEBRUARY 20, 2020

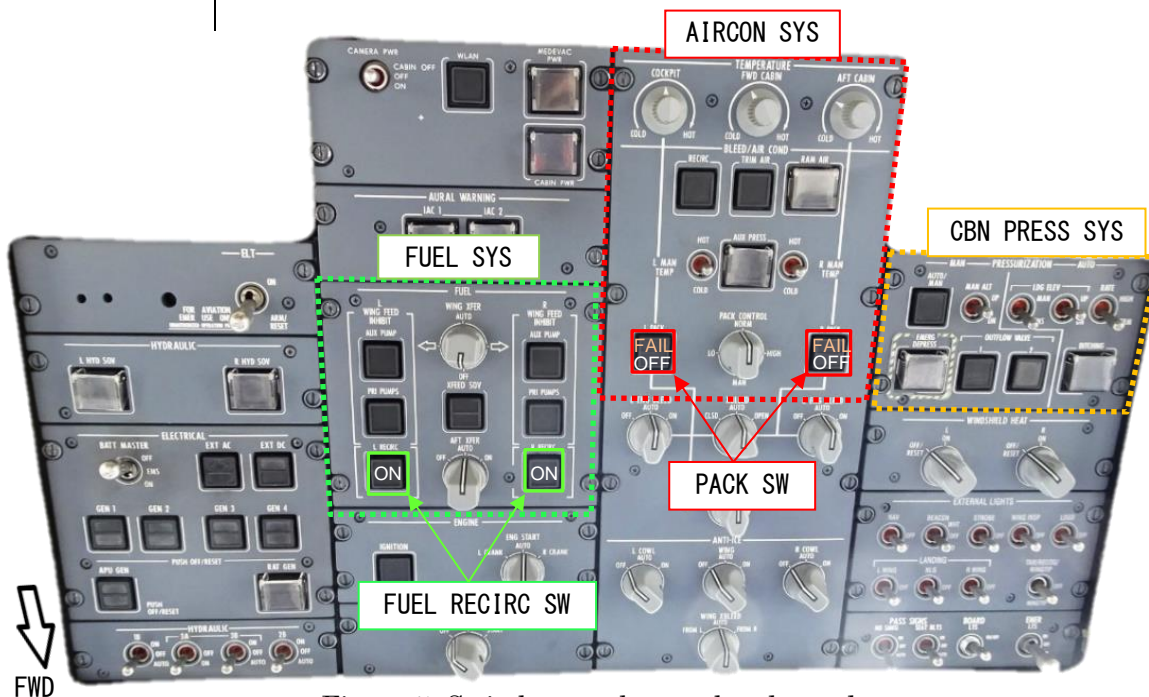
Figure 5: Switches on the overhead panel

The air conditioning system panel and the fuel system panel are located side by side on the overhead panel. These switches are similar in shape and size and action.

- (3) Fuel RECIRC and PACK switches are similar in placement and shape as well as operations, and according to the CVR records at 18:24, the flight crew member said a word about fuel recirculation system, therefore it is possible that the flight crew member was going to push “ON” the switches of fuel RECIRC system but erroneously pushed both PACK switches to position “OFF”.

- (1) Strict adherence to checklists and procedures during all phases of flight, especially in climb out and cruise, as was identified in this incident.
- (2) It was informed that it is important for a PIC to emphasis on Crew Resource Management (CRM) and crew communication is vital and will be briefed and emphasized during all phases of flight.
- (3) Review of fuel recirculation procedures on aircraft with manual fuel recirculation action, such as N829RA, crew shall do a thorough review of the fuel recirculation system to include limitations of such actions.
- (4) Re-emphasis the challenge and response items to various phases of the checklist to ensure proper cockpit switchology.

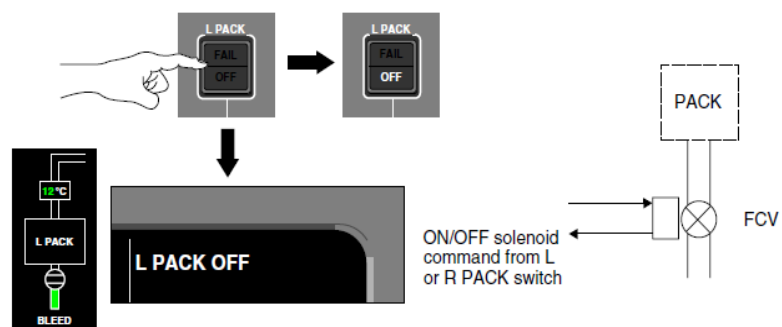
Figure 7: PACK operation

- (2) The PIC stated that “Neither pilot, nor any crewmember, at any time turned off the PACKS or any portion of the cabin pressurization system during the flight”, however, the message of “L-R PACK OFF” (Status) was indicated around 18:00. Because the logic is that this message is not indicated unless both PACKS switches are turned "OFF", it is highly probable that the flight crew member erroneously pushed both PACK switches to position “OFF” and both PACKS were shut down resulting in cabin altitude climb.

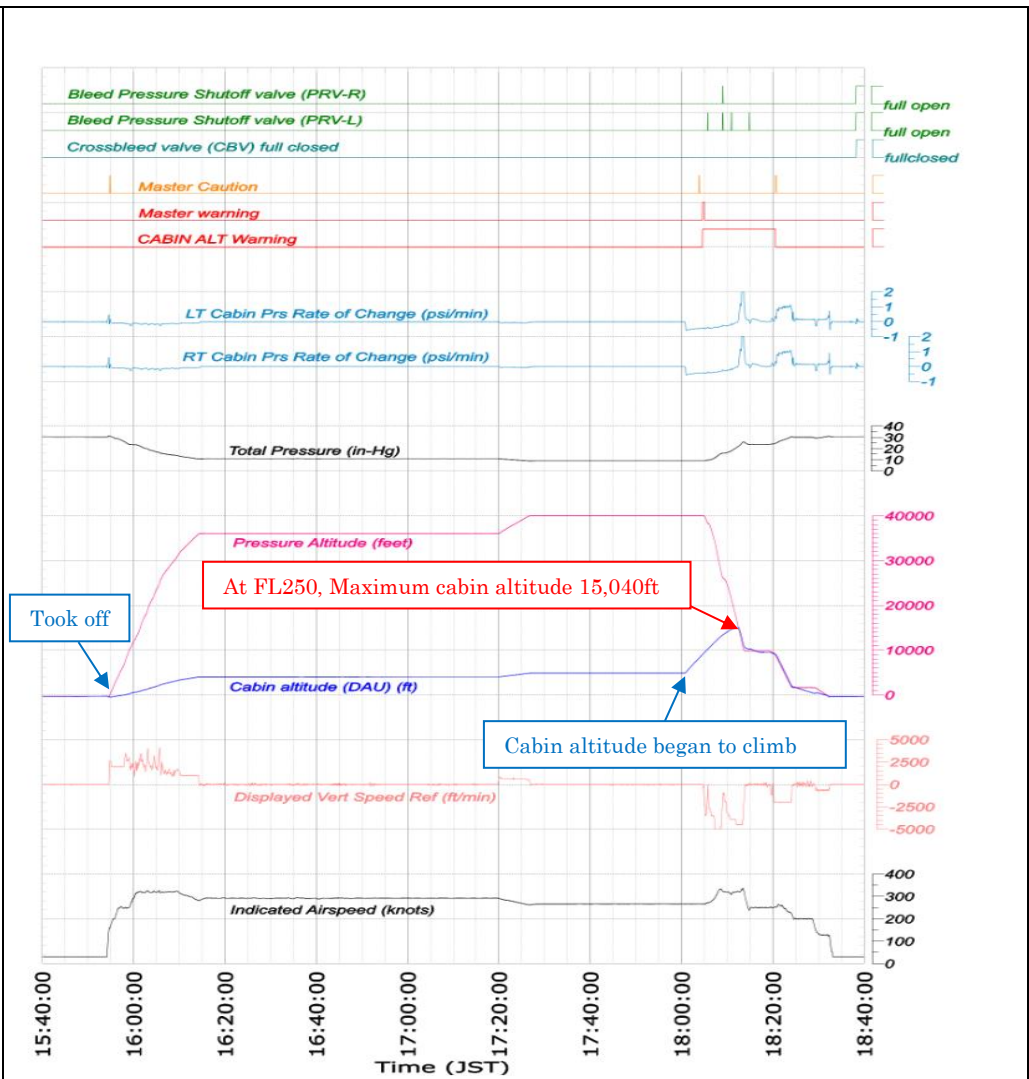
Figure 8: DFDR records

According to DFDR records, around 18:00, the cabin altitude began to climb. Any other records indicating the abnormality of the aircraft were not recognized.
